STILL GOING WRONG!

Case Histories of Process Plant Disasters
and How They Could Have Been Avoided

Trevor Kletz

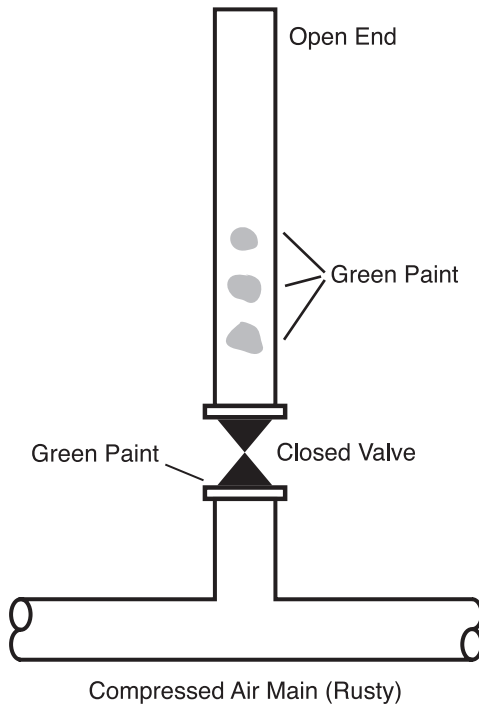
Figure 1-1. The lower flange was unbolted in error.

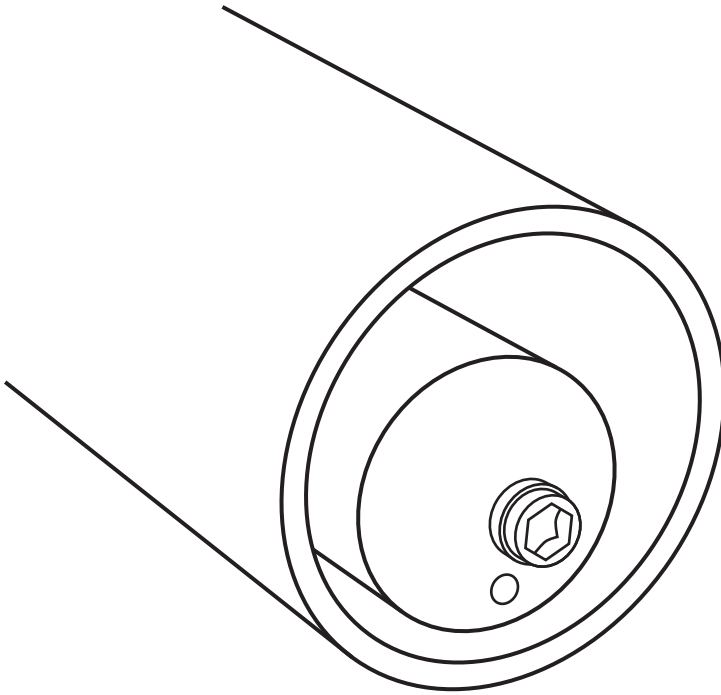
Figure 1-2. When a length of new pipe was cut open, a propane cylinder was found inside it. Fortunately the cutting tool just missed it.

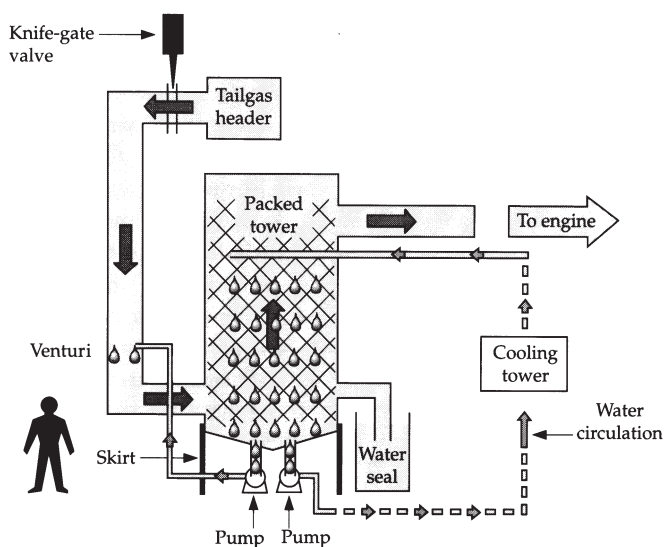
Figure 2-1. A man was overcome by leaking gas while replacing a pump in a confined space. From reference 7. Reprinted with the permission of the Institution of Chemical Engineers.

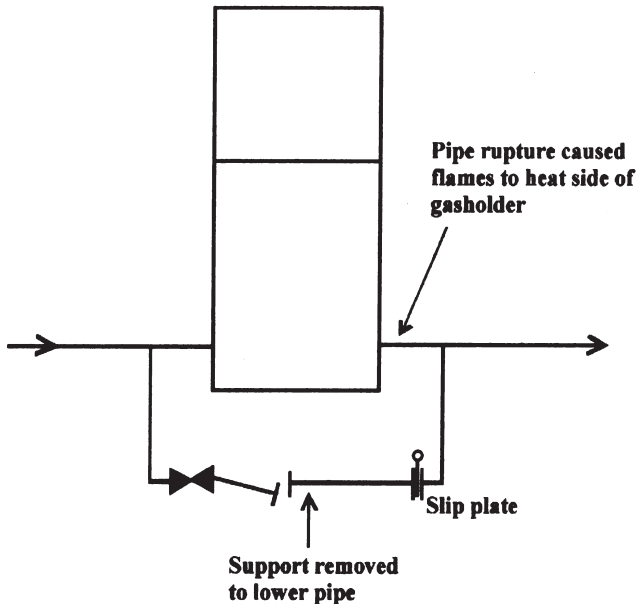
Figure 2-3. Gas leaked through closed valve while burning was in progress nearby.

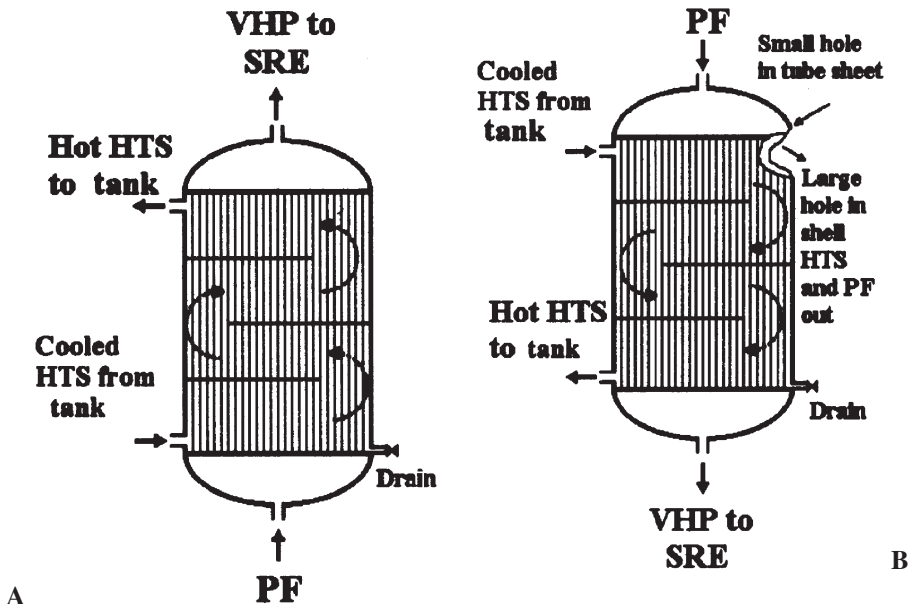
Figure 3-1a,b. (a) Original design of reactor; (b) Reversing the flow allowed a gas bubble to be trapped below the top tubesheet and led to overheating of the tops of the tubes. PF = Preheated feed; HTS = Heat transfer salt; VHP = Very hot product gases; and SRE = Steam raising exchanger. From reference 10. Reprinted with the permission of the Institution of Chemical Engineers.

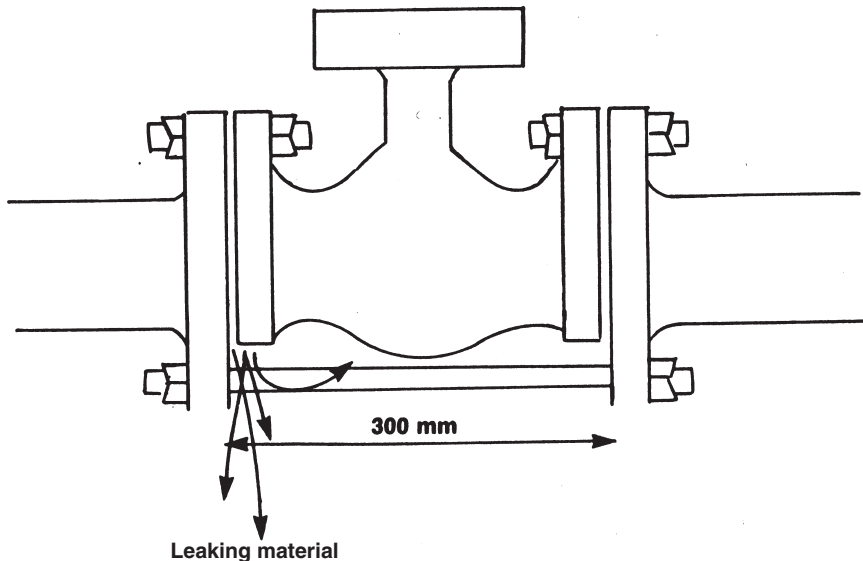
To save energy, a company decided to insulate a valve, shown in Figure 3-2, which operated at 310 °C (600 °F). The three long bolts expanded and

Figure 3-2. When this valve was insulated to save heat, the long bolts expanded and the flanges leaked.

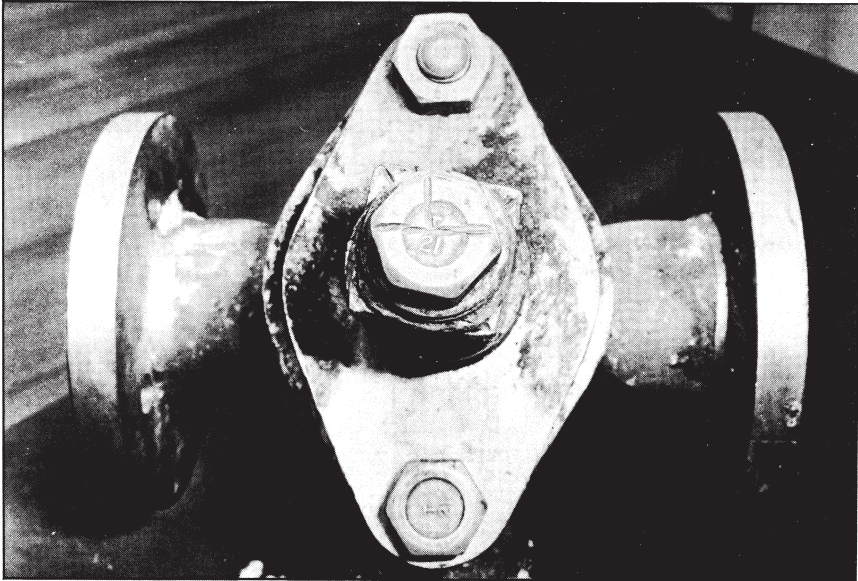
Figure 3-3. The central bolt was marked to show the position of the cock. When two washers were inserted under the bolt, it could not be screwed down as far as before and the marks no longer corresponded with the position of the cock.

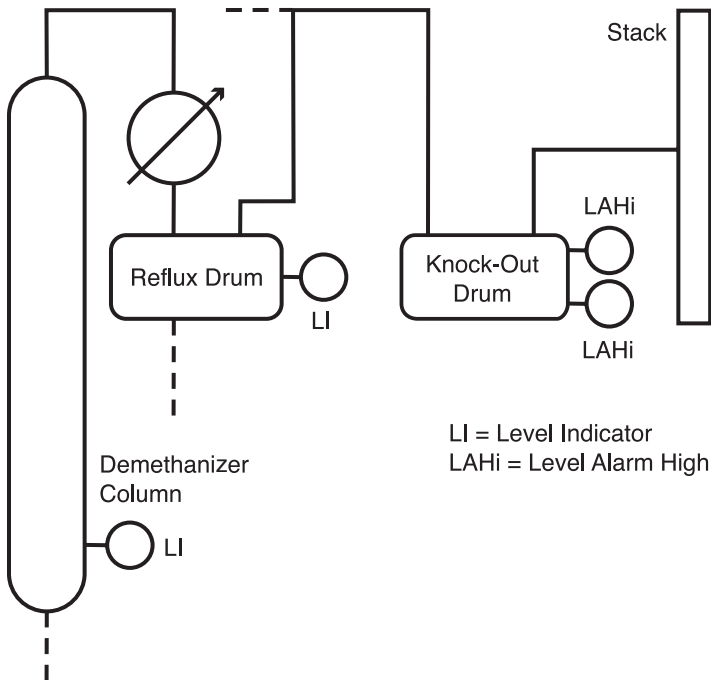
Figure 4-1. The level indicator on the column and the level alarms on the knock-out drum were out of order. The column filled with liquid, which overflowed into the drums and then into the stack.

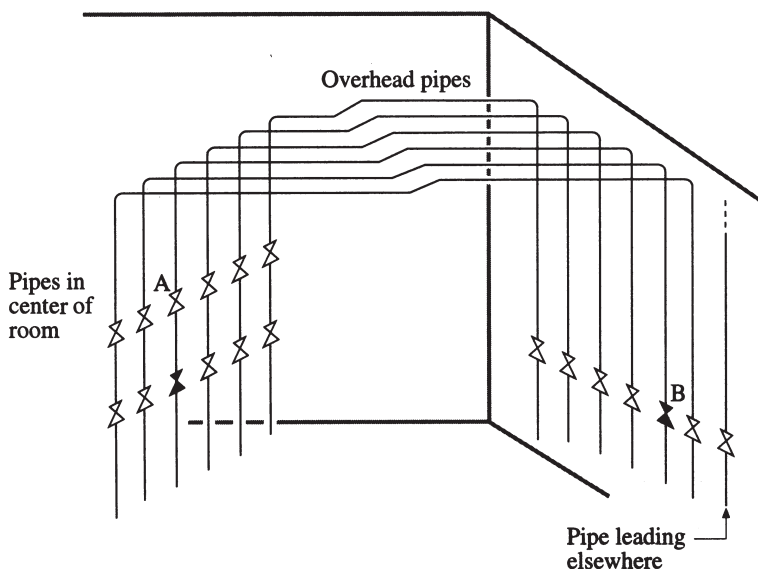
The fine adjustment valve A in Figure 5-1 had to be changed. The operator closed the valve below it. To complete the isolation, he intended to close the valve on the other side of the room in the pipe leading to valve A. He overlooked the double bends overhead and closed valve B, the one opposite valve A. Both of the valves that were closed were the third from the ends of their rows. Note that the bends in the overhead pipes are in

Figure 5-1. To change valve A, the operator closed valves B and C. From reference 5. Reprinted with the permission of the Institution of Chemical Engineers.

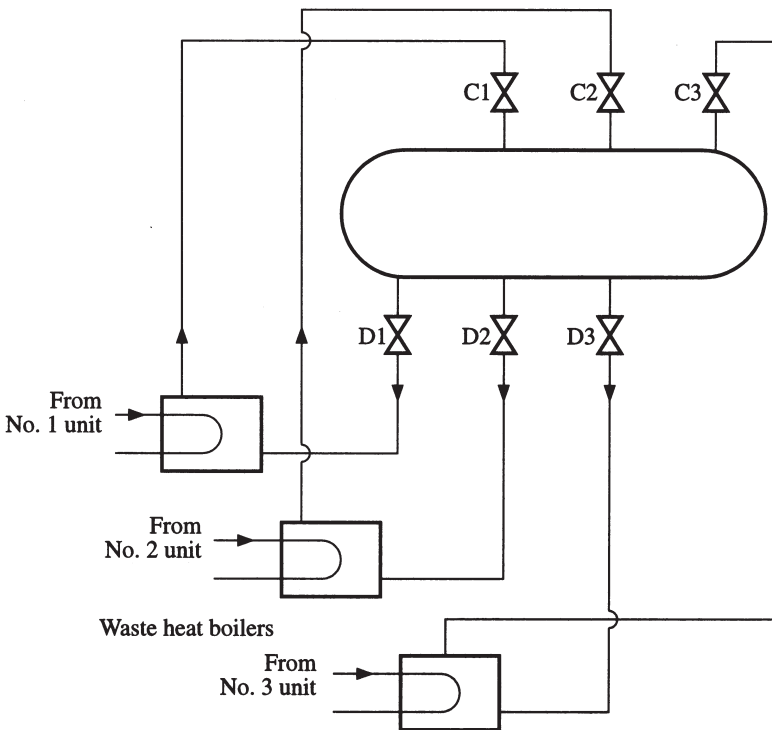
Figure 5-2 shows a similar situation. To save cost, three waste heat boilers shared a common steam drum. Each boiler had to be taken off line from time to time for cleaning. On two occasions, the wrong valve was closed (D3 instead of D2) and an on-line boiler was starved of water and

Figure 5-2. Note positions of isolation valves on the common steam drum. Reprinted with permission of *EVHE*, Fig. 2.6, 2001, page 23.

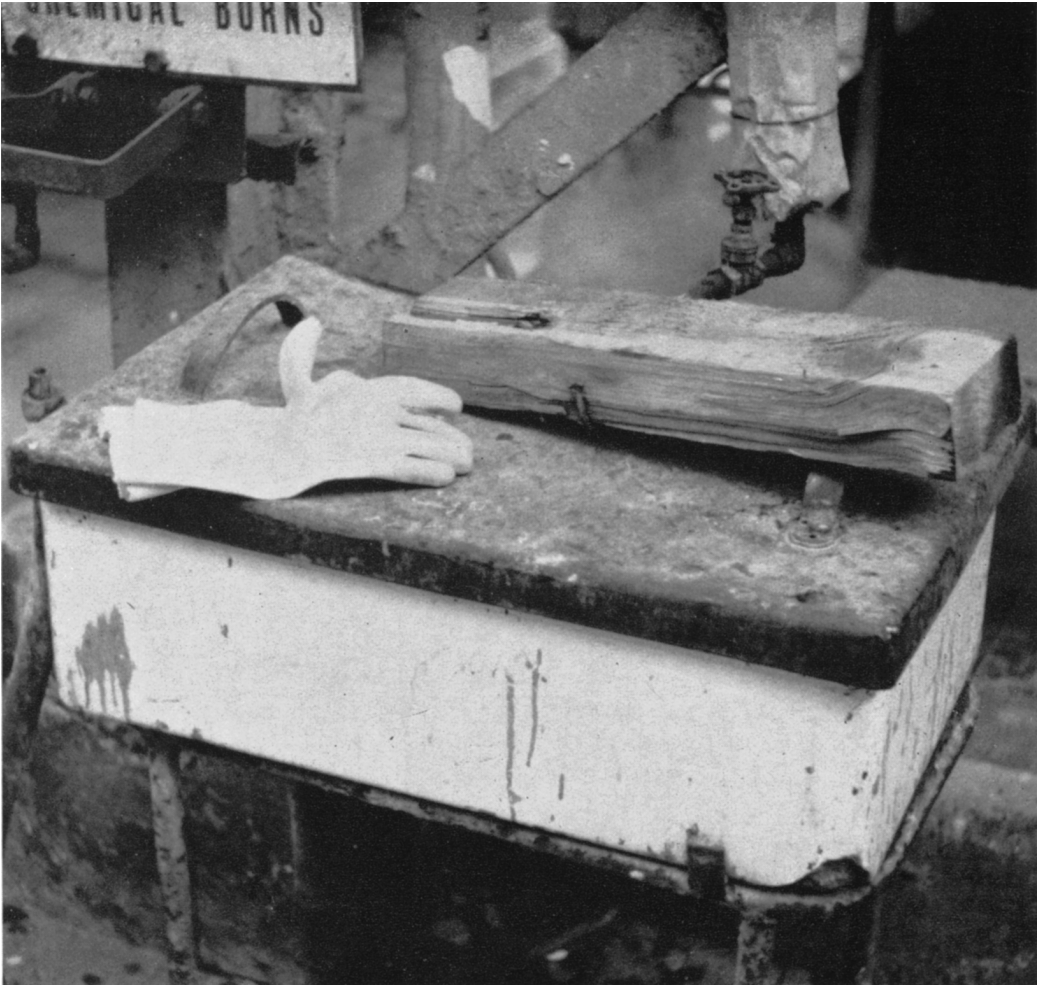
Figure 5-4a. The cover over the wash basin was used as a table.

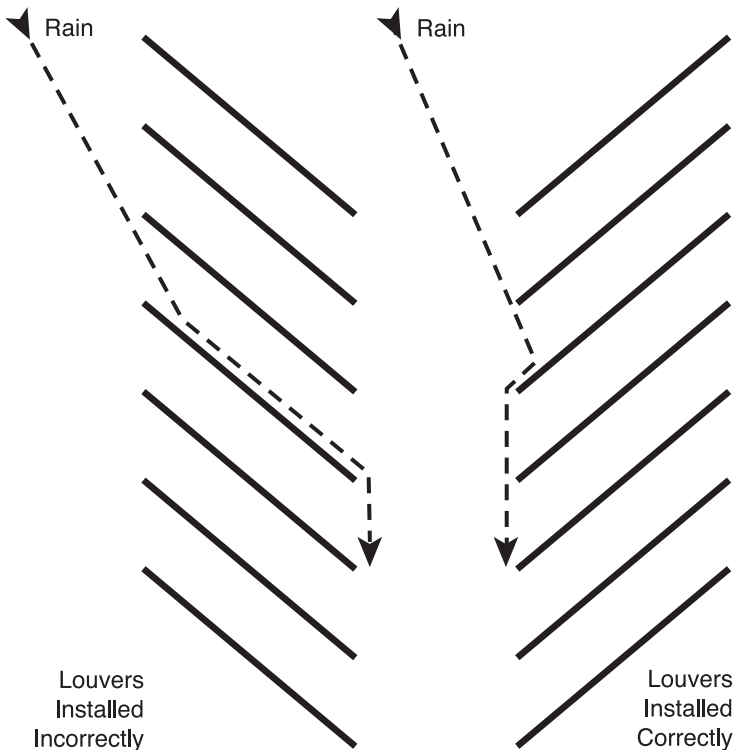
Figure 5-5. The louvers were installed so that they directed spray and rainwater through them.

The report's first recommendation [4] was that louvers should be checked to make sure they are fitted correctly. It did not suggest that they should be designed so that they could not be fitted incorrectly, so that it was obvious if they were or so that the inside and outside, top and bottom,

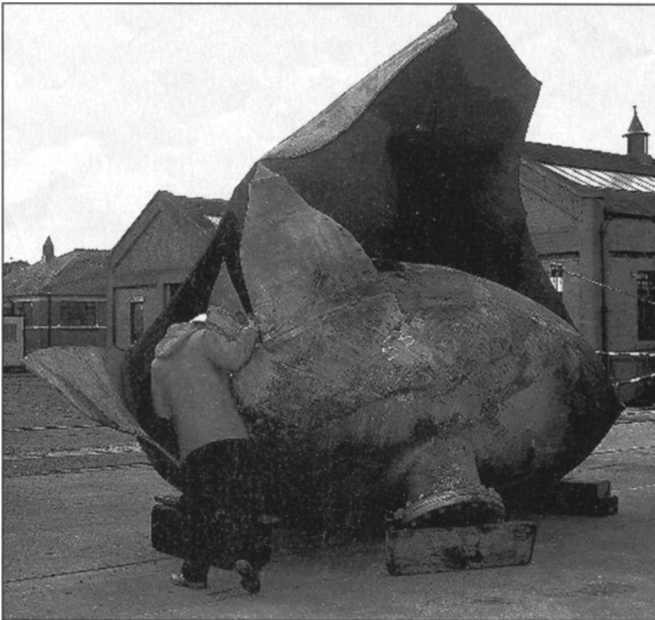
The investigation showed that the welding of the new bottom section, without any post-welding heat treatment, had produced a hard microstructure which was susceptible to hydrogen attack and brittle failure [14,15,16].

Figure 6-1. The result of an absorber failure. From reference 18. Reprinted with the permission of Gulf Professional Publishing.

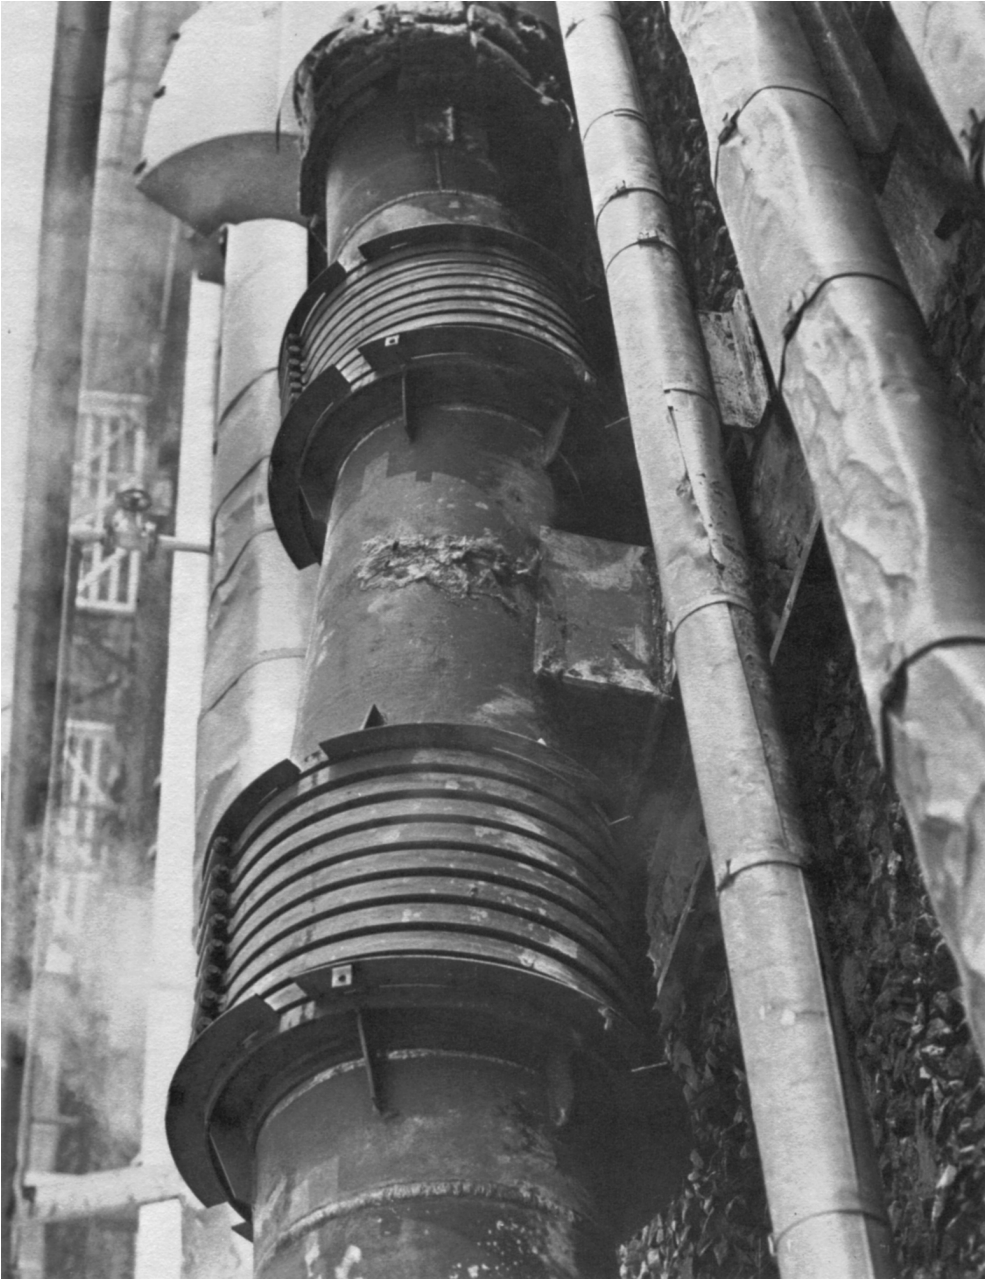
Figure 6-2. This low-pressure steam main was not scheduled for regular inspection and the damage was undetected for months, perhaps years.

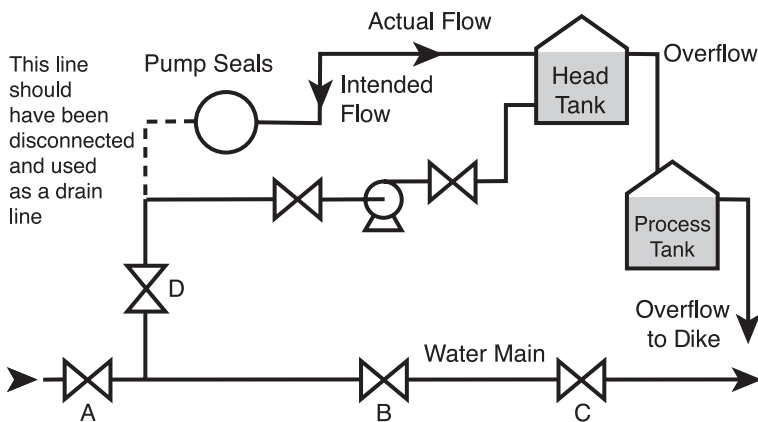
Figure 7-1 shows the layout of the relevant pipework on an experimental unit that was used intermittently. In the original design, the pump seals were supplied with water via valve D. However, the pressure in the main varied and therefore, to provide a more consistent supply, a small head tank was installed and the old supply line to the pump seals was then used as the drain line. During construction, the need to disconnect it from the water main was overlooked and it remained connected. Perhaps the designers of the modification failed to tell the construction team that the line should have been disconnected or perhaps they were told but failed to do so. Either way, nobody checked the job thoroughly (if at all) after completion and the company’s procedure for the control of modifications was ignored, as the plant was only an experimental one.

Figure 7-1. When the unit was modified, the contractors forgot to disconnect the dotted pipeline. As a result, water flowed in the opposite direction to that intended and into the head tank.

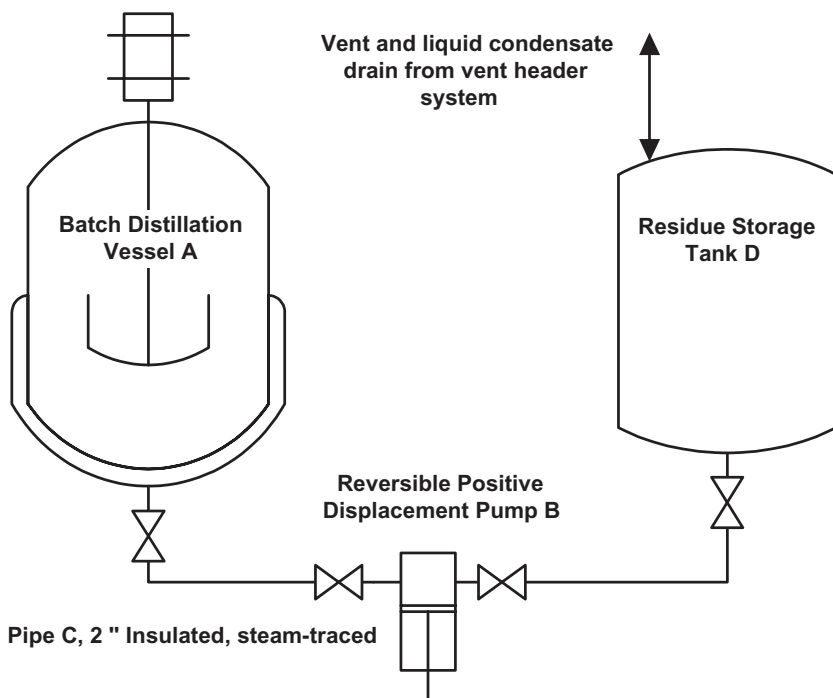
Analysis of the remaining material in other parts of pipe C showed that decomposition and self-heating started at $\approx 140^\circ\text{C}$ (280°F) and that the rate of temperature rise soon exceeded 1,000 degrees C (1,800 degrees F) per minute. This was surprising as the residues reached 140°C in normal operation and had never shown signs of decomposition or exothermic activity. Further investigation showed that the instability was due to the presence of 3% water that had entered vessel D with the condensate from the vent headers. Water is a very reactive substance and can form unstable mixtures with many other compounds. The disaster at Bhopal, India was due to the contamination of methyl isocyanate with water.

Figure 8-1. Some of the residue moved from D to A and left in pipe C decomposed and ruptured the pipe. From reference 9. Reprinted with the permission of the American Institute of Chemical Engineers.

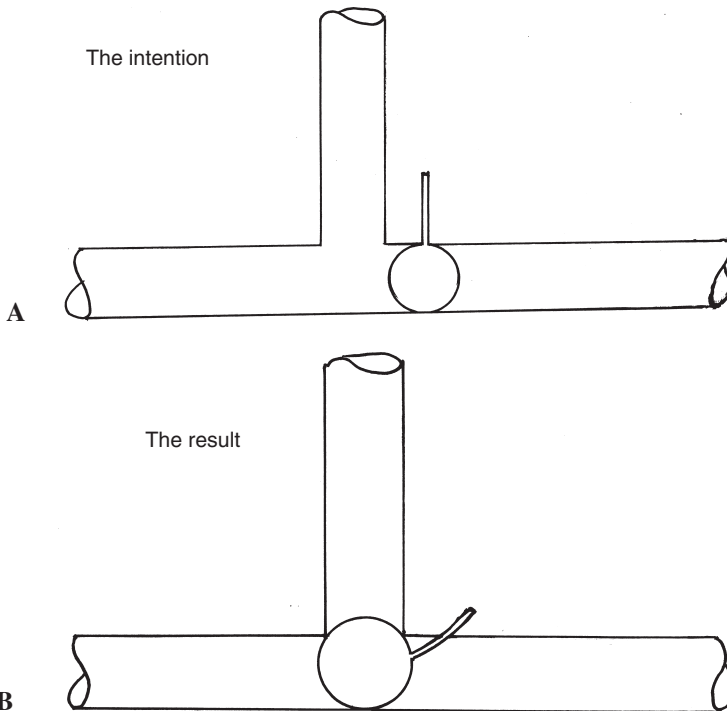
Figure 9-1. An inflatable stopper with a rigid stem was wanted but a *similar* one was fitted instead.

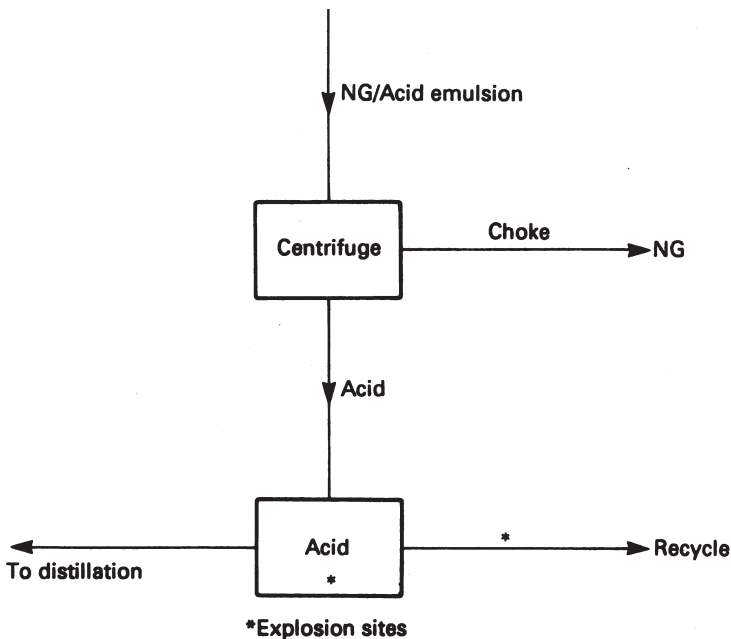
Figure 10-1. A choke caused NG to enter the acid line. A Hazop could have foreseen this.

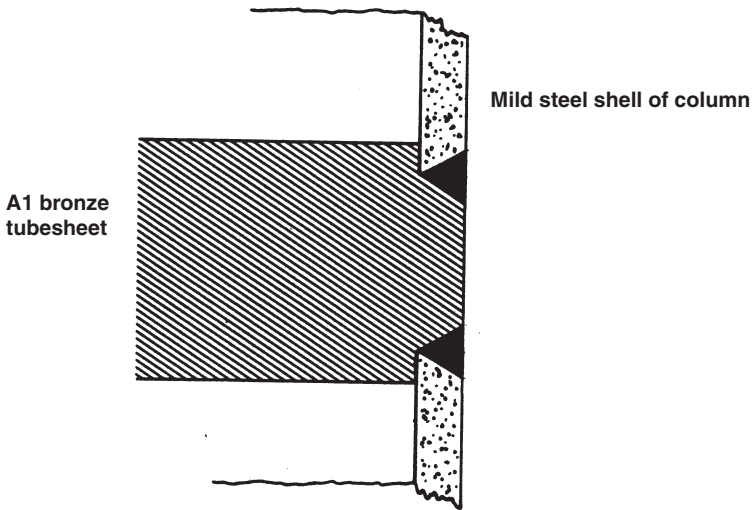
An unusual method of construction produced another hidden hazard. A steel fractionation column was fitted with an internal condenser with an aluminum-bronze tubesheet. It had the same diameter as the vessel but was welded to it in an unusual way, as shown in Figure 10-2. One of the

Figure 10-2. No one at the plant was aware of this unusual method of construction.

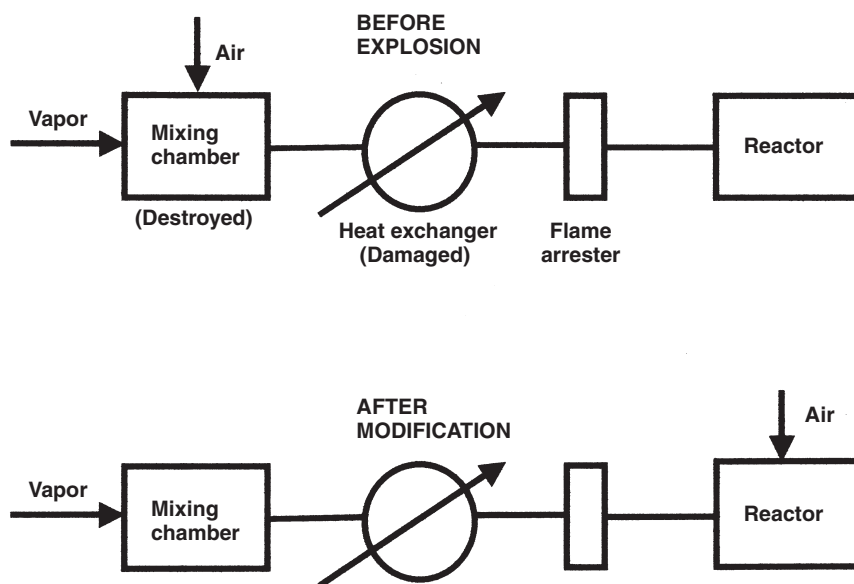
Figure 10-4. Layout of equipment in vapor phase oxidation unit before and after explosion in reactor.

When the plant was repaired, the reactant vapor and air were mixed in the reactor, not before. A flammable mixture was then present only in the reactor. This is an inherently safer solution [17]. This could have been

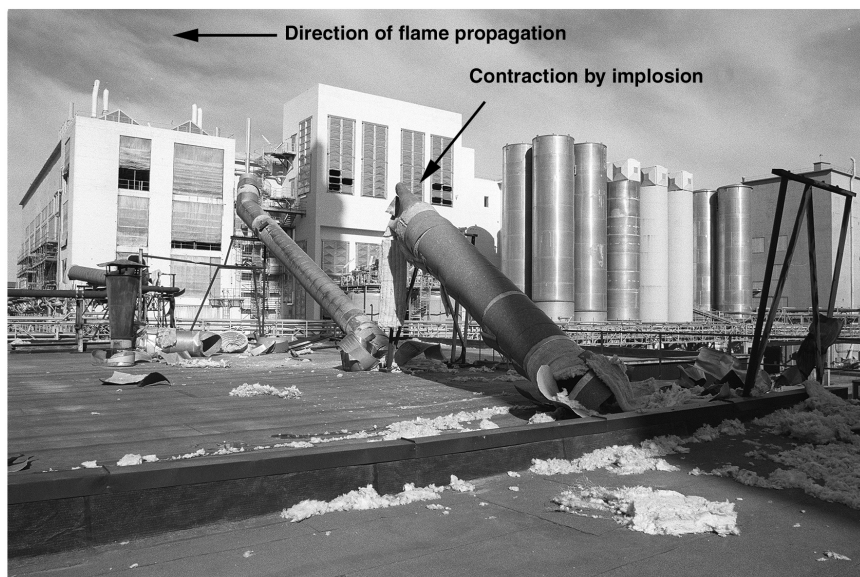
Figure 11-2. The result of hydrogen and air entering a pipeline. From reference 1. Reprinted with the permission of the American Institute of Chemical Engineers.

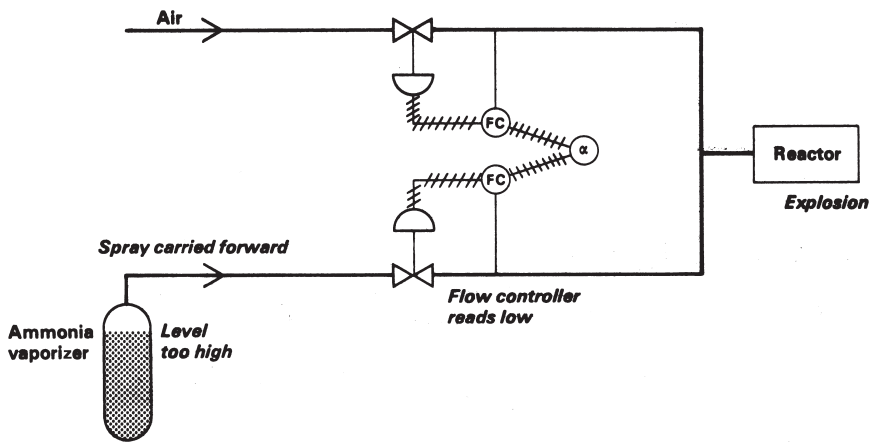
Figure 11-4. An increase in the level in the vaporizer led to an explosion in the nitric acid reactor. From *Chemical Engineering Progress*, July 1980. Reprinted with the permission of the American Institute of Chemical Engineers.

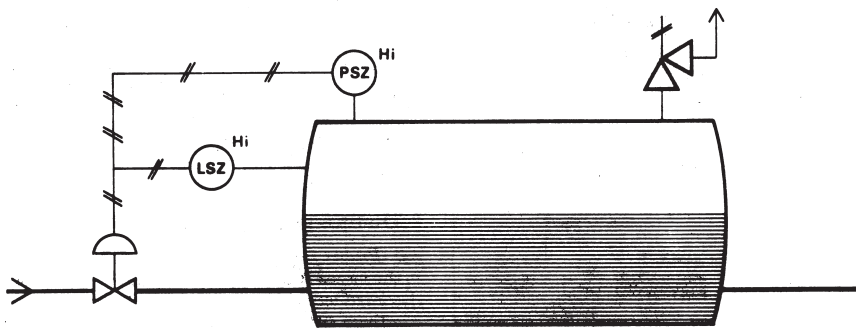
Figure 11-5. The designer of this system seemed unaware of the difference between vapors and noncondensable gases. From *Chemical Engineering Progress*, July 1980. Reprinted with the permission of the Institute of Chemical Engineers.

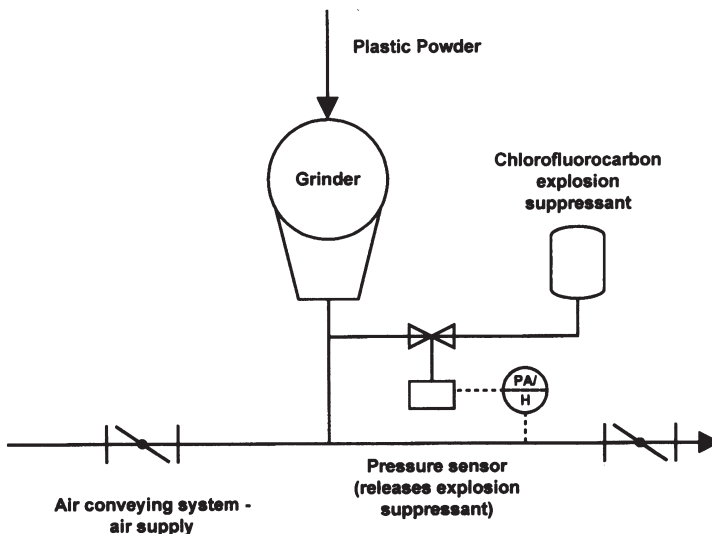
The system was in use for nearly 20 yr but was never called upon to operate. Then the grinder exploded and the cause was the suppression

Figure 11-6. Accidental operation of the protective equipment — the explosion suppressant — caused an explosion. From reference 2. Reprinted with the permission of the American Institute of Chemical Engineers.

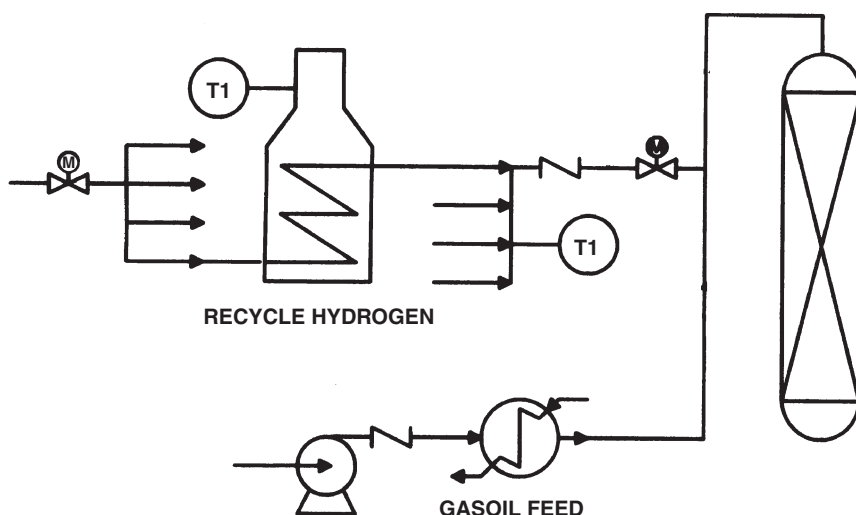
Figure 11-8. Restricted flow in one of the parallel streams led to a tube rupture and fire. From reference 4. Reprinted with the permission of Elsevier (UK).

When the furnace was rebuilt, changes were made to the design to reduce the stress in the convection section, more temperature measurements were installed, isolation and control valves were installed in each

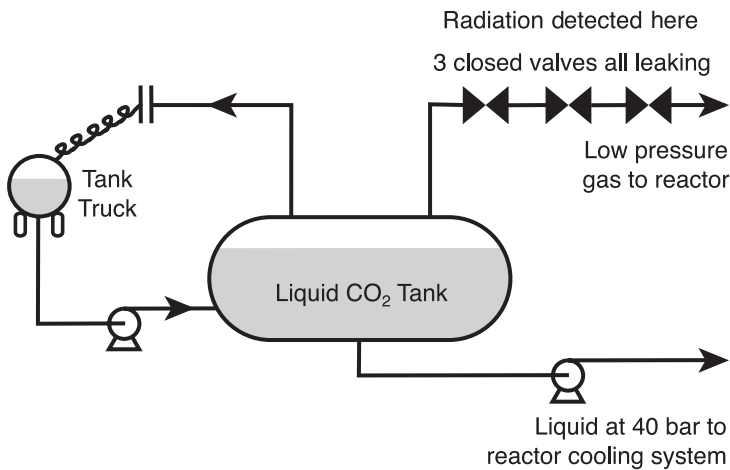
Figure 12.1. Contaminated gas leaked through 3 valves into the fixed tank and from there could have entered the tank truck.

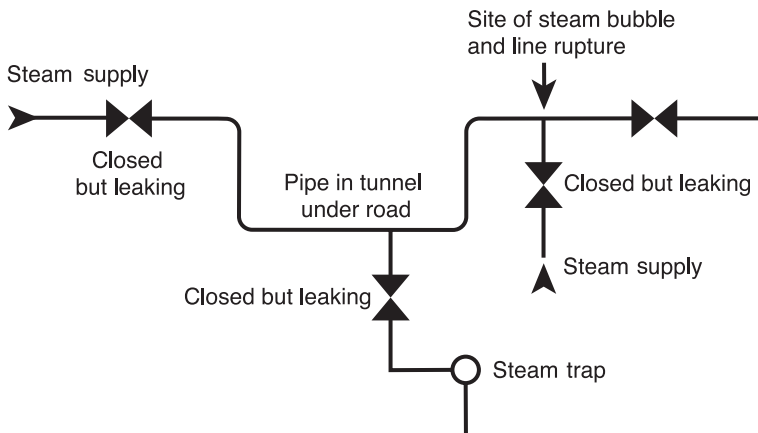
Figure 12.2. Condensate filled the dip in the steam main and overflowed into the horizontal section on the right, condensing a steam bubble. The resultant water hammer ruptured the main.

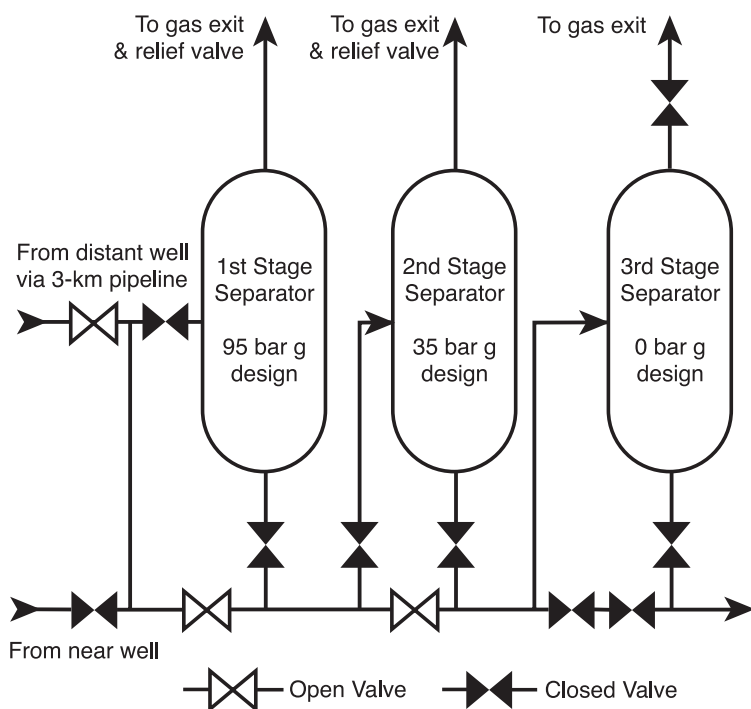
Figure 14-1. The third separator was overpressured and ruptured when its bypass valves were closed in error.
