Library of Congress Cataloging-in-Publication Data
Kletz, Trevor A.

What went wrong? : case histories of process plant disasters and how they could have been avoided / Trevor Kletz. —5th ed.

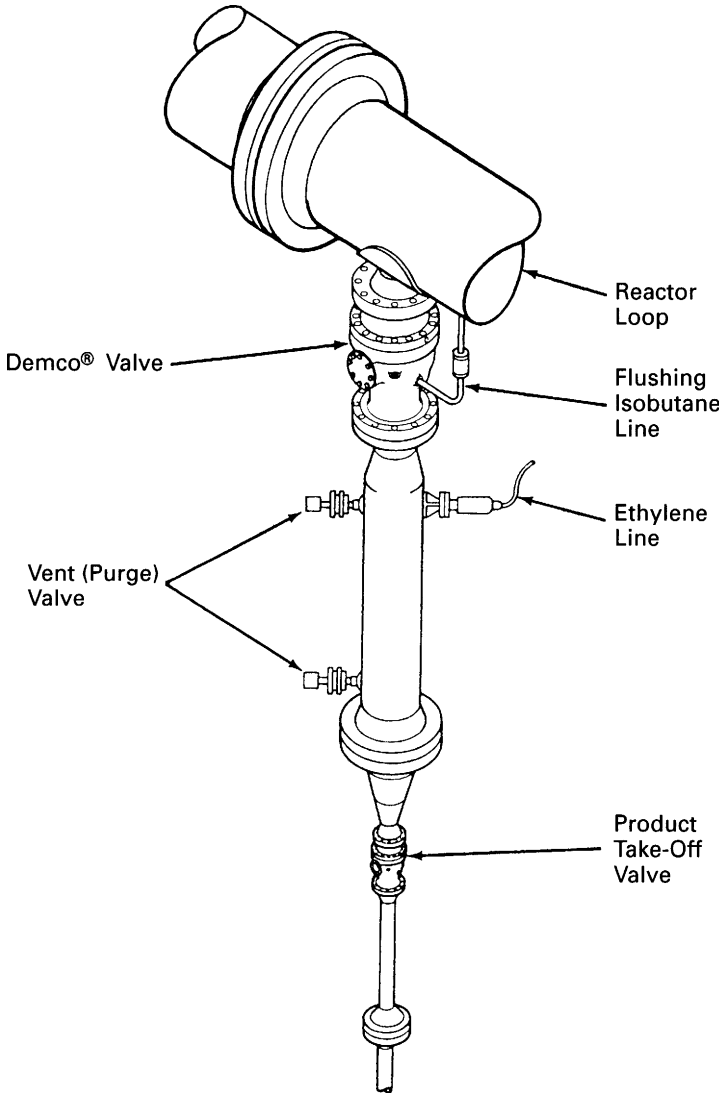
A similar but more serious incident occurred in a polyethylene plant in 1989. A take-off branch was dismantled to clear a choke. The 8-in. valve isolating it from the reactor loop (the Demco valve in Figure 1-2) was open, and hot ethylene under pressure came out and exploded, killing 23 people, injuring more than 130, and causing extensive damage. Debris was thrown 10 km (6 miles), and the subsequent fire caused two liquefied petroleum gas tanks to burst.

FIGURE 1-2 The take-off branch was dismantled with the Demco valve open. (Illustration courtesy of the U.S. Department of Labor.)

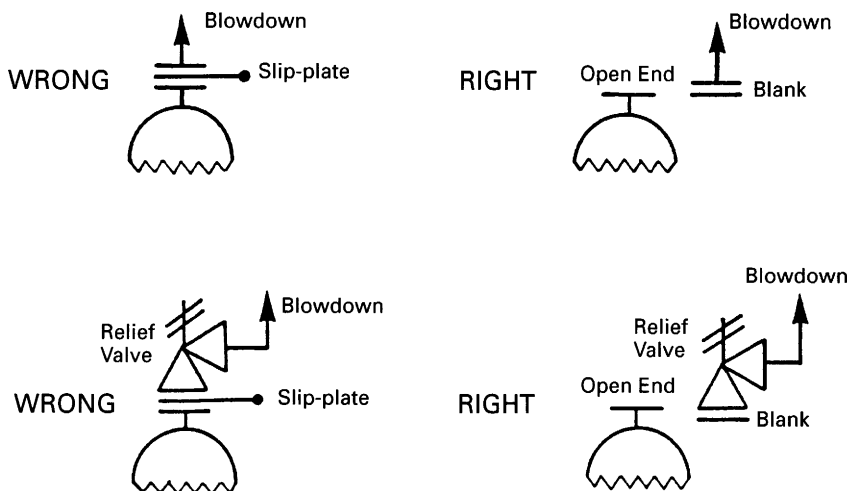
FIGURE 1-4 The right and wrong ways to isolate a vent line.

If a vent line has to be slip-plated because the line is too rigid to be moved, then the vents should be slip-plated last and de-slip-plated first. If all slip-plates inserted are listed on a register, they are less likely to be overlooked.

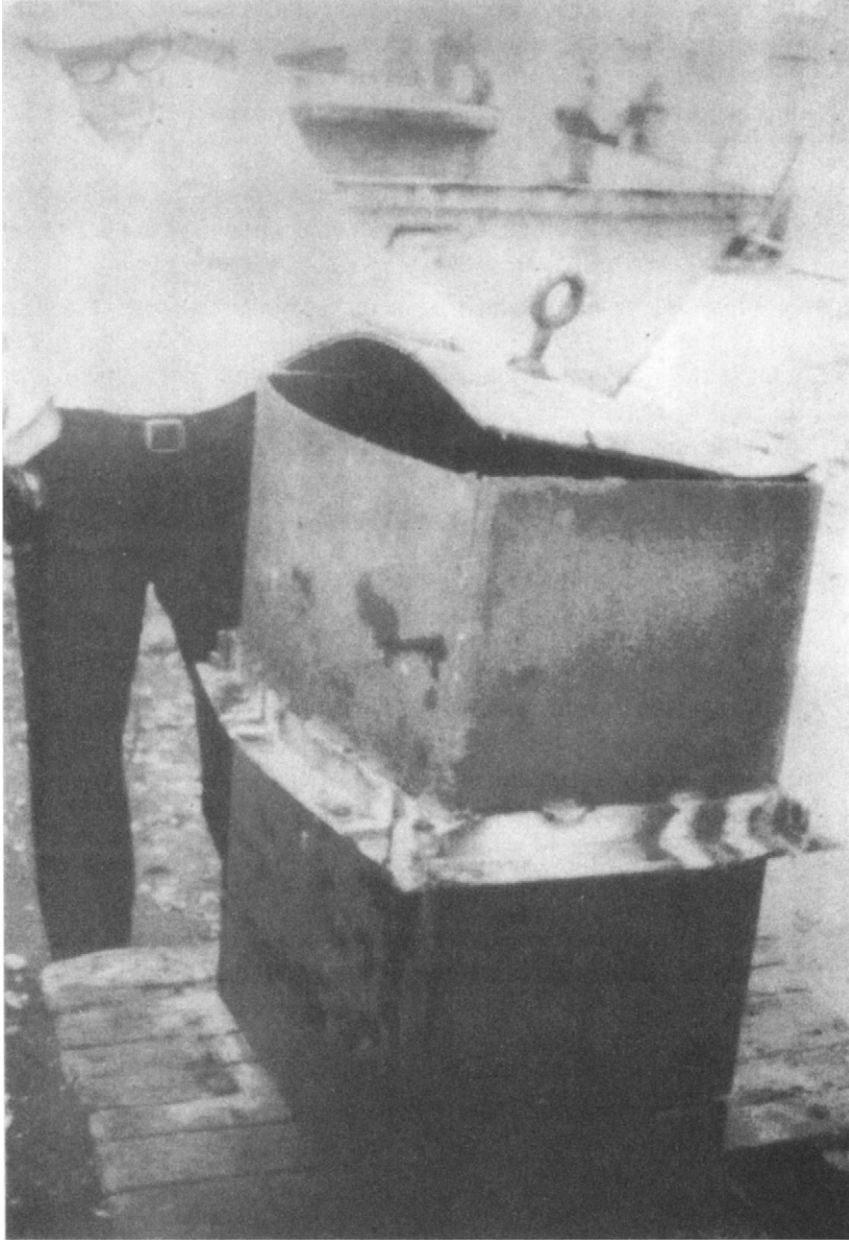
FIGURE 1-13 This steel box was quite incapable of containing a leak of steam at a gauge pressure of 300 psi (20 bar).

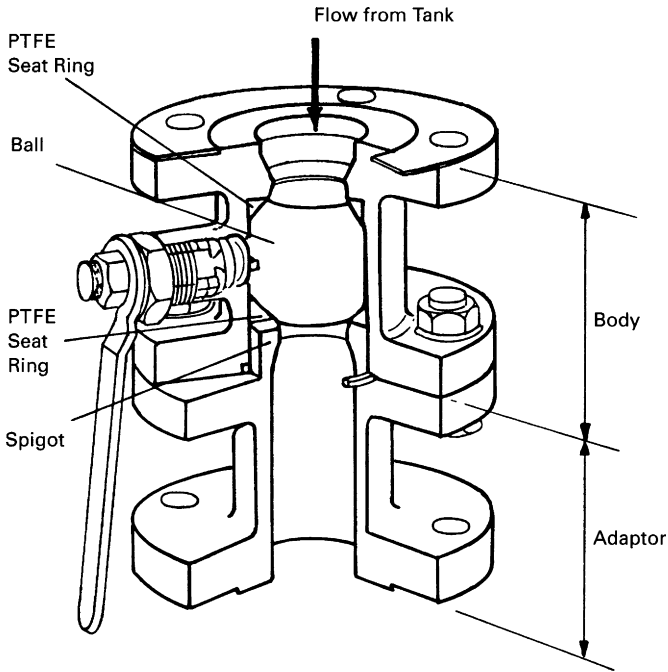
FIGURE 1-16 Valve dismantled in error.

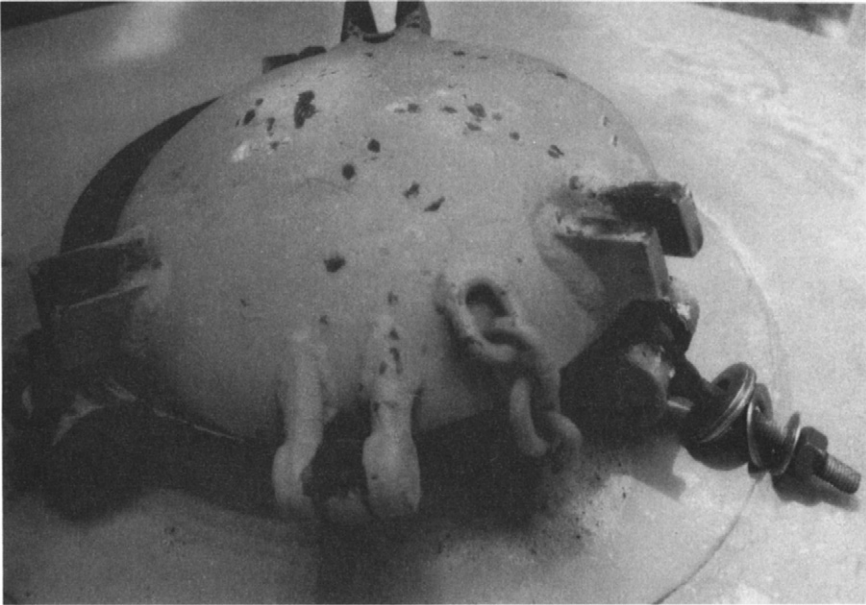
FIGURE 1-18 Instead of replacing the eyebolts, new studs were welded in place of the threaded portions. They were made brittle by the heat and failed in use. Fortunately, the chain prevented the lid from going into orbit.

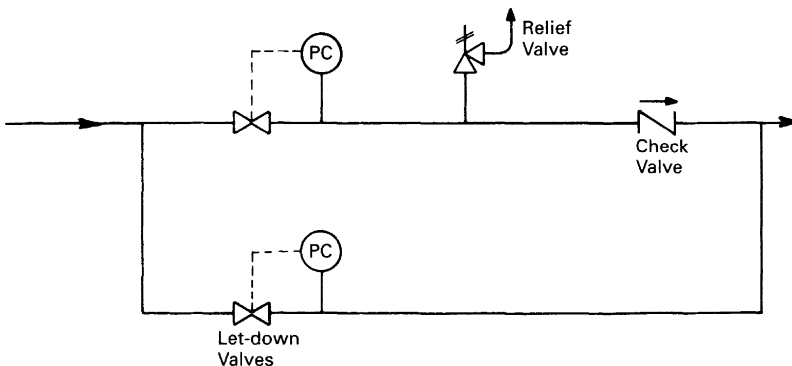
FIGURE 2-3 The second (*lower*) let-down valve was joined to the original line downstream of the check valve. When this let-down valve leaked, the downstream equipment was overpressured.

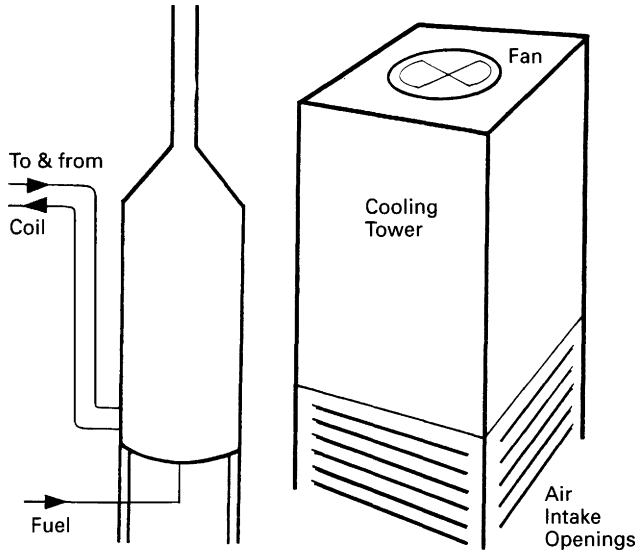
FIGURE 2-8 Gas entered the furnace when the cooling tower fan was switched off.

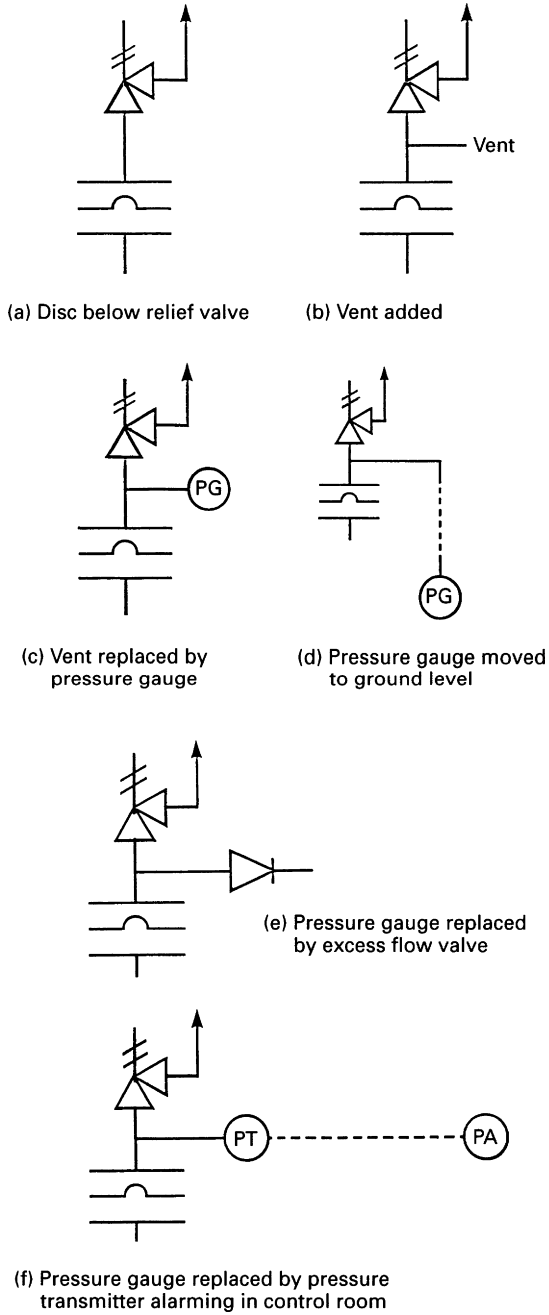
FIGURE 2-11 A modification chain—rupture discs below relief valves.

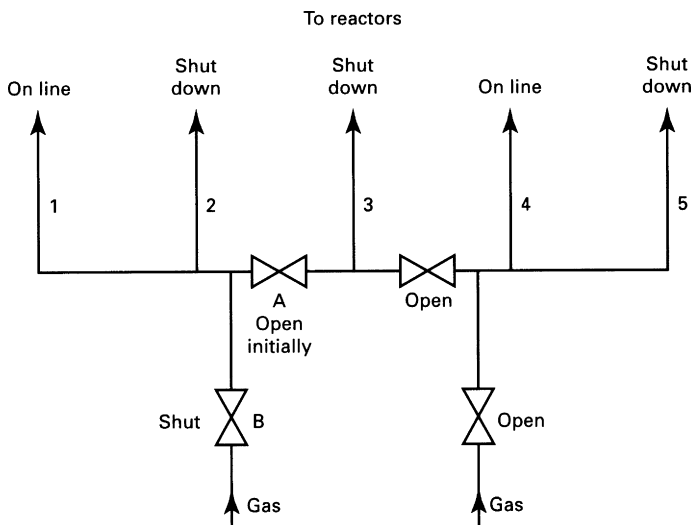
FIGURE 3-5 Accidental closing of a valve can cause an explosion.

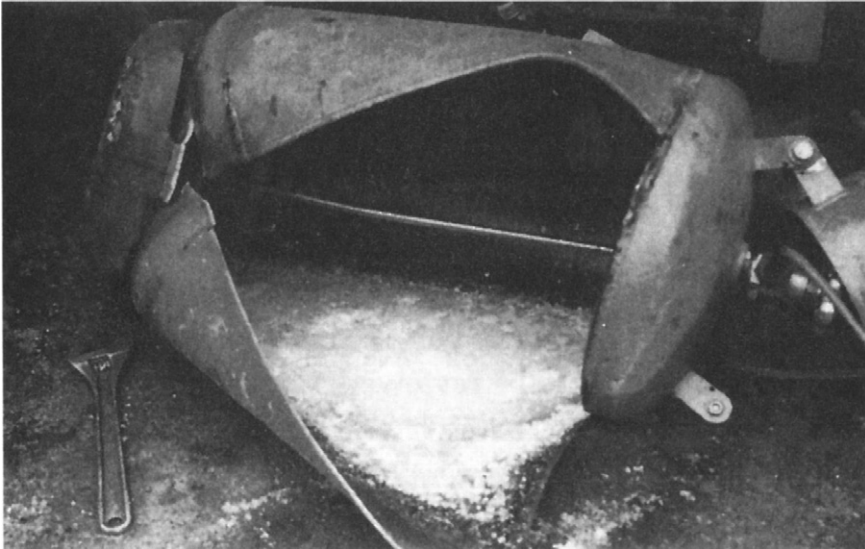
FIGURE 4-3 The result of pressurizing a cylinder to “two divisions” on a scale graduated in kg/cm^2 instead of psi. (Photo courtesy of the Institution of Chemical Engineers.)

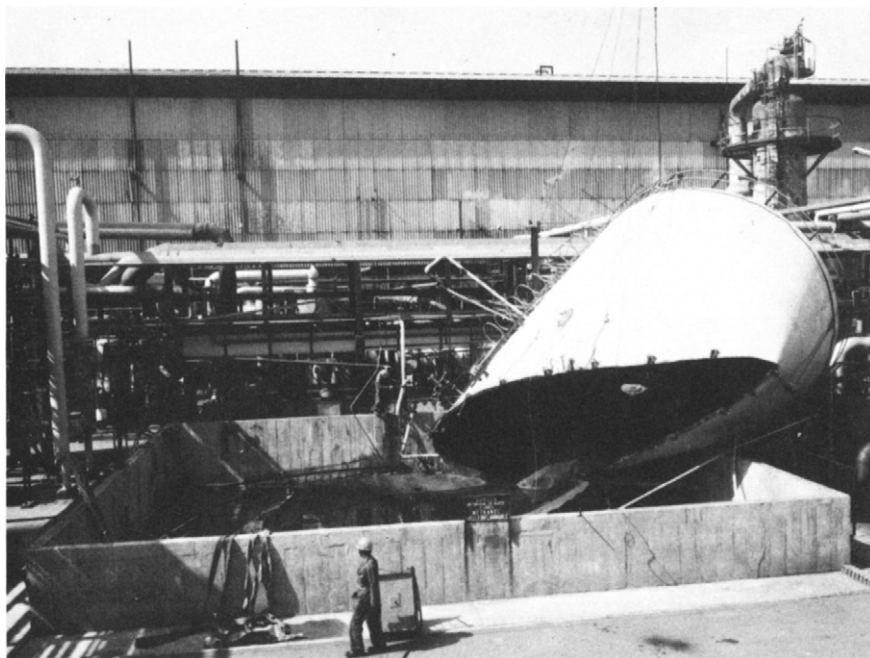
Tanks designed to fail at the roof/wall weld have failed at the base/wall weld because this weld was corroded or fatigued or because holding-down bolts were missing (Figure 5-1). Corrosion is most likely to occur in tanks containing a water layer or when spill absorbents have been placed

FIGURE 5-1 Corrosion and missing holding-down bolts caused this tank to fail at the base instead of the top.

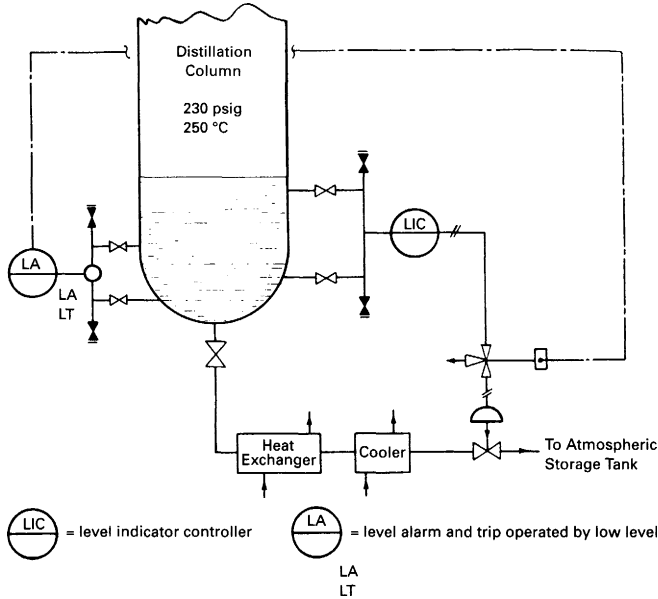
FIGURE 5-4 How failure of a level controller can overpressure a tank.

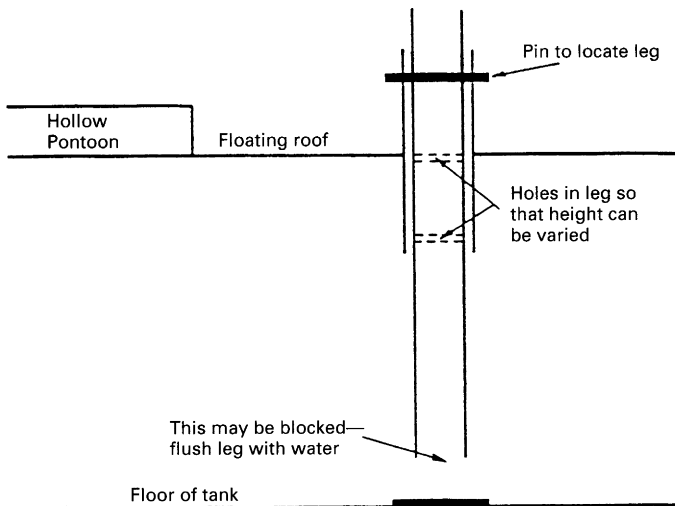
FIGURE 5-15 Oil trapped in the leg of a floating-roof tank caught fire during demolition.

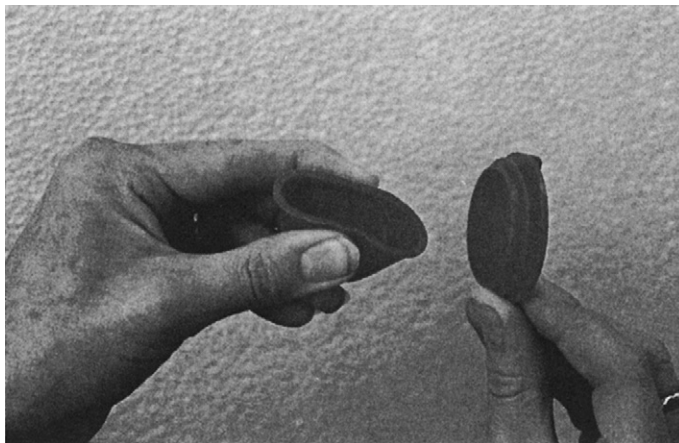
FIGURE 7-4 A soft plastic “top hat” plug (*left*) was fitted to the end of a railway carriage brake pipe to keep it clean. It was the same color as the end of the pipe and was not noticed and removed before the pipe was installed. The brakes failed, and the train overran. A more rigid plug with a larger lip (*right*) would have failed the brake test and would have been more visible. (*Photo courtesy of Roger Ford.*)

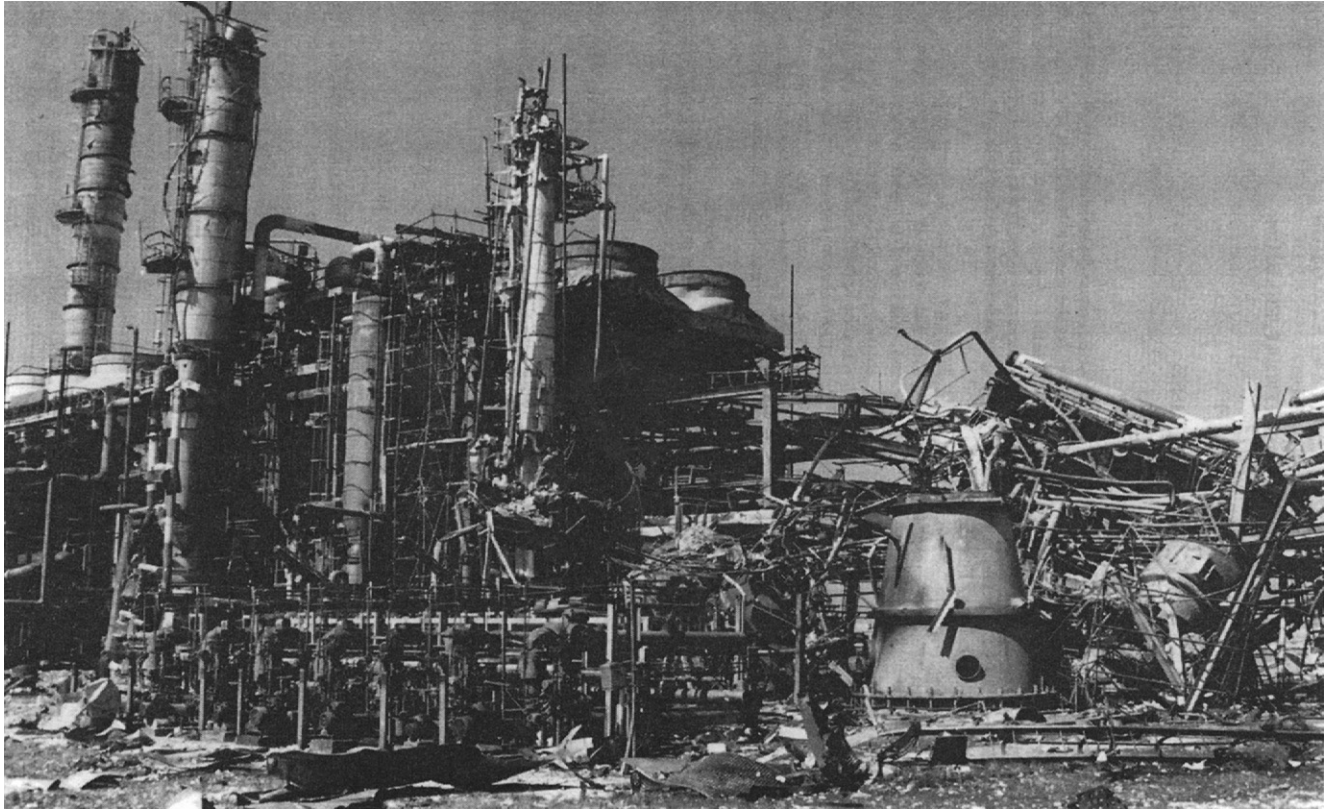
FIGURE 7-8 The ethylene oxide plant after the fire and explosion. (Photo courtesy of BP Chemicals Limited.)

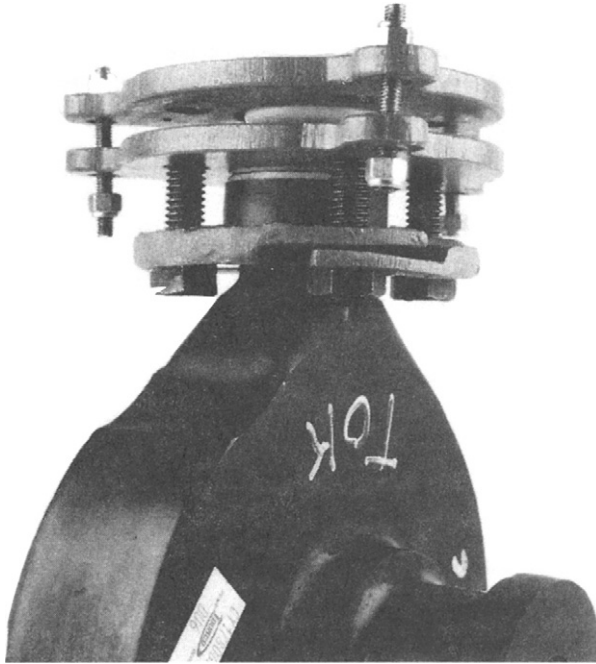
FIGURE 8-3 Split flange assembly similar to one that leaked. (Photo courtesy of the UK Health and Safety Executive.)

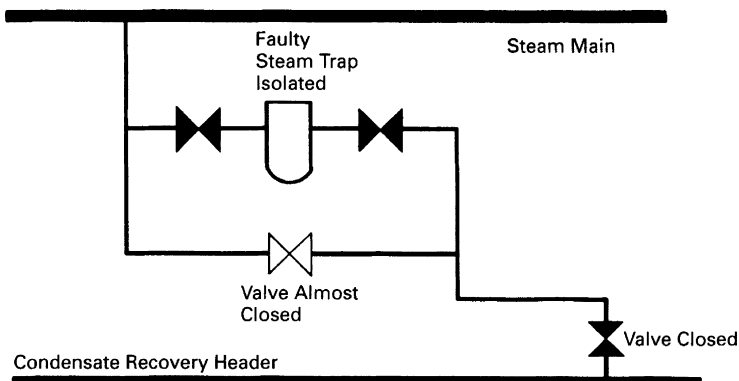
FIGURE 9-9 Arrangement of valves on a steam main that was broken by a water hammer.

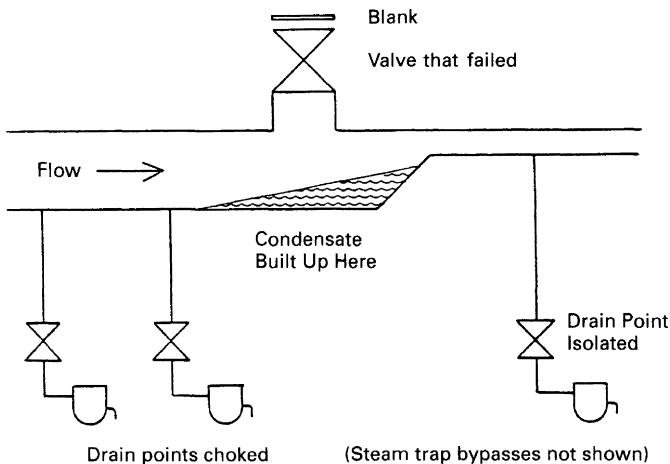
FIGURE 9-10 Arrangement of drains on a steam main that was broken by a water hammer.

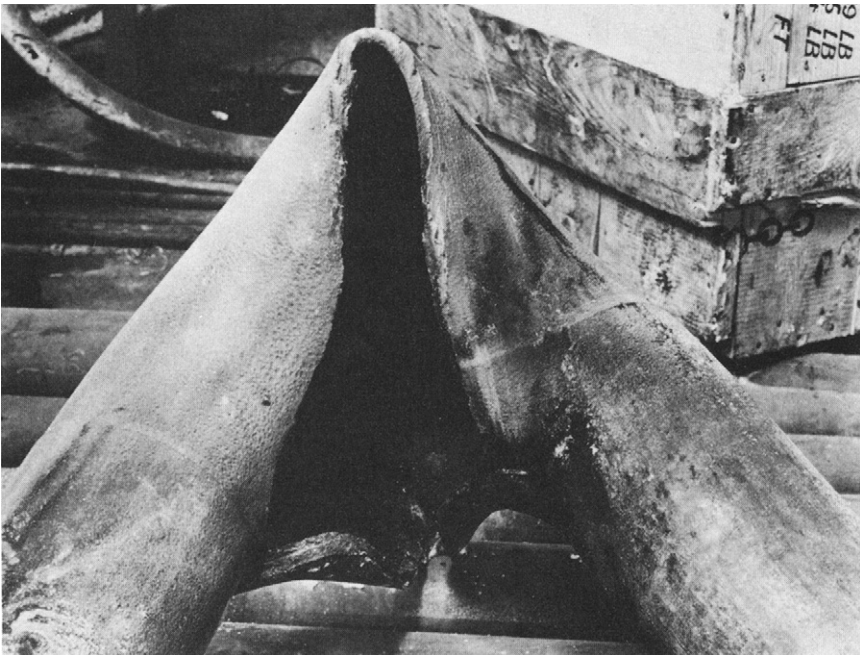
FIGURE 9-12 An old pipe was reused and failed by creep.

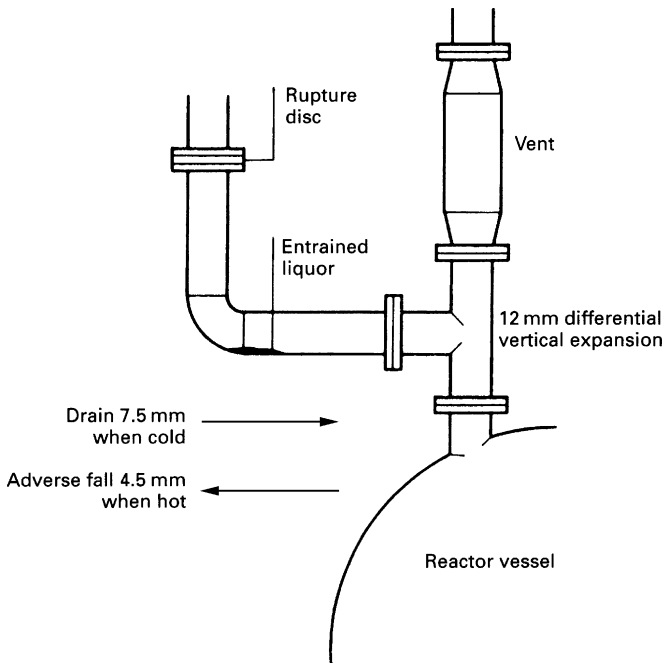
FIGURE 9-13 The vent arrangements at the top of the reactor. Liquid drained out when the pipework was cold but not when it was hot.

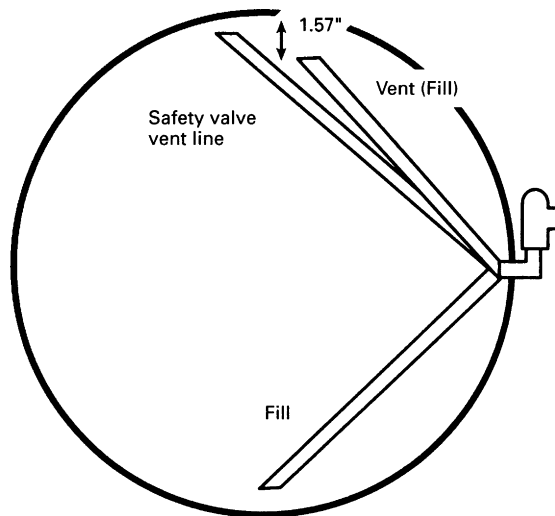
FIGURE 9-14 Unusual arrangement of a relief valve and pipework on a tank truck used to transport liquid carbon dioxide. The relief valve was cooled by the liquid and became blocked by ice from condensed atmospheric moisture. (Illustration courtesy of the Institution of Chemical Engineers.)

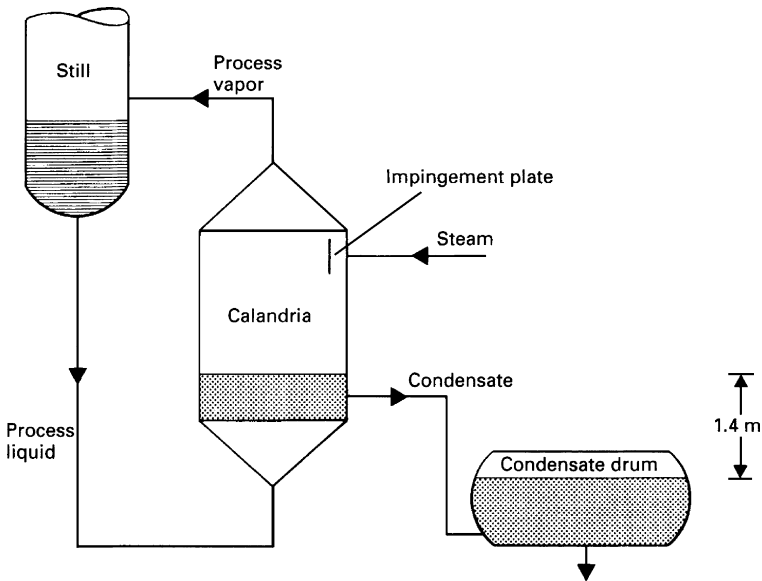
FIGURE 10-11 Condensate in the steam—the result of too few steam traps—knocked off the impingement plate and damaged the calandria tubes.

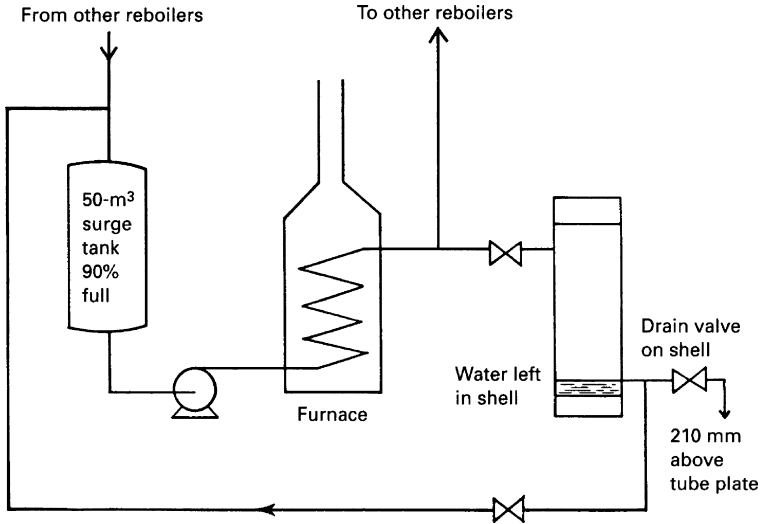
FIGURE 12-2 Water left in the heat exchanger was vaporized by hot oil.

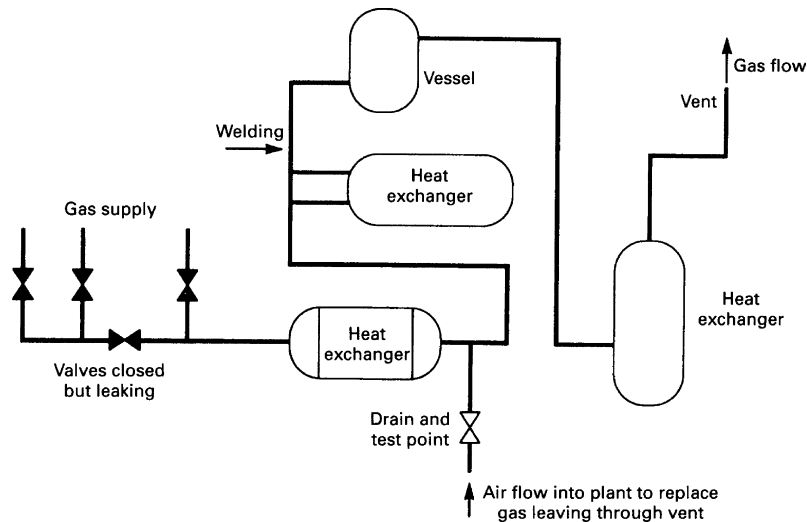
FIGURE 17-5 A simplified diagram of a plant, showing why hydrogen gas was not detected at the drain point. (Reproduced with permission of the American Institute of Chemical Engineers. Copyright © 1995 AIChE. All rights reserved.)

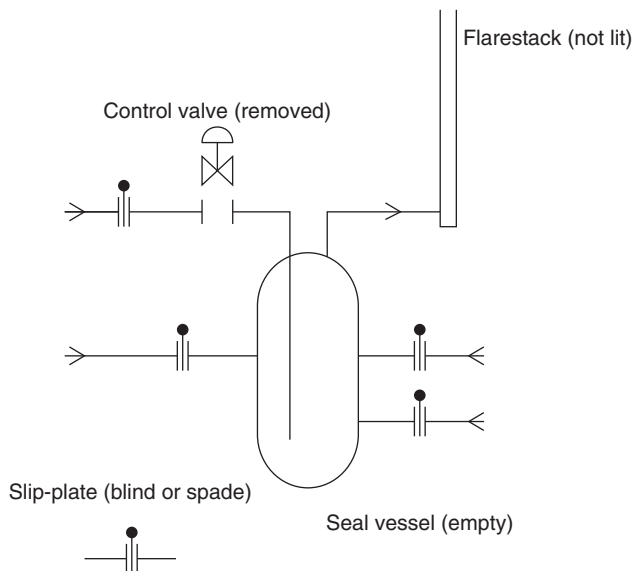
FIGURE 17-6 When the control valve was removed, a chimney effect caused air to enter the system, and an explosion occurred. (Reproduced with permission of the American Institute of Chemical Engineers. Copyright © 1995 AIChE. All rights reserved.)

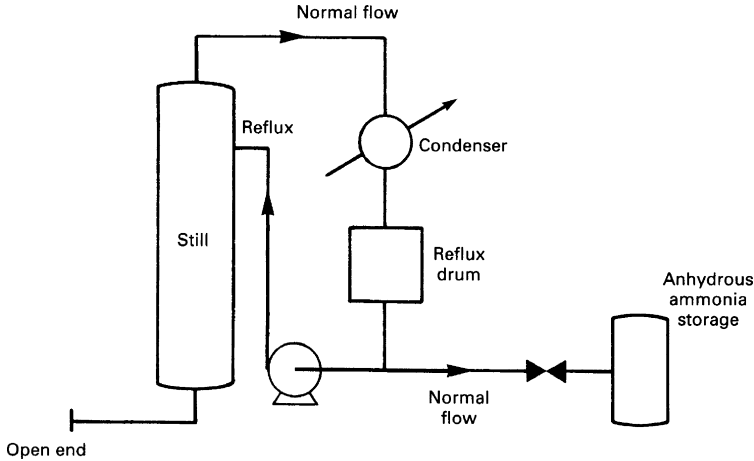
FIGURE 18-1 Reverse flow occurred from the storage vessel to the open end.

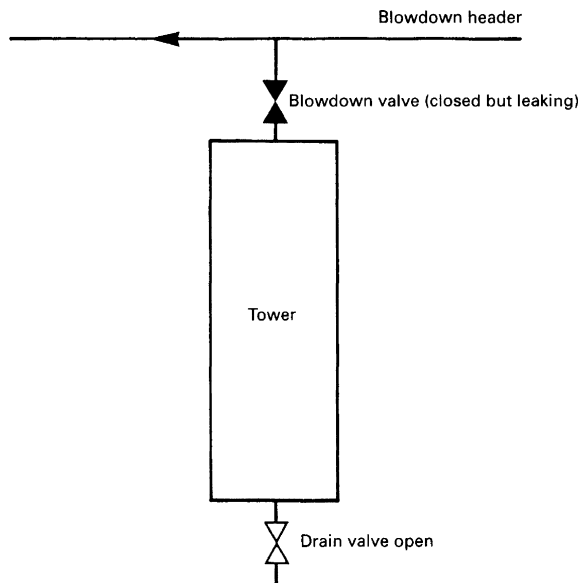
FIGURE 18-2 Flow occurred from the blowdown header into the vessel and out of the drain valve.

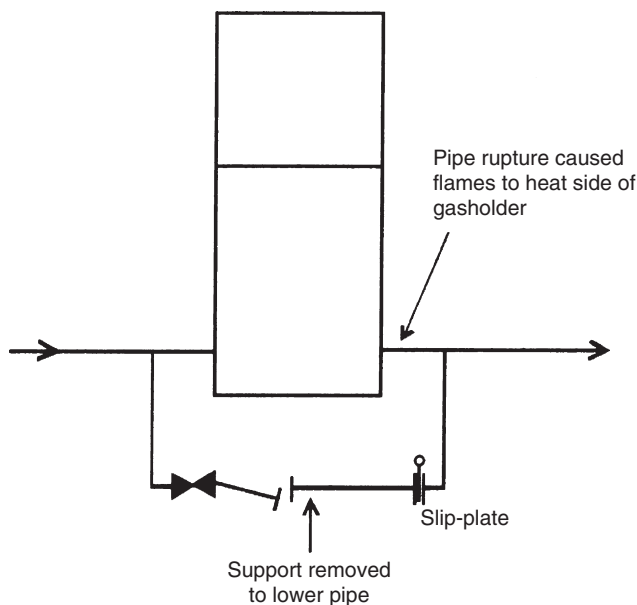
FIGURE 24-3 Gas leaked through a closed valve while burning was in progress nearby.

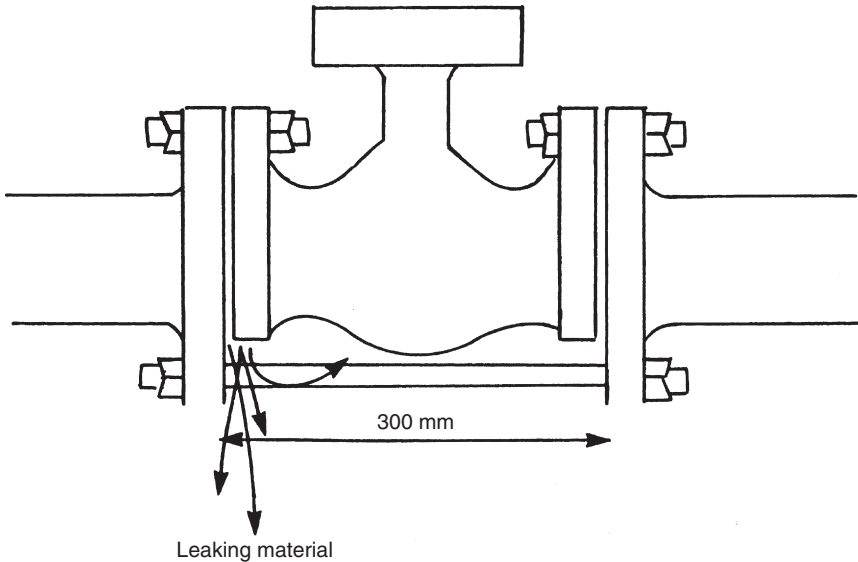
FIGURE 25-2 When this valve was insulated to save heat, the long bolts expanded and the flanges leaked.

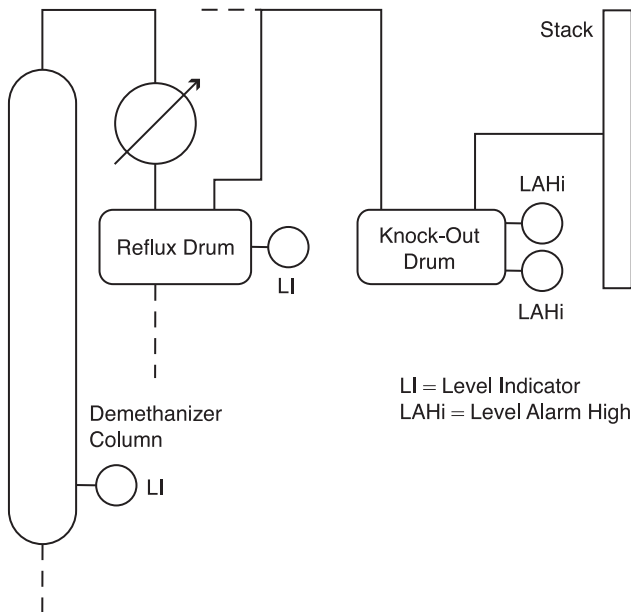
FIGURE 26-1 The level indicator on the column and the level alarms on the knock-out drum were out of order. The column filled with liquid, which overflowed into the drums and then into the stack.

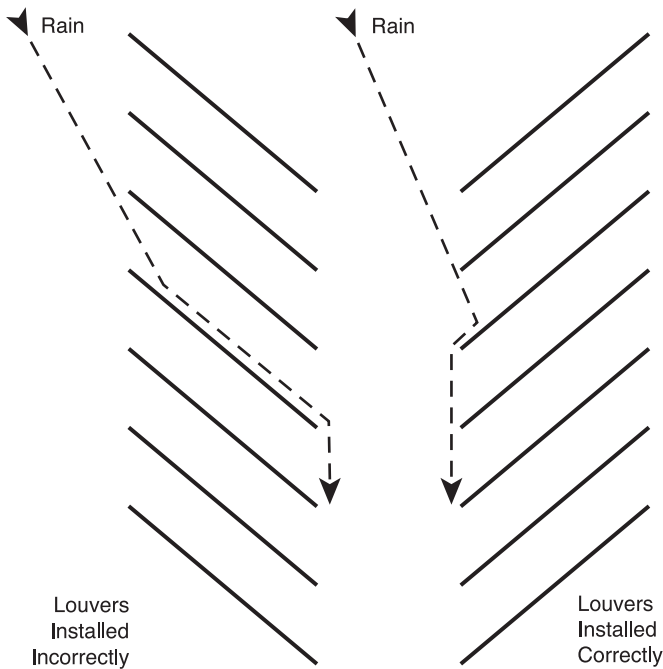
FIGURE 27-5 The louvers were installed so that they directed spray and rainwater through them.

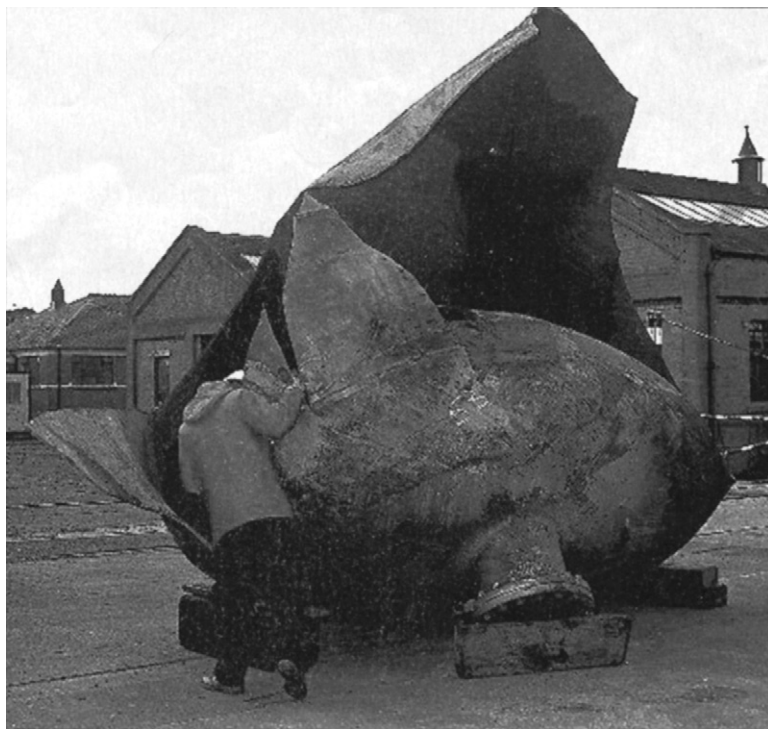
FIGURE 28-1 The result of an absorber failure. From reference 18. (Reprinted with the permission of Gulf Professional Publishing.)

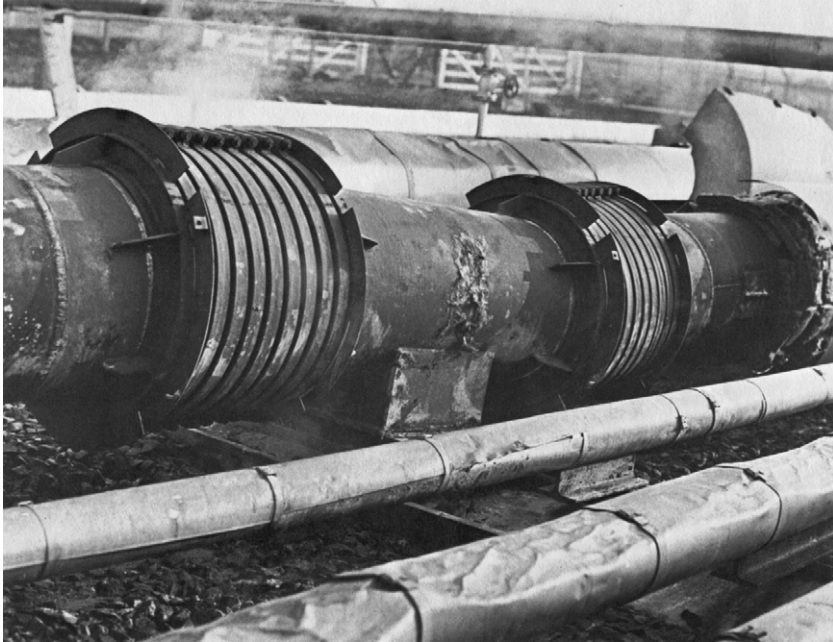
FIGURE 28-2 This low-pressure steam main was not scheduled for regular inspection and the damage was undetected for months, perhaps years.

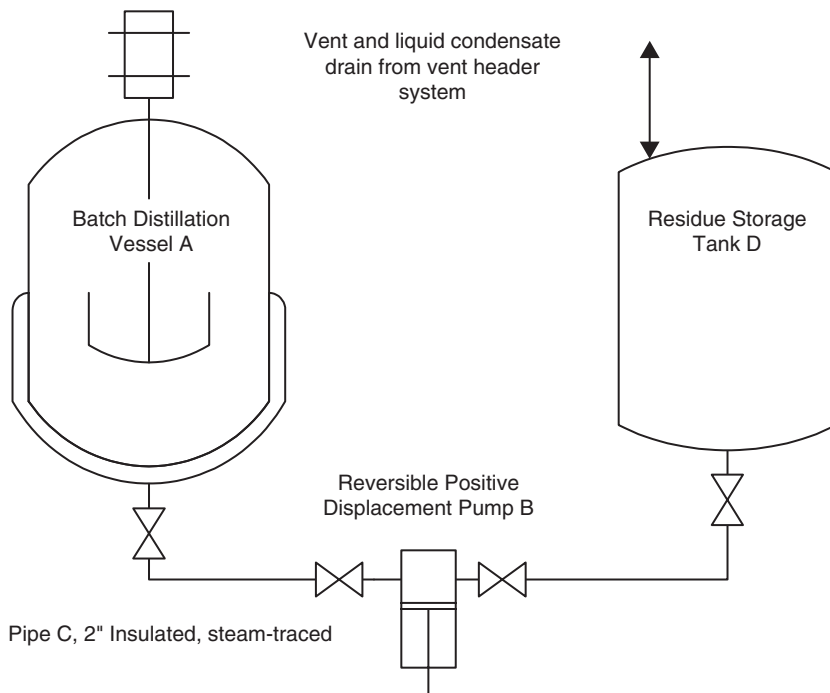
FIGURE 30-1 Some of the residue moved from D to A and left in pipe C decomposed and ruptured the pipe. From reference 9. (Reprinted with the permission of the American Institute of Chemical Engineers.)

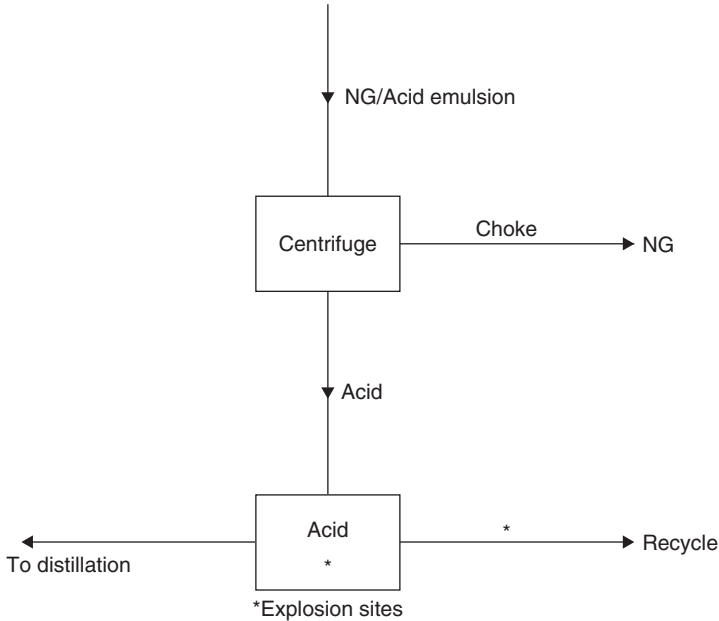
FIGURE 32-1 A choke caused NG to enter the acid line. A Hazop could have foreseen this.

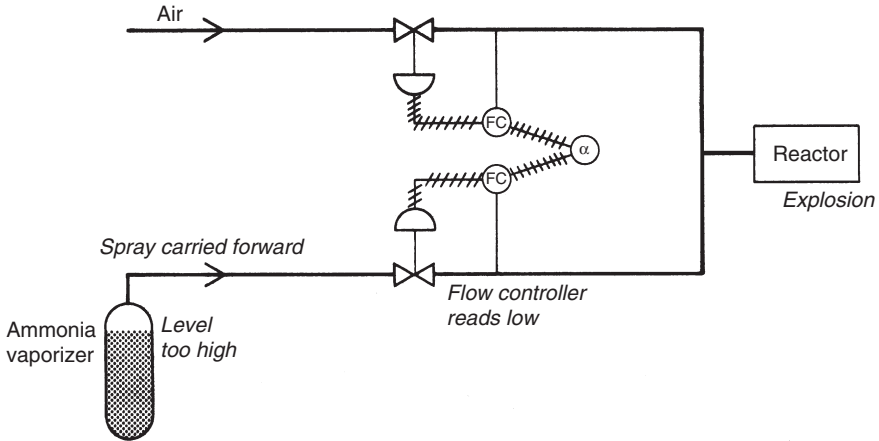
FIGURE 33-5 An increase in the level in the vaporizer led to an explosion in the nitric acid reactor. From *Chemical Engineering Progress*, July 1980. (Reprinted with the permission of the American Institute of Chemical Engineers.)

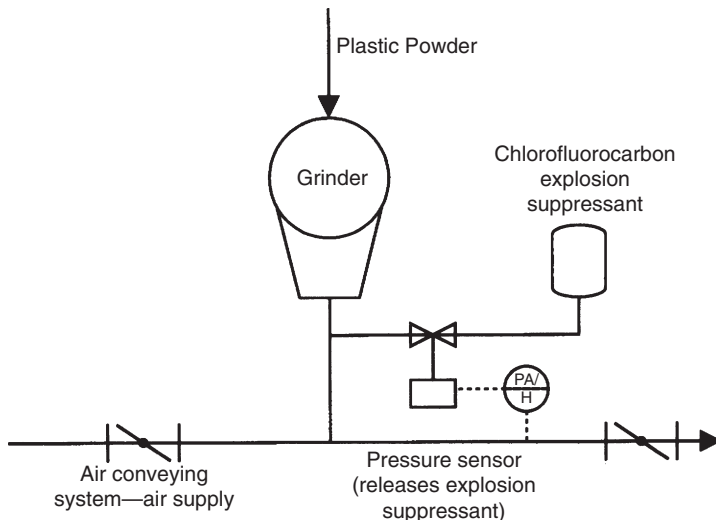
FIGURE 33-7 Accidental operation of the protective equipment—the explosion suppressant—caused an explosion. From reference 2. (Reprinted with the permission of the American Institute of Chemical Engineers.)

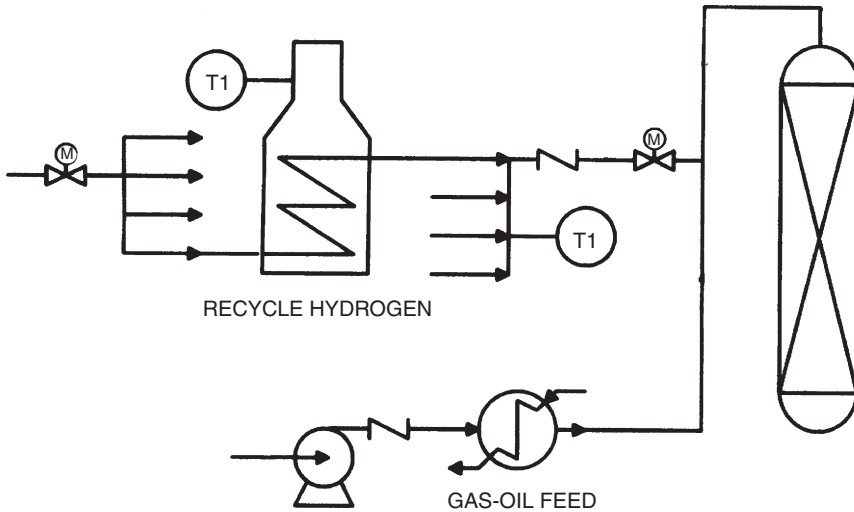
FIGURE 33-9 Restricted flow in one of the parallel streams led to a tube rupture and fire. From reference 4. (Reprinted with the permission of Elsevier (United Kingdom).)
