STILL GOING WRONG!

Case Histories of Process Plant Disasters
and How They Could Have Been Avoided

Trevor Kletz

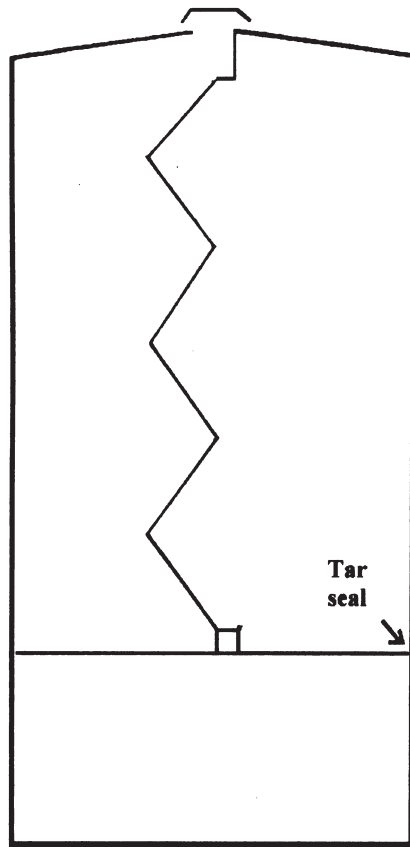
At a guess the volume of the gasholder was several thousand m^3 and its height was $\approx 3 \times$ its diameter. To get inside it, we had to go up a staircase onto the roof, through an opening in the center, and then down a Jacob's ladder, a folding ladder, onto the disc. As Figure 2-2 shows, during half the descent we were clinging to the wrong side of the sloping ladder. Fortunately, the gasholder was nearly empty and the angle of the ladder was not too great.

Figure 2-2. Diagram of dry gasholder showing Jacob's ladder.

phere above the disc in the gasholder was not tested before we entered and there was no entry permit and no standby man, although the foreman mentioned that strictly speaking there should have been one (this was many years ago). The whole experience was eerie and I have never forgotten it.

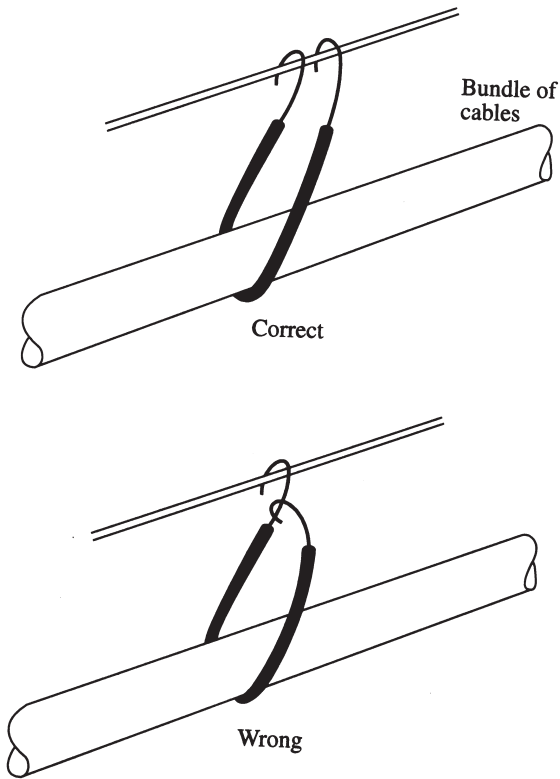
A bundle of electric cables was supported by cable hangers. The hooks on the ends of the cable hangers were hooked over the top of a metal strip (Figure 5-3 top). The electric cables had to be lowered to the ground to provide access to whatever lay behind them and then replaced. They were put back as shown in the second part of Figure 5-3. This increased the load on the upper hooks. One failed, thereby increasing the load on the adjacent ones and then they also failed. Altogether, a 60m (200ft) length of cables fell down [2].

Figure 5-3. Different ways of supporting a bundle of cables. Reprinted with permission of EVHE, Fig. 10.2, 2001, p 177.

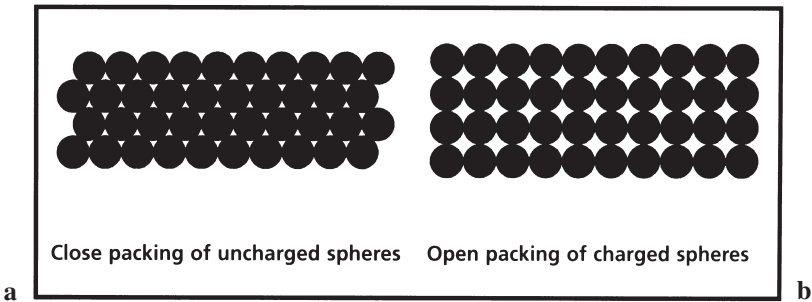
A company was filling bags with a powder automatically, using a machine that delivered 50kg (110lb) into each bag. Although hand filling showed that this amount of powder would fit into the bags, nevertheless it backed up into the machine and caused it to stall. It had to be stripped down and cleaned before packing could continue.

Figure 10-3a,b. (a) Close packing of uncharged spheres. (b) Open packing of charged spheres.

Experiments showed that rapid filling of the powder lowered the bulk density by 10% as charges of static electricity on the particles pushed them farther apart. Instead of being closely packed as in Figure 10-3a, they were more openly packed as shown in Figure 10-3b. As the output of the plant was large, a machine for eliminating the static charge was designed and installed [13].

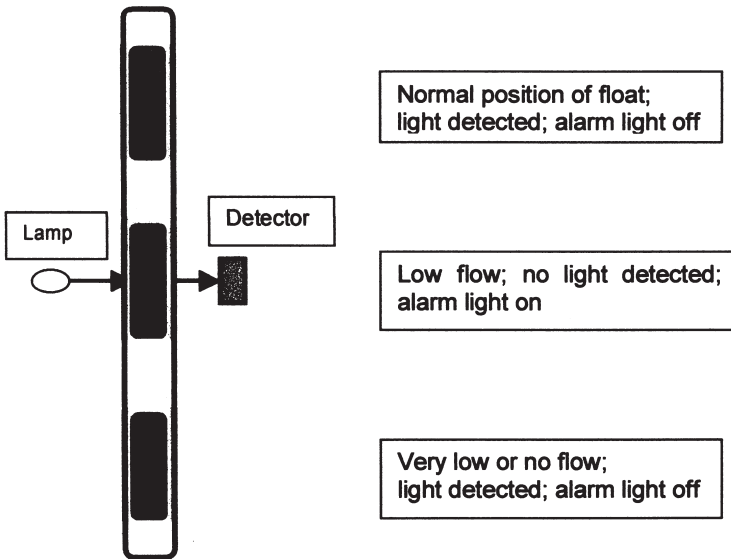
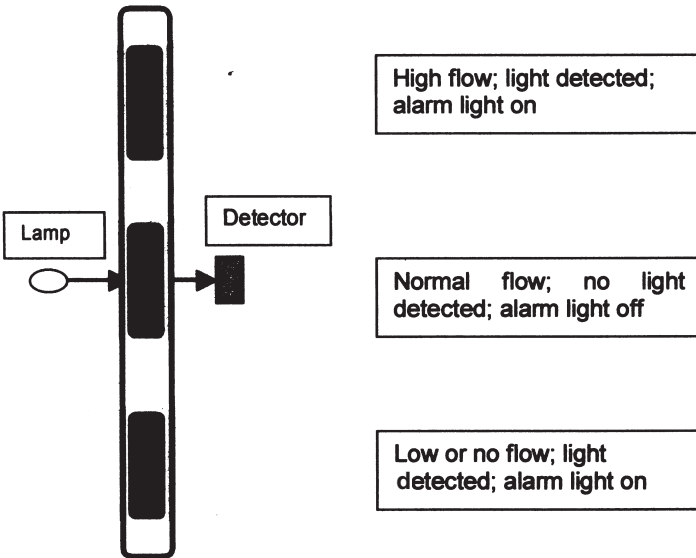
The design had limitations. If the flow diminished only slightly, the light beam remained broken and the alarm light stayed on after the alarm bell was silenced. However, if the flow fell substantially or stopped completely, the float dropped farther, the light beam was no longer broken, and the alarm light went out (Figure 11-1). One day when the flow actually failed, the operator canceled the alarm, but with no light to remind him he was distracted by other problems and forgot that the gas flow had stopped. Several hours passed before this was discovered.

Figure 11-1a,b. (a) Original design of rotameter low flow alarm. (b) Revised design of rotameter low flow alarm.

Afterwards, the design was changed so that the light beam was broken when the flow was normal but fell on the light sensor if the flow changed (see Figure 11-1b). The alarm light then remained lit as long as the low flow continued. As a bonus, it was also activated by a high flow.

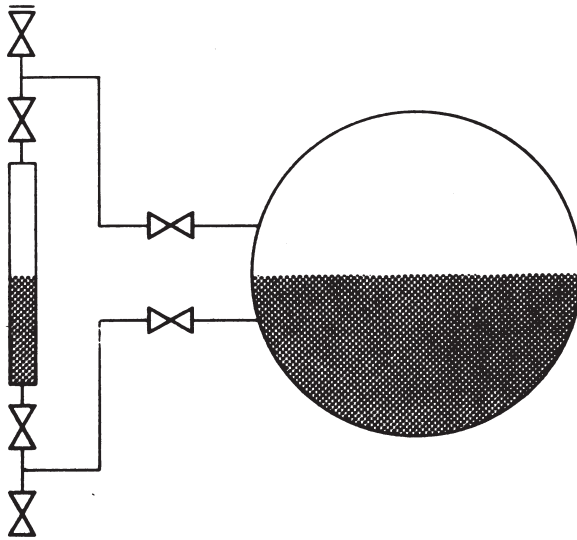
A sight-glass 1.2 m (4 ft) long was connected to vessel branches 0.6 m (2 ft) apart as shown in Figure 11-3. It will indicate the correct level only when the liquid in the vessel is between the two branches. If the liquid level is below the lower branch, the liquid in the sight-glass is isolated and its level cannot fall. If the liquid level is above the upper branch, vapor will be trapped in the upper part of the sight-glass. As the level rises, this vapor will be compressed. If there is any noncondensable gas present, the pressure in the sight-glass will rise and the level in the sight-glass will be depressed below the level in the vessel.

Figure 11-3. A level glass with a limited range. From *Chemical Engineering Progress*, July 1980. Reprinted with the permission of the American Institute of Chemical Engineers.

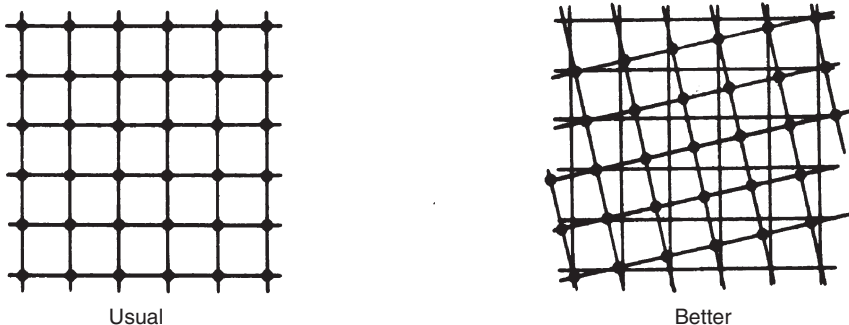
Figure 11-7. If test points are on a grid, it should be tilted so that any lines of weakness are not missed.

If tests are being carried out on a vessel, they are often made on the points of a grid. Lines of weakness (such as welds) may then be missed. The grid should be tilted so that the test points are not all above or below each other (Figure 11-7).

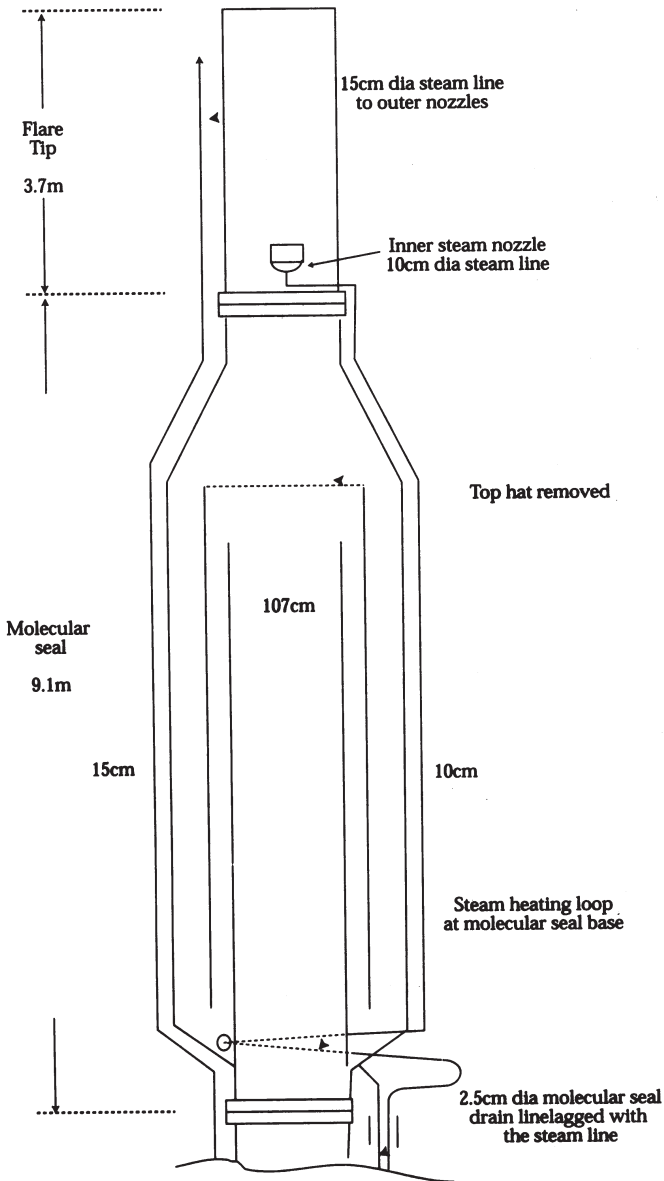
the stack, forming an explosive mixture (see *WWW*, Chapter 6). To reduce such diffusion, many companies have installed molecular seals: the gas leaving the stack and any air diffusing down follow a labyrinthine path, as shown in Figure 14-2. However, these seals have disadvantages. Carbon from incompletely burnt gas can fall into the bottom of the seal and block the flow. Ideally, material discharged from a relief valve should follow a simple and straightforward path without any equipment that might obstruct the flow in the way. For this reason, some companies have had second thoughts and removed the top of the molecular seal, called the “top hat,” as shown by the dotted line in Figure 14-2. This effectively neutralizes the seal but leaves the rest of it in position. On one plant, a steam nozzle was added inside the stack to cool the tip and to reduce smoke formation. Some of the steam condensed and flowed down the drain line into the knock-out drum. In the stack shown in Figure 14-2, the drain line was insulated with the steam line to prevent freezing.

Figure 14-2. The top of a flare stack fitted with a "top hat." From reference 6. Reprinted with the permission of the Institution of Chemical Engineers.

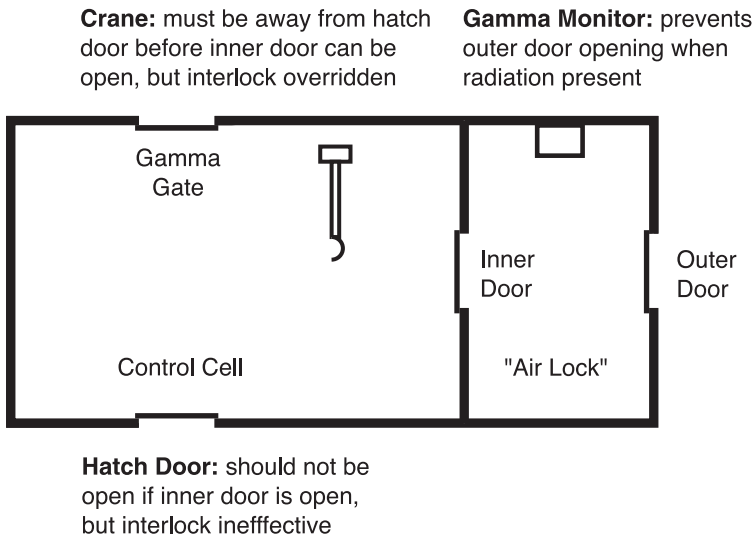
Equipment contaminated with radioactivity was cleaned in a shielded room known as a control cell (Figure 14-3). The contaminated equipment

Figure 14-3. An overly complex system of interlocks to prevent both doors being open at the same time, unless maintenance was in progress.

was brought into the cell through a hole in the floor (the hatch door) and removed after cleaning through a hole in the ceiling (the gamma gate). Cleaning and other operations were carried out by remote control. No one was allowed in the cell when radioactive equipment was present but people could enter the cell at other times to maintain the cleaning equipment. They entered through double doors that acted as an air lock. A key exchange system — only one key could be withdrawn at a time — ensured that only one door could be open at a time.

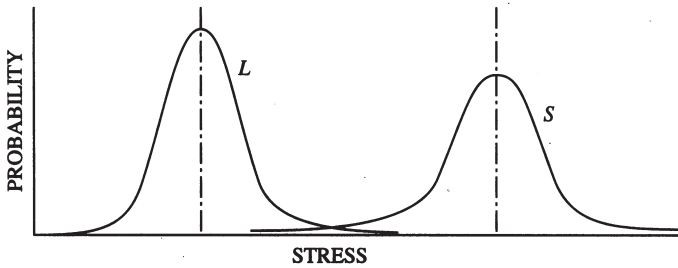
Figure 15-1 may make this clearer. In any system, the strength and the load vary to some extent from their design values and there is inevitably a small overlap between the two asymptotes. Its area is a measure of the probability that the load will exceed the strength and the system will fail, not necessarily immediately but in the long run. Normally, this probability is negligible. In the case of the railways, the wear on the wheel increases the load and cracks in the rail decrease the strength. Both were just within specification and the overlap was too large. This led to rolling contact fatigue of the track (also called gauge corner cracking), the train

Figure 15-1. Overlapping distributions of load (L) and strength (S). Reprinted with permission of *H & H*, Fig. 7.1, 1999, p. 208.

crash, and the consequent upheaval while hundreds of miles of faulty rail were replaced.
