Library of Congress Cataloging-in-Publication Data
Kletz, Trevor A.

What went wrong? : case histories of process plant disasters and how they could have been avoided / Trevor Kletz. —5th ed.

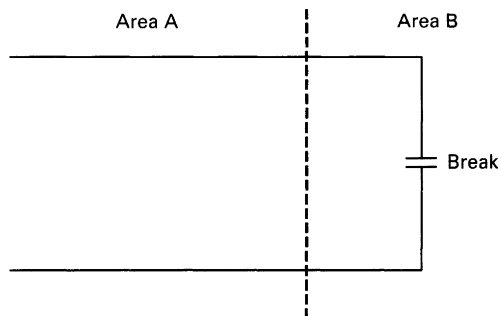
Suppose a pipeline belonging to area A passes through area B and that this pipeline has to be broken in area B (Figure 1-10).

FIGURE 1-10 Who should authorize the pipeline break?

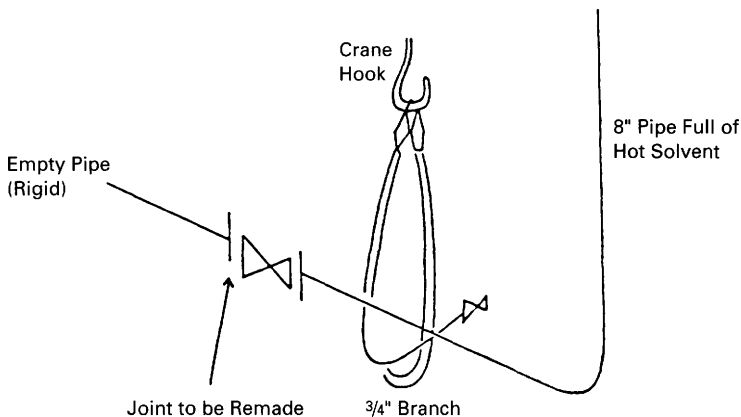
A joint on an 8-in. line containing a hot solvent had to be remade. The two sides were $\frac{3}{4}$ -in. out of line. There was a crane in the plant at the time, so it was decided to use it to lift one of the lines slightly. The lifting strap pulled against a $\frac{3}{4}$ -in. branch and broke it off (Figure 1-11).

FIGURE 1-11 A branch broke when a crane was used to move a live line.

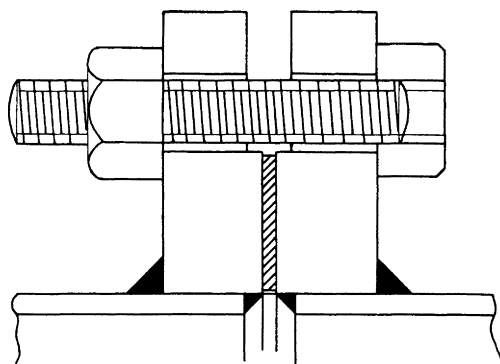
- (a) When a plant came back on line after a long shutdown, some of the flanges had been secured with stud bolts and nuts instead of ordinary bolts and nuts. And some of the stud bolts were located so that

more protruded on one side than on the other. On some flanges, one of the nuts was secured by only two or three threads (Figure 1-12).

FIGURE 1-12 Nuts fitted incorrectly to studs.

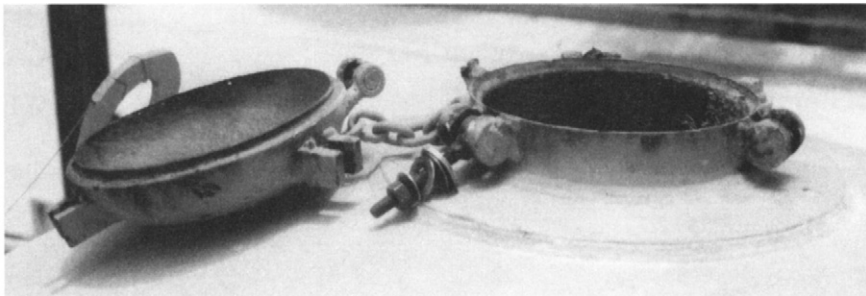
- (a)** A pressure vessel was fitted with a quick-opening lid, with a 10-in. diameter, secured by four eyebolts (Figure 1-18). They had to be replaced, as the threads were corroded. Instead of replacing the whole eyebolt, a well-meaning person decided to save time by simply cutting the eyes off the bolts and welding new studs onto them. As soon as the vessel was pressurized (with compressed air), the new studs, which had been made brittle by the welding, failed, and the lid flew off. Fortunately, a short length of chain restrained it, and it did not

FIGURE 1-18 Instead of replacing the eyebolts, new studs were welded in place of the threaded portions. They were made brittle by the heat and failed in use. Fortunately, the chain prevented the lid from going into orbit.

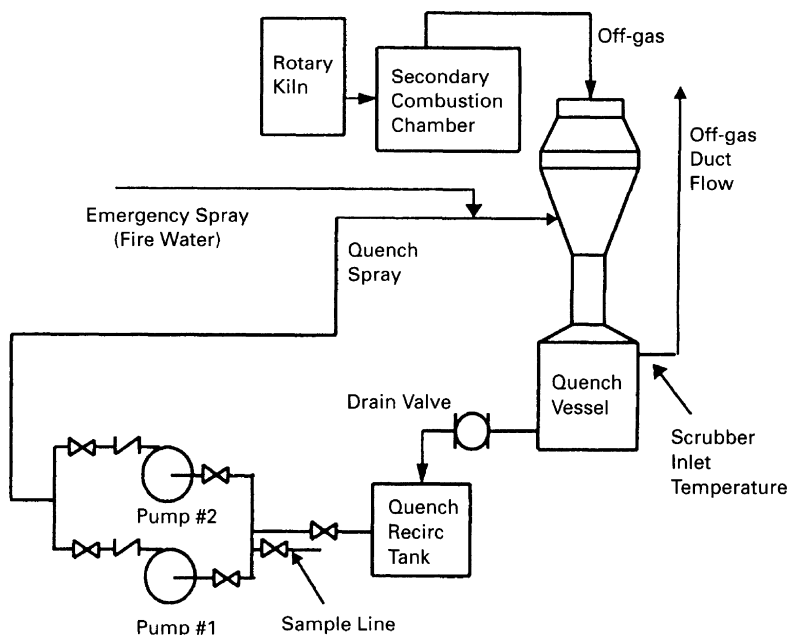
A sample point on the suction line of two water pumps became choked, and a maintenance worker was asked to clear it. He was not told how to do so—craftspeople dislike people from other departments telling them how to do their jobs—but the operators assumed he would use water under pressure or a rod. Instead he used compressed air at a gauge pressure of 115 psi (8 bar), and a pocket of air caused the pumps to lose suction (Figure 1-19).

The results were not serious. The pumps supplied water to cool the hot gases leaving an incinerator; when the water flow stopped, a high-temperature trip shut down the burner. The incinerator was new, it was still undergoing tests, and the job had not been done before. The water was recycled, and ash in it probably caused the choke [40].

FIGURE 1-19 Simplified drawing of incinerator quench recirculation system. (Illustration courtesy of the U.S. Department of Energy.)

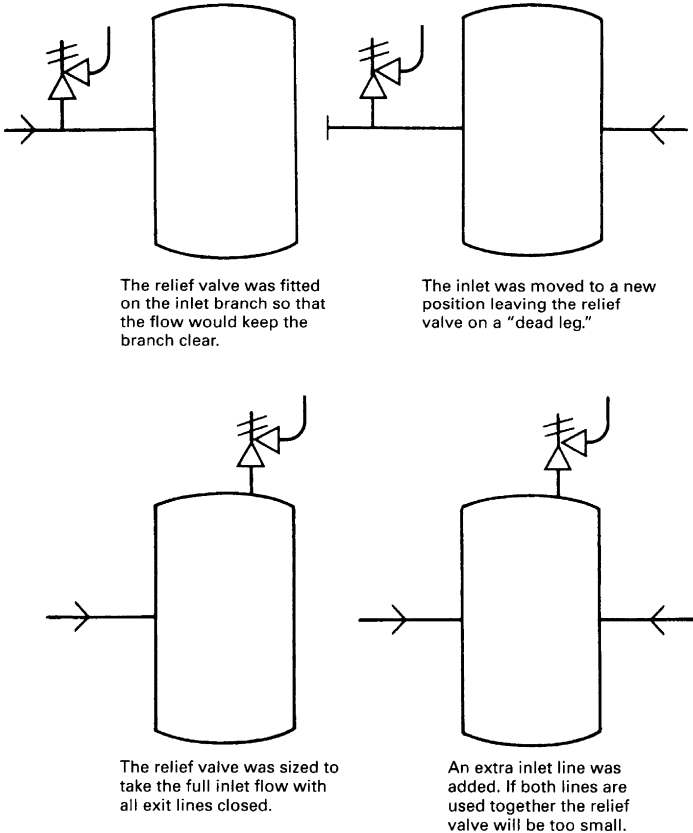
At one plant, a repeat relief and blowdown review was carried out one year after startup. The startup team had been well aware of the need to look for the consequences of modifications and had tried to do so as modifications were made. Nevertheless, the repeat relief and blowdown review brought to light 12 instances in which the assumptions of the original review were no longer true and additional or larger relief valves, or changes in the position of a relief valve, were necessary. Figure 2-1 shows some examples.

FIGURE 2-1 Some of the modifications made to the relief system in a plant during its first year on line.

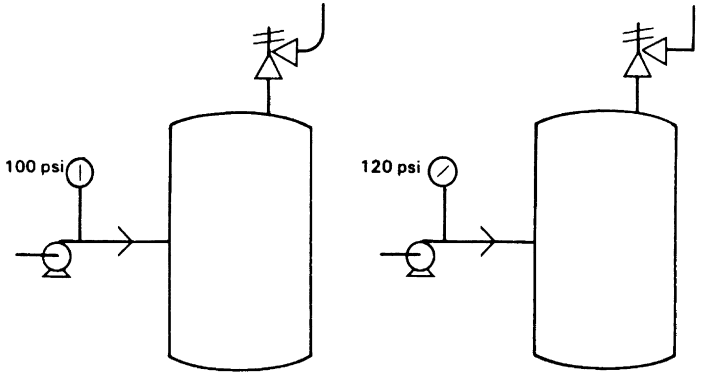
The vessel was designed to withstand the maximum pressure the pump could deliver. The relief valve was not designed to take the maximum flow from the pump.

The pump actually proved capable of producing 20 psi more than design. If the exit from the vessel is isolated when the pump is running the vessel will be overpressured.

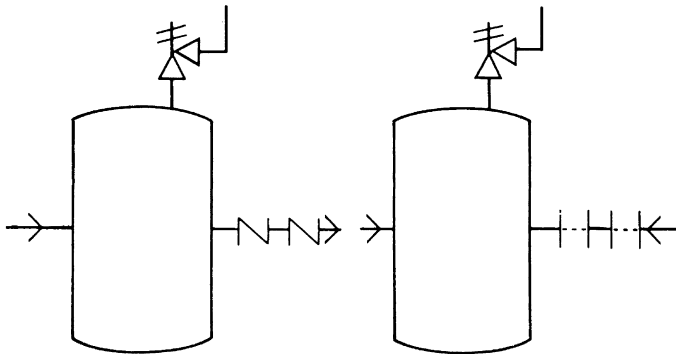
The relief valve was sized on the assumption that two nonreturn valves in series would prevent backflow into the vessel.

Both nonreturn valves corroded, allowing backflow to take place.

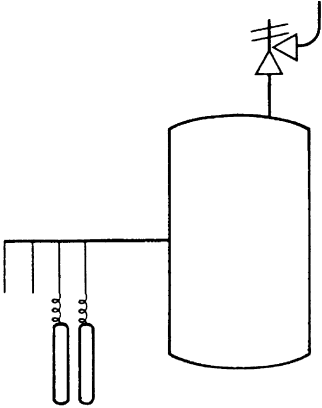
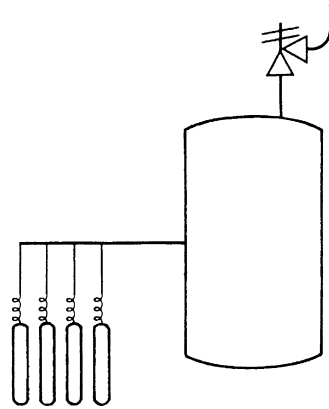
The relief valve was sized on the assumption that only two gas cylinders would be used at a time, though connections were provided for four cylinders.

Inevitably, four cylinders were connected up and sometimes used.

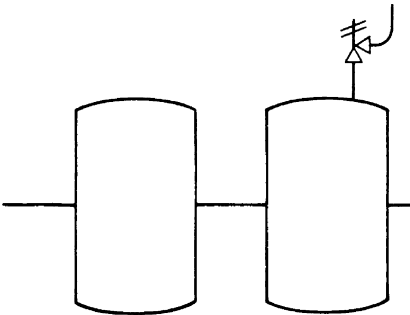
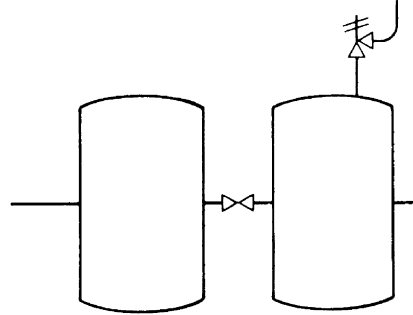
A single relief valve was designed to protect two vessels, which were connected together by a line without any valve or other restriction between them.

An extra isolation valve was fitted between the two vessels, thus making it possible to isolate the first vessel from its relief valve.

In another similar case, chokes occurred in the line between the two vessels.

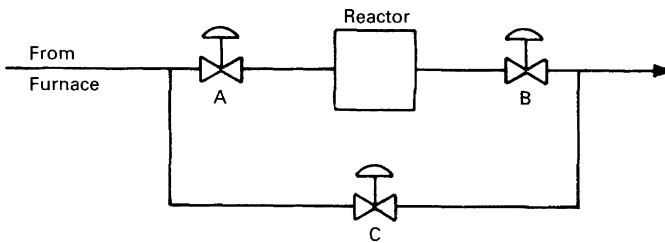
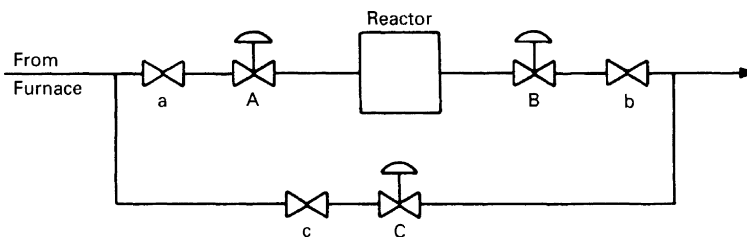
- (b)** A reactor was fitted with a bypass (Figure 2-2a). The remotely operated valves A, B, and C were interlocked so that C had to be open before A or B could be closed. It was found that the valves leaked, so hand-operated isolation valves (a, b, and c) were installed in series with them (Figure 2-2b).

After closing A and B, the operators were instructed to go outside and close the corresponding hand valves a and b. This destroyed the interlocking. One day, an operator could not get A and B to close. He had forgotten to open C. He decided that A and B were faulty and closed a and b. Flow stopped. The tubes in the furnace were overheated. One of them burst, and the lives of the rest were shortened.

FIGURE 2-2a Original reactor bypass.

FIGURE 2-2b Modified reactor bypass.

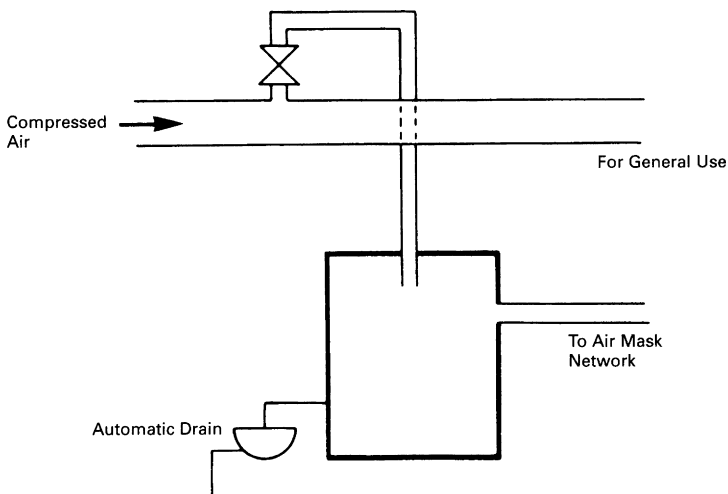
Many years ago, a special network of air lines was installed for use with air masks only. A special branch was taken off the top of the compressed air main as it entered the works (Figure 2-4).

FIGURE 2-4 Original arrangement of air lines.

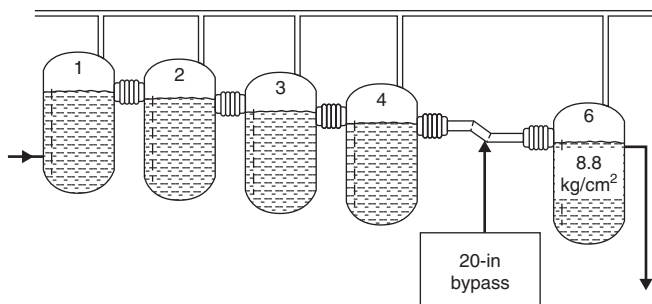
At the Flixborough plant, there were six reactors in series. Each reactor was slightly lower than the one before so that the liquid in them flowed by gravity from No. 1 down to No. 6 through short 28-in.-diameter connecting pipes (Figure 2-5). To allow for expansion, each 28-in. pipe contained a bellows (expansion joint).

One of the reactors developed a crack and had to be removed. (The crack was the result of a process modification; see Section 2.6b.) It was replaced by a temporary 20-in. pipe, which had two bends in it, to allow for the difference in height. The existing bellows were left in position at both ends of the temporary pipe (Figure 2-5).

The design of the pipe and support left much to be desired. The pipe was not properly supported; it merely rested on scaffolding. Because there was a bellows at each end, it was free to rotate or “squirm” and did so when the pressure rose a little above the normal level. This caused the bellows to fail.

FIGURE 2-5 Arrangement of reactors and temporary pipe at Flixborough.

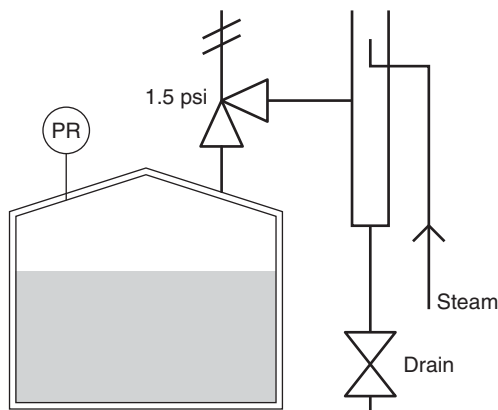
- (a)** A low-pressure refrigerated ethylene tank was provided with a relief valve set at a gauge pressure of about 1.5 psi (0.1 bar), which discharged to a vent stack. After the design had been completed, it was realized that cold gas coming out of the stack would, when the wind speed was low, drift down to ground level, where it might be ignited. The stack was too low to be used as a flarestack—the radiation at ground level would be too high—and was not strong enough to be extended. What could be done?

FIGURE 2-6 Liquid ethylene tank venting arrangements.

Someone suggested putting steam up the stack to disperse the cold vapor. This seemed a good idea, and the suggestion was adopted (Figure 2-6).

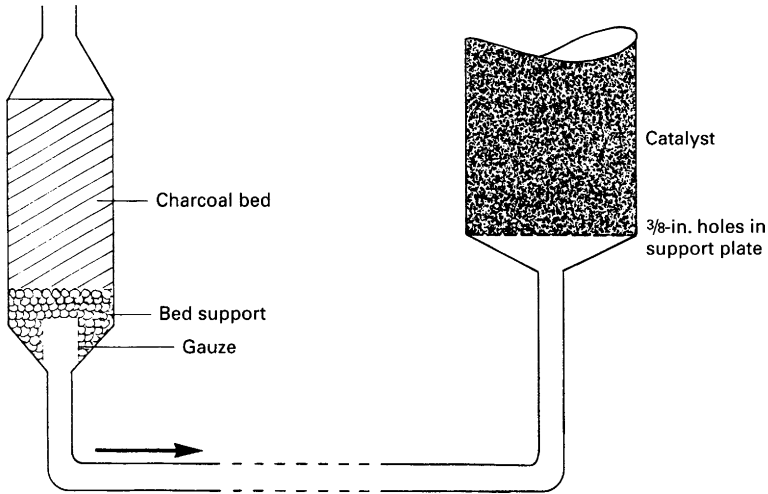
The hydrogen came from another plant and was passed through a charcoal filter to remove traces of oil before it left the supplying plant. Changes of charcoal were infrequent, and the initial stock lasted several years. Reordering resulted in a finer charcoal being supplied and charged without the significance of the change being recognized. Over a long period, the new charcoal passed through its support into the line to the other plant. Small amounts of the charcoal partially clogged the $\frac{3}{8}$ -in. (10 mm) distribution holes in the catalyst retaining plate (Figure 2-7). There was a big loss of production.

FIGURE 2-7 Hydrogen purification system.

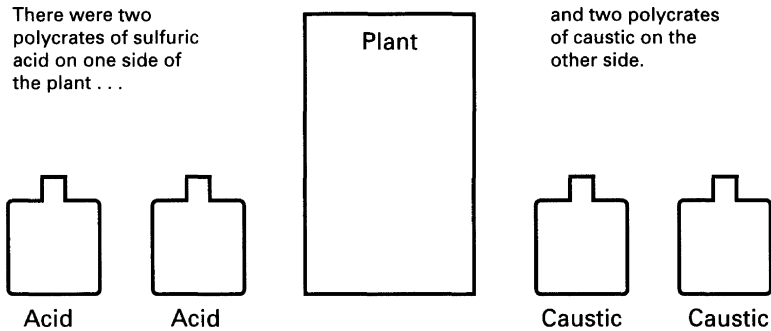
- (a)** A plant used sulfuric acid and caustic soda in small quantities, so the two substances were supplied in similar plastic containers called polycrates (Figure 2-9). While an operator was on his day off, someone decided it would be more convenient to have a polycrate of acid and a polycrate of alkali on each side (Figure 2-10). When the operator

FIGURE 2-9 Original layout of acid and caustic containers.

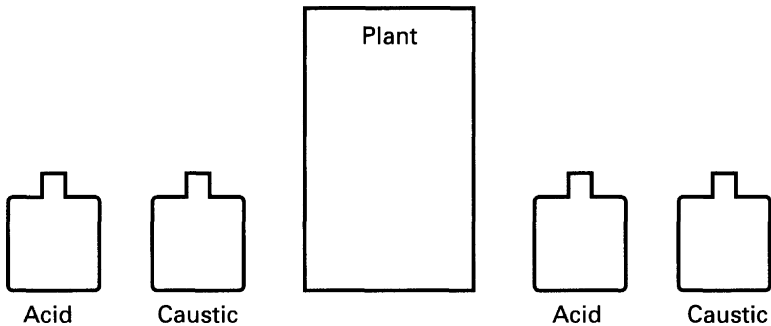
FIGURE 2-10 Modified layout of acid and caustic containers.

came back, no one told him about the change. Without checking the labels, he poured some excess acid into a caustic crate. There was a violent reaction, and the operator was sprayed in the face. Fortunately, he was wearing goggles.

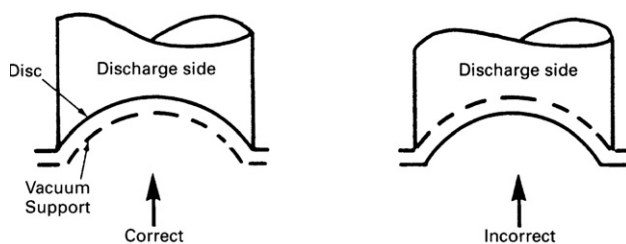
- (e) A runaway reaction occurred in a polymerization reactor. A rupture disc failed to burst. It had been fitted on the wrong side of the vacuum support, thus raising its bursting pressure from a gauge pressure of 150 psi (10 bar) to about 400 psi (27 bar) (Figures 3-1a and 3-1b).

The polymer escaped through some of the flanged joints, burying the reactor in a brown polymer that looked like molasses candy (treacle toffee). The reactor was fitted with class 150 flanges. If these are overpressured, the bolts will stretch, and the flanges will leak,

FIGURE 3-1a Arrangements of rupture disc and vacuum support.

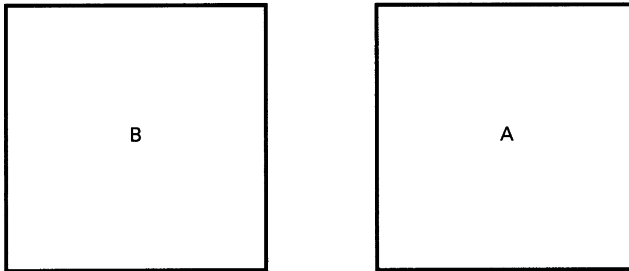
The mechanic, who had done the job many times before, took the cover off the back of B recorder, the one on the left behind the panel (Figure 3-3), and disconnected one of the leads. The effect was the same as if the recorder had registered a high temperature. The controller closed the fuel gas valve, shutting down the furnace and the rest of the plant.

FIGURE 3-3 Layout of recorders behind panel.

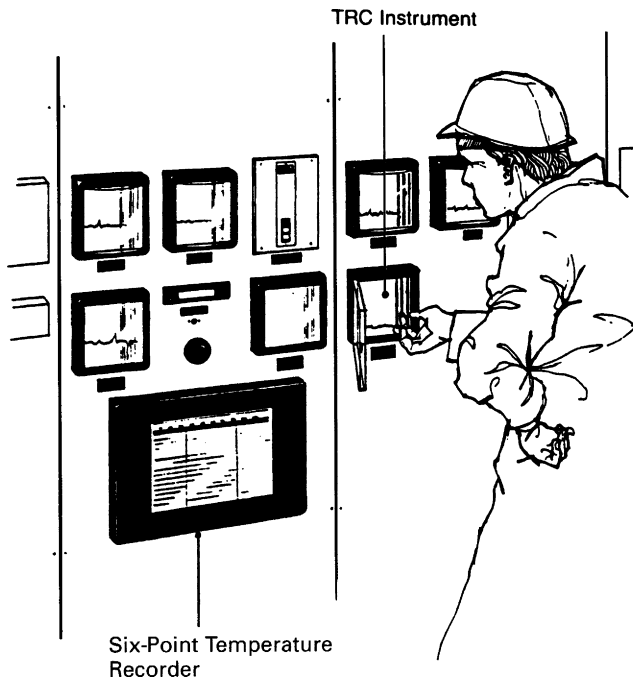
Unfortunately, there was a fault in the temperature recorder, and although the temperature actually rose, this was not indicated. The result was a runaway reaction. The rise in temperature was, however, indicated on a six-point temperature recorder at a lower level on the panel, but the operator did not notice this (Figure 3-4).

An interesting feature of this incident was that no one blamed the operator. The plant manager said he would probably have made the same mistake because the check instrument was at a low level (about 1 m above the floor) and because a change in one temperature on a six-point recorder in that position is not obvious unless you are actually looking for it. It is not the sort of thing you notice out of the corner of your eye.

FIGURE 3-4 Instruments below eye level may not be noticed.

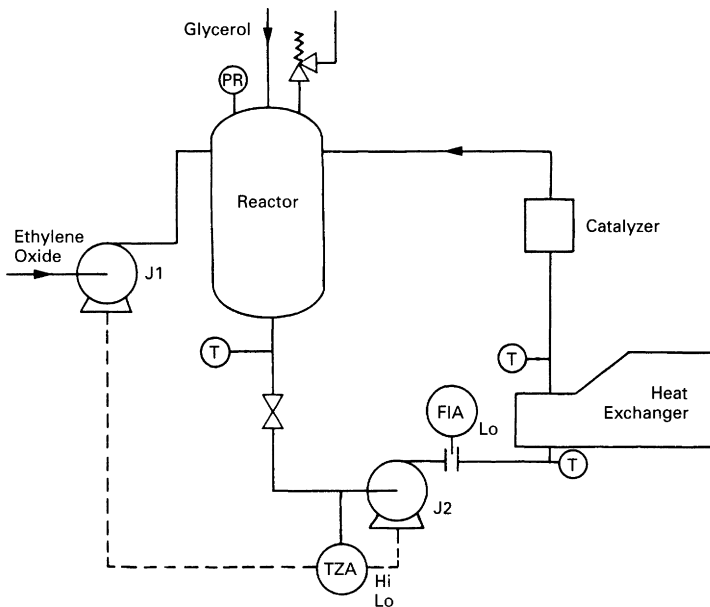
Figure 3-6 shows a batch reaction system. A batch of glycerol was placed in the reactor and circulated through a heat exchanger, which could act as both a heater and a cooler. Initially it was used as a heater, and when the temperature reached 115°C, ethylene oxide was added. The reaction was exothermic, and the exchanger was now used as a cooler.

FIGURE 3-6 Arrangements of reactor circulating system.

Despite these precautions, an explosion occurred. One day, when the ethylene oxide addition was started, the pressure in the reactor rose. This showed that the ethylene oxide was not reacting. The operator decided that perhaps the temperature point was reading low or perhaps a bit more heat was required to start the reaction, so he adjusted the trip setting and allowed the indicated temperature to rise to 200°C (390°F). Still the pressure did not fall.

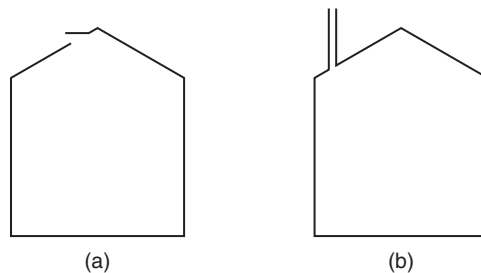
This overflow device should be fitted to the roof near the wall. If it is fitted near the center of the roof, the height of liquid above the top of the walls may exceed 8 in., and the tank may be overpressured (see Figure 5-2a).

Similarly, if the vent is designed to pass liquid, it should be fitted near the edge of the roof, and its top should not be more than 8 in. above the tops of the walls. Vessels have been overpressured because their vent pipes were too long (see Figure 5-2b). Tanks in which hydrogen may be evolved should be fitted with a vent at the highest point as well as an overflow (see Section 16.2).

FIGURE 5-2 A tank may be overpressured if the vent or overflow is more than 8 in. above the tops of the walls.

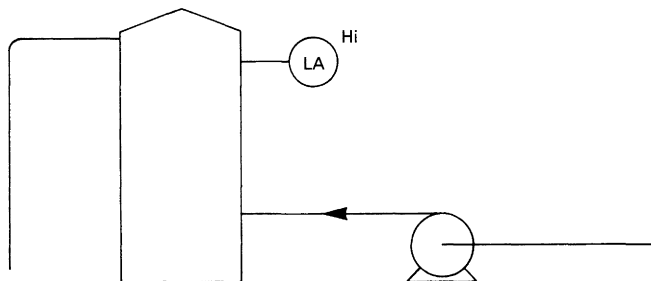
- (j)** Before emptying a tank truck, the driver propped the manhole lid open. It fell shut.
- (k)** A tank was fitted with an overflow, which came down to ground level. There was no other vent. When the tank was overfilled, the contents siphoned out (Figure 5-5). The tank should have been fitted with a vent on its roof, as well as the liquid overflow.

FIGURE 5-5 Overflow to ground level can cause a tank to collapse if there is no other vent.

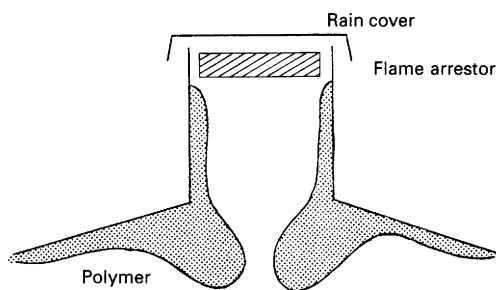
- (l)** A vent was almost blocked by polymer (Figure 5-6). The liquid in the tank was inhibited to prevent polymerization, but the vapor that condensed on the roof was not inhibited. The vent was inspected regularly, but the polymer was not noticed. Now a wooden rod is pushed through the vent to prove it is clear. (The other end of the rod should be enlarged so it cannot fall into the tank.)

FIGURE 5-6 Vent almost blocked by polymer.

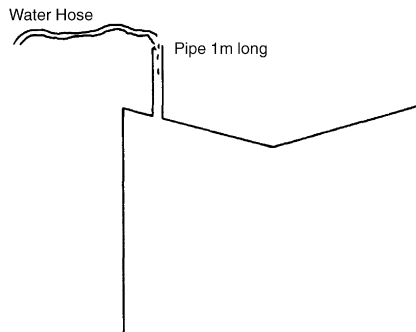
The need for such training is shown by the action taken following one of the incidents. Only the roof had been sucked in, and it was concave instead of convex. The engineer in charge decided to blow the tank back to the correct shape by water pressure. He gave instructions for this to be done. A few hours later, he went to see how the job was progressing. He found that the tank had been filled with water and that a hand-operated hydraulic

FIGURE 5-7 Method of restoring a tank with a concave roof to its original shape.

pump, normally used for pressure-testing pipework, was being connected to the tank. He had it removed, and he replaced the vent with a vertical pipe, 1 m long. He dribbled water into the pipe from a hose, and as he did so, the tank was restored to its original shape (Figure 5-7) to the amazement of onlookers. The static pressure of the water in the pipe was sufficient.

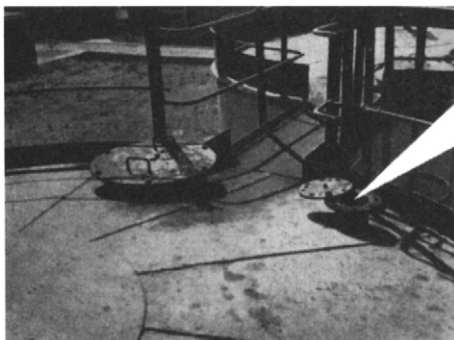
FIGURE 5-8

External sources of ignition, such as lightning (Figure 5-8) or welding near an open vent, can also trigger a tank explosion. Sample and dip

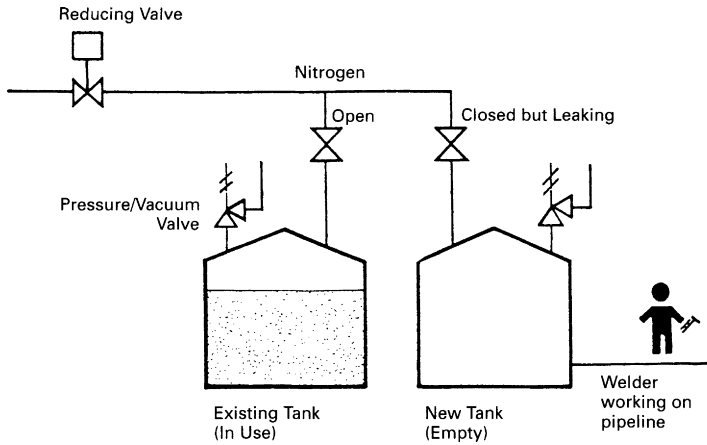
The new tank and an existing one were designed to be on balance with each other to save nitrogen (Figure 5-9), but the contractors did not understand this. The valve to the new tank was closed but leaking. Nitrogen and methanol vapor entered the tank, and a welder who was completing the inlet line to the tank ignited the vapor. The roof was blown right off. By great good fortune, it landed on a patch of empty ground just big enough to contain it (Figure 5-10).

FIGURE 5-9 If tanks are on balance, the nitrogen entering one tank is inevitably mixed with vapor.

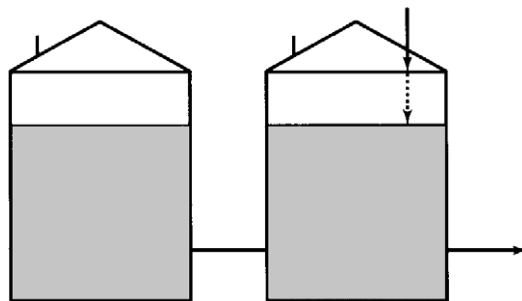
- (f) Paper mills use large quantities of water, and the water is usually recycled. Buffer storage is needed, and at one paper mill, it took the form of a 740-m³ tank. Experience showed that this was insufficient, and another tank of the same size was installed alongside. To simplify installation, it was not connected in parallel with the original tank but on balance with it, as shown in Figure 5-13. A week after the new tank was brought into use, welders were completing the hand-rails on the roof when an explosion occurred in the tank. Two welders were killed, and the tank was blown 20 m into the air, landing on a nearby building.

Investigation showed that the explosion was due to hydrogen formed by anaerobic bacteria. In the original tank, the splashing of the inlet liquor aerated the water and prevented anaerobic conditions. This did not apply in the new tank [20].

FIGURE 5-13 Extra buffer storage for water was provided by installing a second tank on balance with the first one. Lack of aeration allowed hydrogen-forming bacteria to grow, and an explosion occurred. (Reproduced with permission of the American Institute of Chemical Engineers. Copyright © 1995 AIChE. All rights reserved.)

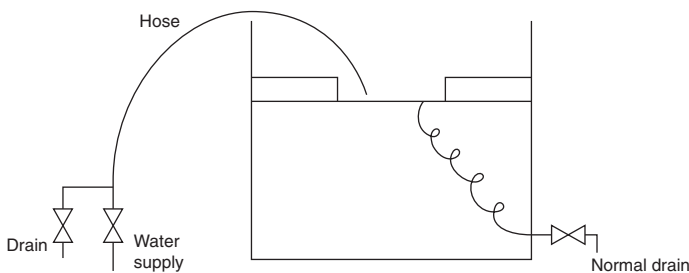
A choke occurred in the flexible pipe that drained the roof of a floating-roof tank. It was decided to drain rainwater off the roof with a hose. To prime the hose and establish a siphon, the hose was connected to the water supply. It was intended to open the valve on the water supply for just long enough to fill the hose. This valve would then be closed and the drain valve opened (Figure 5-14). However, the water valve was opened in error and left open, with the drain valve shut. Water flowed onto the floating roof, and it sank in 30 minutes (see also Section 18.8).

FIGURE 5-14 How to sink the roof of a floating-roof tank.

Temporary modifications should be examined with the same thoroughness as permanent ones (see Section 2.4).

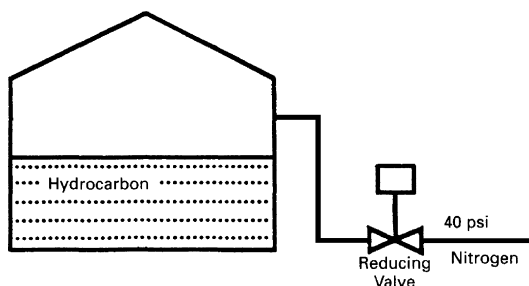
On one group of tanks, the reducing valve on the nitrogen supply was installed at ground level (Figure 5-17). Hydrocarbon vapor condensed in the vertical section of the line and effectively isolated the tank from the nitrogen blanketing.

FIGURE 5-17 Incorrect installation of nitrogen blanketing.

All safety equipment and systems should be scheduled for regular inspection and test. Nitrogen blanketing systems should be inspected at least weekly. It is not sufficient to check that the nitrogen is open to the tank. The atmosphere in the tank should be tested with a portable oxygen analyzer to make sure that the oxygen concentration is below 5%.

Large tanks (say, over 1,000 m³) blanketed with nitrogen should be fitted with low-pressure alarms to give immediate warning of the loss of nitrogen blanketing.

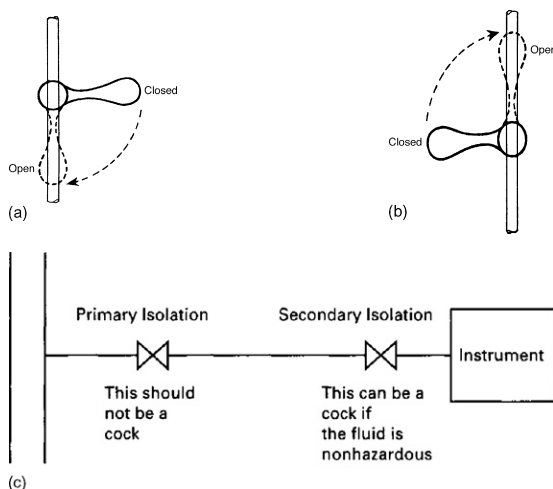
Small cocks have often been knocked open or have vibrated open, as shown in Figure 7-1a. To prevent this from happening the valves should be installed so that when they are open the valve handle points upward, as shown in Figure 7-1b. Cocks should never be used as the sole isolation valve (and preferably not at all) on lines carrying hazardous materials, particularly flammable or toxic liquids, at pressures above their atmospheric boiling points (for example, liquefied flammable gases and most heat transfer oils when hot). These liquids turn to vapor and spray when they leak and can spread long distances. It is good practice to use other types of valves for the first isolation valve, as shown in Figure 7-1c.

FIGURE 7-1 (a) Vibration can cause the cock to open. (b) A better arrangement. (c) Small cocks should not be used as primary isolation valves.

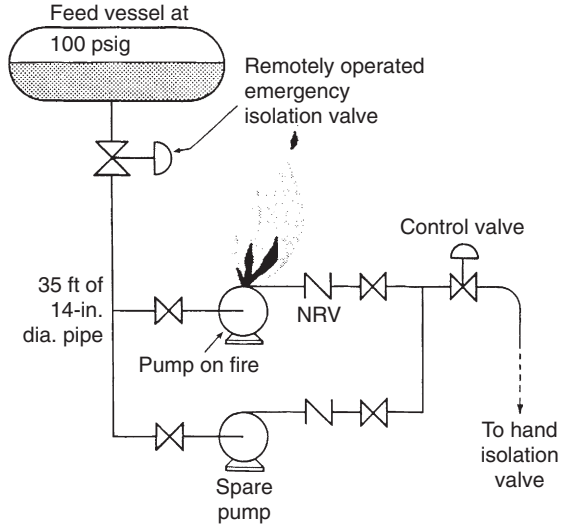
Backflow from the delivery side of the pump was prevented by a check (nonreturn) valve. In addition, a control valve and a hand valve well away from the fire were closed (Figure 7-5).

FIGURE 7-5 An emergency isolation valve stopped a fire.

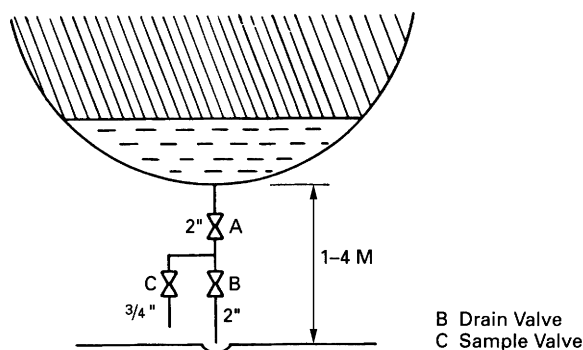
An operator had to drain water from a 1,200-m³ spherical storage vessel nearly full of propane (Figure 8-1). He opened valves A and B. When traces of oil showed that the draining was nearly complete, he shut A and then cracked it to complete the draining. No flow came. He opened A fully. The choke—presumably hydrate, a compound of water and a light hydrocarbon with a melting point above 0°C (32°F)—cleared suddenly, and the operator and two others were splashed with liquid. The handle came off valve A, and they could not get it back on. Valve B was frozen and could not be moved. Access was poor because the drain valves were immediately below the tank, which was only 1.4 m (4.5 ft) above the ground.

FIGURE 8-1 Drain valves underneath propane tank at Feyzin.

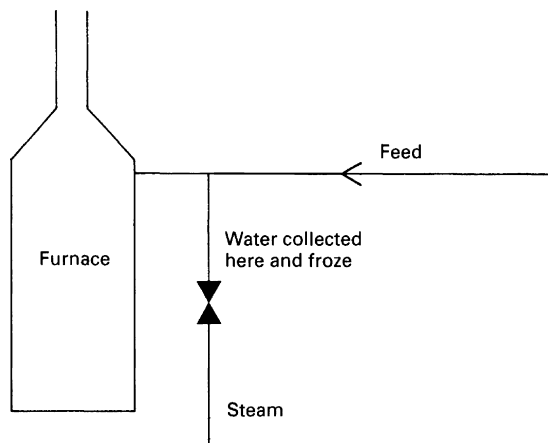
There are other sorts of dead-ends besides pipes that have been blanked. Rarely used valved branches are just as dangerous. The feed line to a furnace (Figure 9-1) was provided with a permanent steam connection for use during de-coking.

The connection was on the bottom of the feed line, and the steam valve was not close to the feed line. Water collected above the steam valve,

FIGURE 9-1 The steam connection to the furnace formed a dead-end.

froze during cold weather, and ruptured the line, allowing oil at a gauge pressure of 450 psi (30 bar) to escape. If dead-ends cannot be avoided, they should be connected to the *top* of the main pipeline (unless the liquid in the pipeline is denser than water).

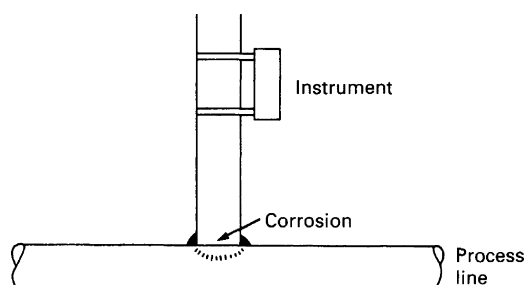
FIGURE 9-2 Water collected in the instrument support and corroded the process line.

An unusual—and unnecessary—dead-end was a length of 2-in. pipe welded onto a process line to provide a support for an instrument (Figure 9-2). Water collected in the support. Four years after it had been installed, the process line corroded through, and a leak of liquefied gas occurred.

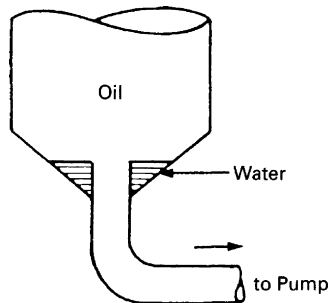
Another serious failure occurred because water in a dead-end was suddenly vaporized. A heavy oil was dried by heating it to 120°C (250°F) in a tank filled with steam coils. The oil was circulated while it was being dried. The suction line projected into the conical base of the tank, forming a dead-end, as shown in Figure 9-3.

FIGURE 9-3 Water in this dead-end was vaporized by oil.

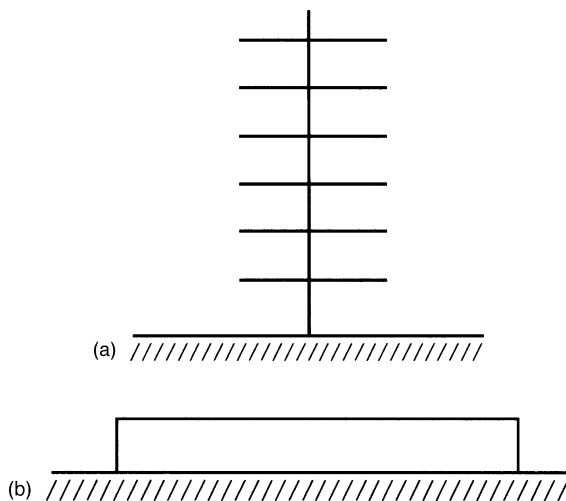
- (h)** Eleven pipelines, 50 to 200 mm (2 to 8 in.) in diameter, containing hydrocarbon liquids and gases, were supported on brackets of the type shown in Figure 9-5a, 2.1 m (7 ft) tall and 6 m (10 ft) apart. The pipes

FIGURE 9-5 (a) The original pipe supports. (b) The supports used after the collapse.

were fixed to two of the brackets and rested on the others. The pipe run passed through a tank farm, and the wind flow through the gaps between the tanks caused the upright part of the supports to incline 2 degrees from the vertical. This was noticed when the pipe run was inspected, but no one regarded it as serious.

As the result of a power failure, the flow through many of the pipes suddenly stopped, and the surge caused the angle of inclination to increase to 6 degrees. The tops of the supports were now 5 in. (125 mm) out of line. The supports were now unstable. Eleven hours after the power failure and three hours after the flows had been restored, the pipe run collapsed over a length of 23 m (75 ft); 14 tons of gasoline spilled. Three hours later, a further length collapsed. The pipe supports were replaced by the type shown in Figure 9-5b.

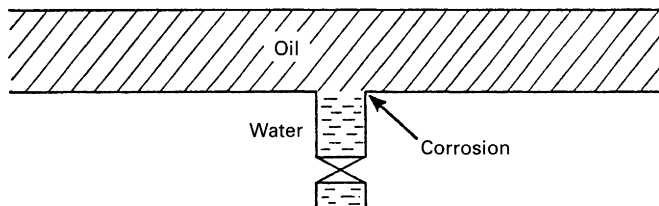
Water was injected into an oil stream using the simple arrangement shown in Figure 9-6. Corrosion occurred near the point shown, and the oil leak caught fire [5]. The rate of corrosion far exceeded the corrosion allowance of 0.05 in. per year.

FIGURE 9-6 Water injection—a poor arrangement.

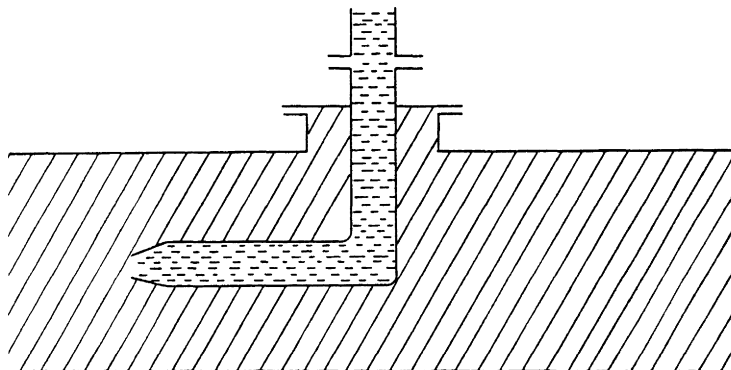
A better arrangement is shown in Figure 9-7. The dimensions are chosen so that the water injection pipe can be removed for inspection. However, this system is not foolproof. One system of this design was assembled with the injection pipe pointing upstream instead of downstream. This increased corrosion.

FIGURE 9-7 Water injection—a better arrangement.

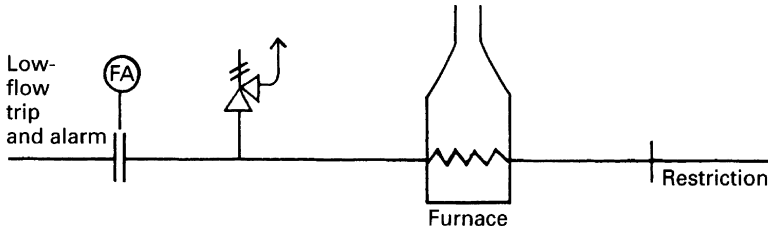
A furnace was protected by a relief valve on its inlet line (Figure 10-1). A restriction developed after the furnace. The relief valve lifted and took most of the flow. The flow through the furnace tubes fell to such a low level that they overheated and burst. The low-flow trip, which should have isolated the fuel supply to the furnace when the flow fell to a low value, could not do so because the flow through it was normal.

FIGURE 10-1 When the relief valve lifted, the flow through the furnace was reduced.

The relief valve should have been placed after the furnace or, if this was not possible, before the low-flow trip.

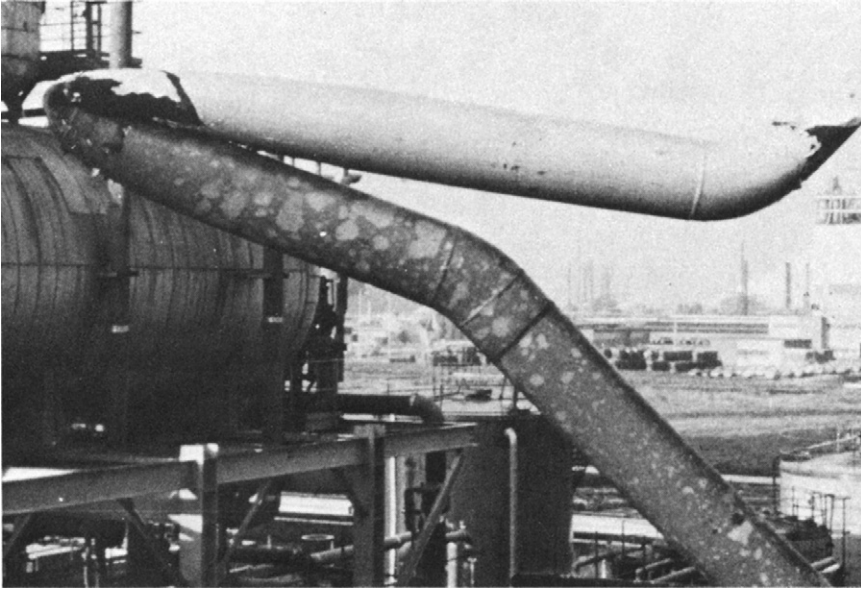
Figure 10-4 shows what happened to the tailpipe of a steam relief valve that was not adequately supported. The tailpipe was not provided with a drain hole (or if one was provided, it was too small), and the tailpipe filled with water. When the relief valve lifted, the water hit the curved top of the tailpipe with great force. Absence of a drain hole in a tailpipe also led to the incident described in Section 9.2.1g.

FIGURE 10-4 This relief-valve tailpipe was not adequately supported.

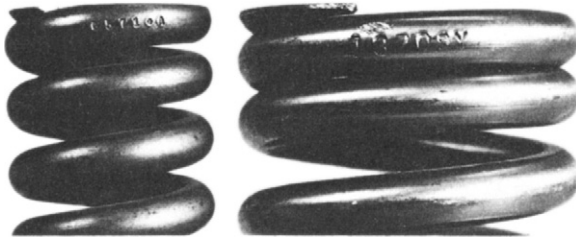
1. Identification numbers stamped on springs, thus weakening them (Figure 10-5).
2. The sides of springs ground down so that they fit.
3. Corroded springs.
4. A small spring put inside a corroded spring to maintain its strength. Sometimes the second spring was wound the same way as the first spring so that the two interlocked (Figure 10-6).
5. Use of washers to maintain spring strength.
6. Welding of springs to end caps (Figure 10-7).
7. Deliberate bending of the spindle to gag the valve (Figure 10-8).
8. Too many coils allowing little, if any, lift at set pressure (Figure 10-9).

FIGURE 10-5 Identification marks on body coils could lead to spring failure.

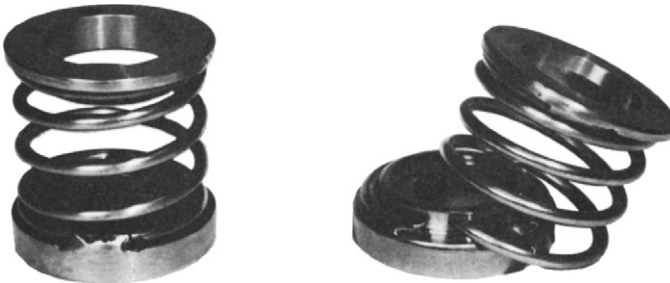
FIGURE 10-7 End caps welded to spring. Failure occurred at weld.

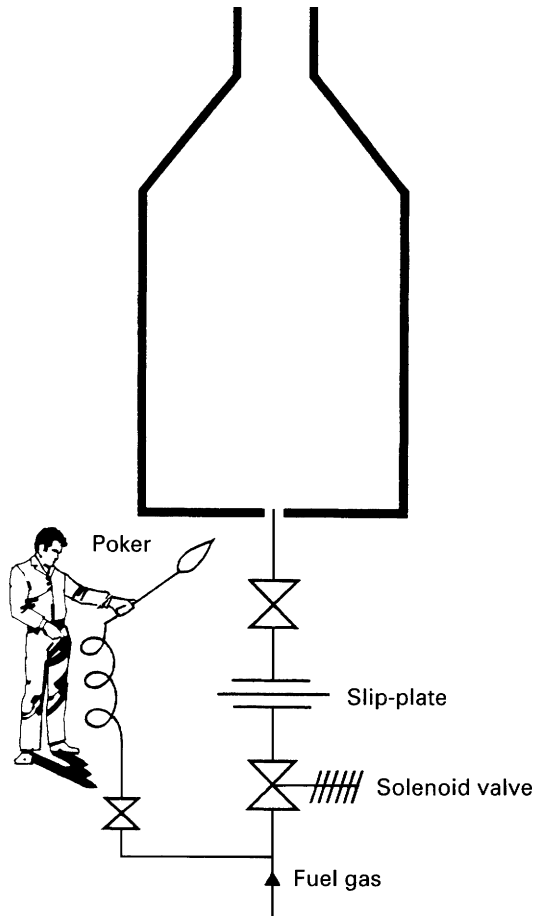
- (a)** A foreman tested the atmosphere inside a furnace (Figure 10-12) with a combustible gas detector. No gas was detected, so the slip-plate (blind) was removed, and two minutes later, a lighted poker

FIGURE 10-12 Lighting a furnace heated by fuel gas.

was inserted. An explosion occurred. The foreman and another man were hit by flying bricks, and the brickwork was badly damaged.

1. Test the atmosphere inside the furnace.
2. If you do not detect gas, light and then insert the poker (or switch on the electric igniter).
3. Remove the slip-plate (or connect the hose, drain the lute, or change over the double block and bleed valves). If the isolation valve is leaking, the poker or igniter will ignite the leaking fuel before it forms an explosive mixture. (The solenoid valve shown in Figure 10-12 should open automatically when the poker is inserted or the igniter is switched on. If it does not, it should be held open until the main burner is lit.)
4. Open the fuel-gas isolation valve.

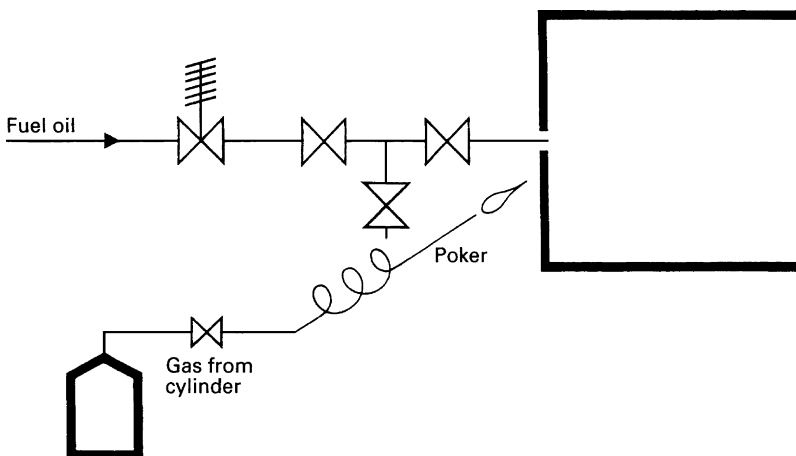
- (b)** A reduction in fuel oil pressure caused the burner in an oil-fired furnace to go out, and the flame failure device closed the solenoid valve in the fuel oil line (Figure 10-13). The operator closed the two hand-isolation valves and opened the bleed between them. (The group of three valves is equivalent to the slip-plate shown in Figure 10-12.) When the fuel oil pressure was restored, the foreman tested the atmosphere in the furnace with a combustible gas detector. No gas was detected, so he inserted a lighted poker. The fuel oil supply was

FIGURE 10-13 Lighting a furnace heated by heavy fuel oil.

1. Calculate the amount of oil between the solenoid valve and the burner.
2. Assume it all drains into the furnace and evaporates. Calculate the volume of the flammable mixture, assuming it is at the lower flammable limit, probably about 0.5% v/v. (If it forms a richer mixture, the volume will be less.)

3. Multiply by four to give a safety margin, and sweep out the furnace with this volume of air [11].

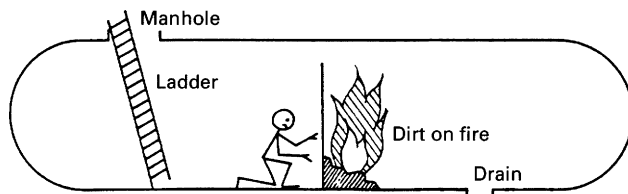
- (a)** A vessel was divided into two halves by a baffle, which had to be removed. The vessel was cleaned out, inspected, and a permit issued for a worker to enter the left-hand side of the vessel to burn out the baffle. It was impossible to see into the right-hand half. But because the left-hand half was clean and because no combustible gas could be detected, it was assumed that the other half was also clean (Figure 11-1). While

FIGURE 11-1 If part of a vessel cannot be seen, assume it is dirty.

the welder was in the vessel, some deposit in the right-hand half caught fire. The welder got out without serious injury but bruised himself in his haste.

If a part of the vessel cannot be inspected and be seen to be safe, then we should assume the vessel contains hazardous materials.

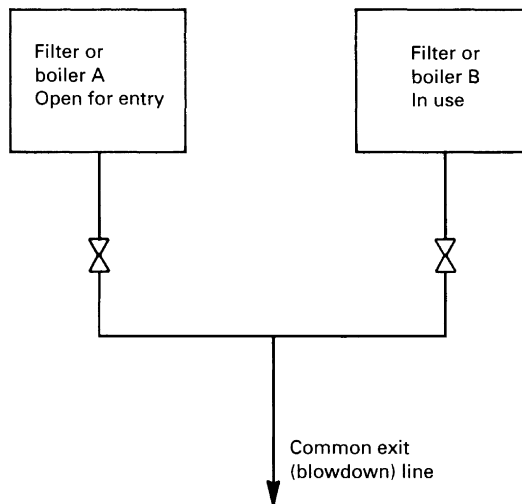
The liquid, after passing through the outlet valve, joined the line from another filter that was in use. It is believed that carbon dioxide gas from the filter liquid passed up the outlet line into the filter that was being inspected (Figure 11-2). A test showed that "contamination was not sufficient to prevent a candle burning."

- (f) Forty-five years later, in the same company, the accident was repeated, and this time a man was killed. While a man was working inside a boiler, the process foreman noticed that the water level in another boiler was too high. He asked an operator to lower the level through the blowdown (drain) valve, which discharged into a common drain line. Steam entered the boiler under repair from this common line. None of the lines had been slip-plated or disconnected, and the blowdown valve had been left open (Figure 11-2).

FIGURE 11-2 Liquid or gas traveled backward from the common line into the vessel that was open for entry.

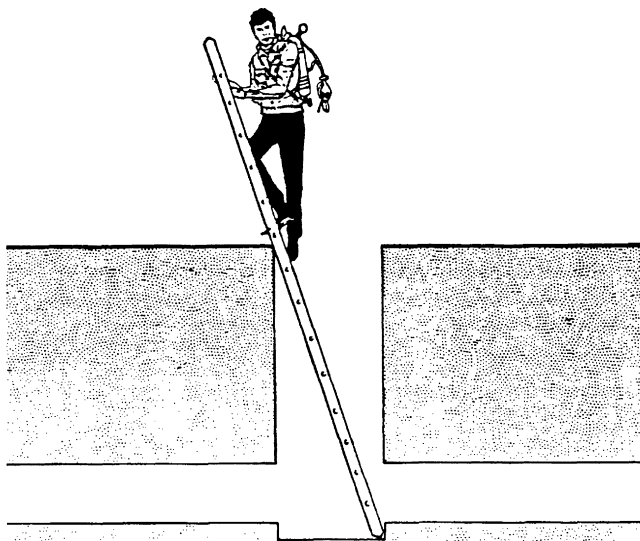
A man was standing on a ladder, ready to go down into a drain manhole to plug one of the inlet lines. The drain contained some hydrogen sulfide, so he had an air mask ready. But he had not yet put it on because he was well outside the manhole. His feet were at ground level (Figure 11-3). He was about to put on a safety harness when his two companions heard a shout and saw him sliding into the manhole. They were unable to catch him, and his body was recovered from the outfall. He had been

FIGURE 11-3 A man was overcome by fumes from the manhole.

overcome by hydrogen sulfide arising from the drains, although his face was 1.5m above ground level.

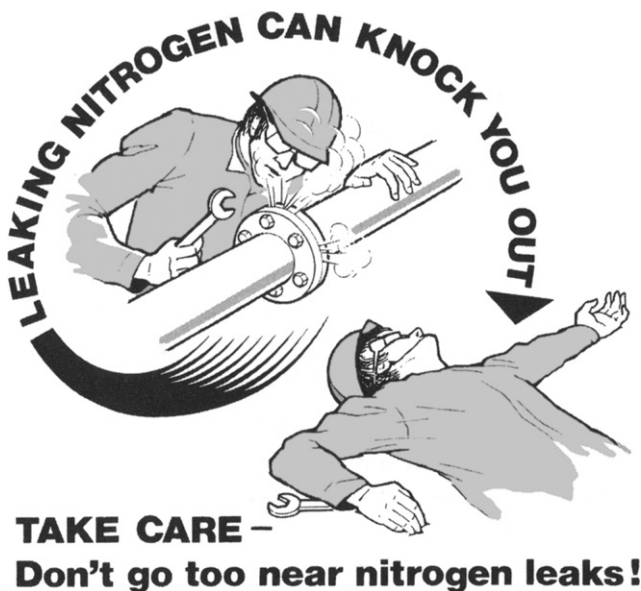
FIGURE 12-1

- (a) A member of a cleaning crew decided to recover a rope, which was half inside a vessel and was caught up on something inside. While kneeling down, trying to disentangle the rope, he was overcome by nitrogen. Afterward he admitted that if necessary, he would have entered the vessel.
- (b) On several occasions, people who were working on or near leaky joints on nitrogen lines have been affected. Although they knew nitrogen is harmful, they did not consider that the amount coming out of a leaky joint would harm them (Figure 12-1).

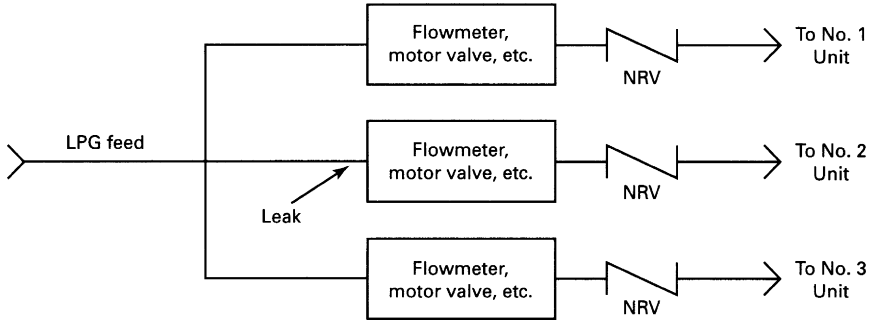
- (f)** A plant was pressure-tested before startup, but the check valves (nonreturn valves, NRV) in the feed lines to each unit (Figure 14-2) made it impossible to test the equipment to the left of them. A leak of liquefied petroleum gas (LPG) occurred during startup at the point indicated. The three check valves were then replaced by a single one in the common feed line at the extreme left of the diagram.

FIGURE 14-2 The check valves (nonreturn valves, NRV) prevented a leak test of the equipment to the left of them. During startup, a leak occurred at the point indicated.

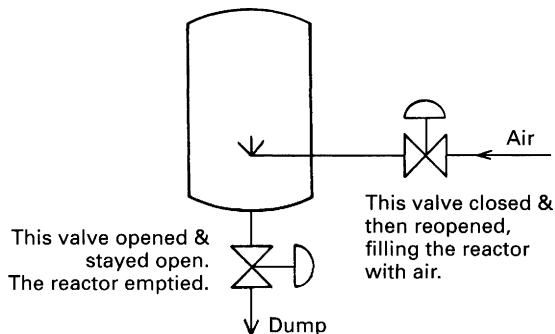
- (b)** A liquid-phase hydrocarbon oxidation plant was fitted with a high-temperature trip, which shut off the air and opened a drain valve that dumped the contents of the reactor in a safe place (Figure 14-4). If the air valve reopened after a dump, a flammable mixture could form in the reactor.

One day the temperature-measuring device gave a false indication of high temperature. The air valve closed, and the drain valve opened. The temperature indication fell, perhaps because the reactor was now empty. The drain valve stayed open, but the air valve reopened, and a flammable mixture was formed in the reactor. Fortunately, it did not ignite.

The air valve reopened because the solenoid valve in the instrument air line leading to the air valve would not stay in the tripped position. It should have been fitted with a latch.

FIGURE 14-4 When the air valve reopened after a dump, a flammable mixture formed in the reactor.

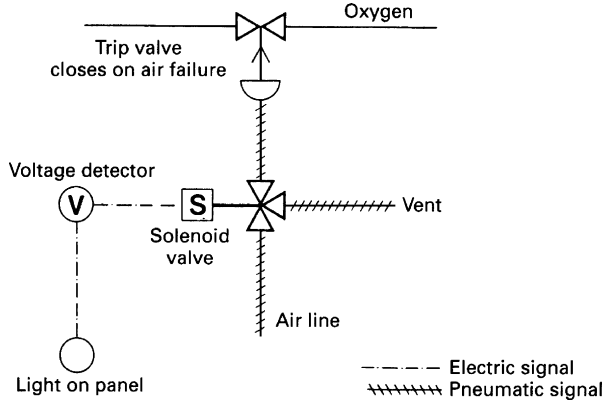
An ethylene oxide plant tripped, and a light on the panel told the operator that the oxygen valve had closed. Because the plant was going to be restarted immediately, he did not close the hand-operated isolation valve as well. Before the plant could be restarted, an explosion occurred. The oxygen valve had not closed, and oxygen continued to enter the plant (Figure 14-5).

Actually the air was not vented. A wasp's nest choked the 1-in. vent line on the air supply. Whenever possible, we should measure directly

FIGURE 14-5 The light shows that the solenoid is de-energized, not that the oxygen flow has stopped.

what we need to know and not some other parameter from which it can be inferred [1].
