Library of Congress Cataloging-in-Publication Data
Kletz, Trevor A.

What went wrong? : case histories of process plant disasters and how they could have been avoided / Trevor Kletz. —5th ed.

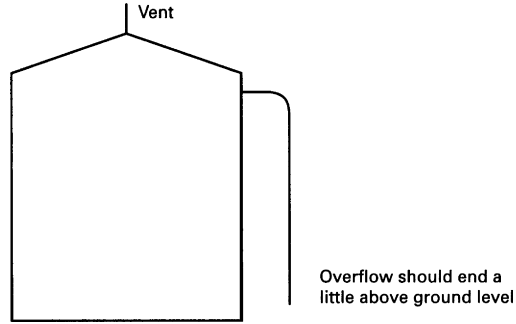
In another case, acidic water was used to clean the inside of the water jacket that surrounded a glass-lined vessel. Some hydrogen

FIGURE 16-1 Acid tanks should be fitted with a high-point vent, as well as an overflow, so that hydrogen can escape.

diffused through the wall of the vessel and developed sufficient pressure to crack the glass lining.

The tank should have been fitted with a vent at the highest point, as shown in Figure 16-1.

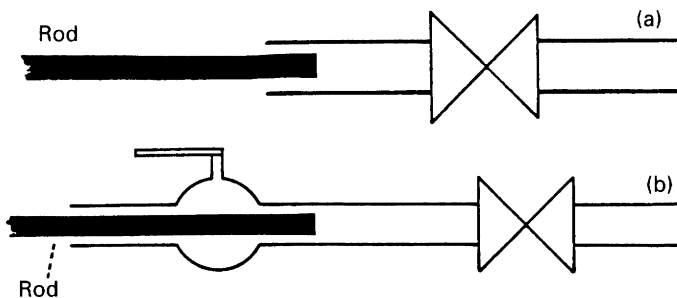
- (a)** A man was rodding out a choked $\frac{1}{4}$ -in. line leading to an instrument (Figure 17-1a). When he had cleared the choke, he found that the valve would not close and he could not stop the flow of flammable liquid. Part of the unit had to be shut down.

FIGURE 17-1 The wrong (a) and right (b) ways of clearing a choked line.

Rodding out *narrow bore* lines is sometimes necessary. But before doing so, a ball valve or cock should be fitted on the end (Figure 17-1b). It is then possible to isolate the flow when the choke has been cleared, even if the original valve will not close.

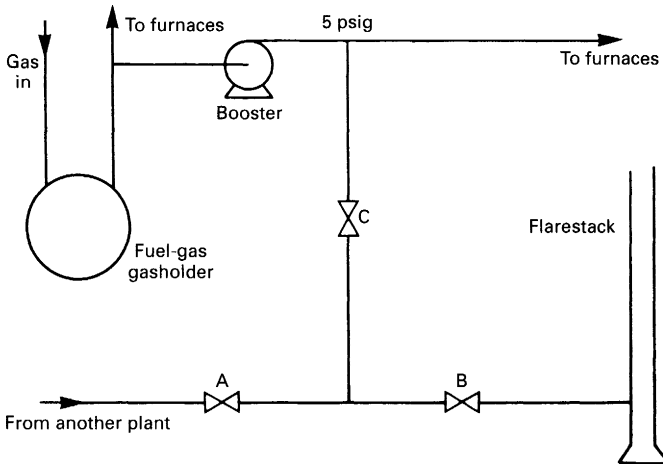
The flarestack shown in Figure 17-3 was used to dispose of surplus fuel gas, which was delivered from the gasholder by a booster through valves C and B. Valve C was normally left open because valve B was more accessible.

One day the operator responsible for the gasholder saw that it had started to fall. He therefore imported some gas from another unit. Nevertheless, a half-hour later the gasholder was sucked in.

Another flarestack at a different plant had to be taken out of service for repair. An operator at this plant therefore locked open valves A and B so that he could use the "gasholder flarestack." He had done this before, though not recently, and some changes had been made since he last used the flarestack. He did not realize that his action would result in the gasholder emptying itself through valves C and B. He told three other men what he was going to do, but he did not tell the gasholder operator. He did not know that this man was concerned.

FIGURE 17-3 Different operators controlled valve B.

Responsibility for each item of equipment should be clearly defined at the supervisor, foreman, and operator levels, and only the people responsible for each item should operate it. If different teams are allowed to operate the same equipment, then sooner or later an incident will occur.

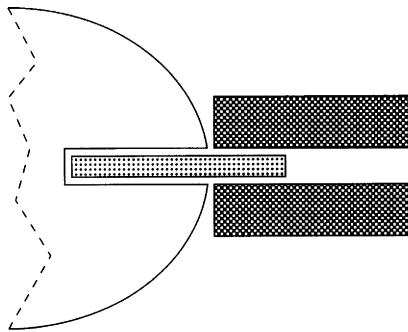
A vessel was fitted with a simple mechanical interlock: a horizontal pin fitted into a slot in the vessel lid; the lid could not be moved sideways until the pin was withdrawn (Figure 17-4). A solenoid controlled movement of the pin. The solenoid could not be activated and the pin withdrawn until various measurements, including the temperature and level of the liquid in the vessel, were within specified ranges.

Nevertheless the lid was moved, although the measurements were not correct. Several possible explanations were considered:

1. The pin might have been seized inside the solenoid. Unfortunately, the operator, believing this to be the case, had squirted a lubricant into the solenoid chamber before any investigation could be carried out. A vertical pin would have been less likely to stick.
2. The operator, believing that all measurements were correct, might have assumed that the system was faulty and inserted a thin strip of metal into the end of the slot and moved the pin back into the solenoid. He denies doing this but admits that he did not check the temperature and level readings to make sure they were correct before trying to move the lid.

FIGURE 17-4 A simple mechanical interlock: the lid could not be moved until the pin was withdrawn from the slot.

In the original design, the pin fitted into a hole, but the hole was changed to a slot so the operator could see the position of the pin. At the time no one realized that this made it possible for someone to move the pin by hand, another example of the unseen results of a plant modification. To prevent this, a sheet of transparent plastic could have been used to cover the slot.

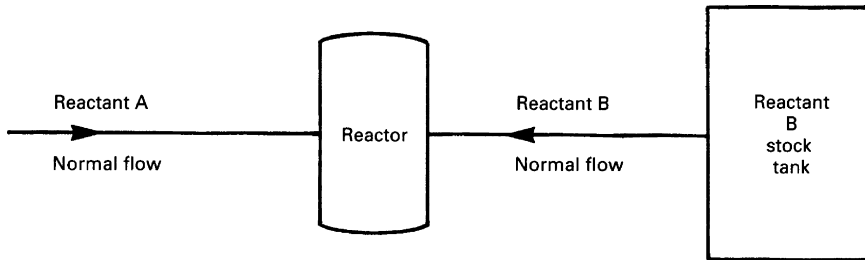
The most serious incidents resulting from reverse flow have occurred when reactant A (Figure 18-5) has passed from the reactor up the reactant B feed line and reacted violently with B.

A more serious incident occurred at a plant in which ethylene oxide and aqueous ammonia were reacted to produce ethanolamine. Some ammonia got back into the ethylene oxide storage tank, past several check valves in series and a positive pump. It got past the pump through the relief valve, which discharged into the pump suction line. The ammonia reacted with 30 m³ of ethylene oxide in the storage tank. There was a

FIGURE 18-5 Reverse flow of A occurred from the reactor into the B stock tank.

violent rupture of the tank, followed by an explosion of the vapor cloud, which caused damage and destruction over a wide area [4].

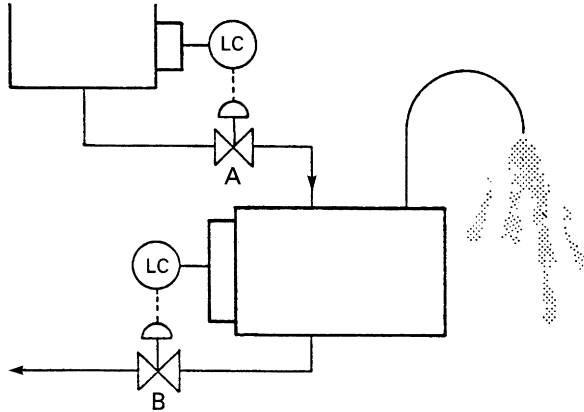
- (a)** Figure 18-6 shows part of an old unit. Valve A could pass a higher rate than valve B. Inevitably, in the end the lower tank overflowed.
- (b)** Raw material was fed to a unit from two stock tanks, A and B. Tank A was usually used; tank B was used infrequently. The raw material was pumped to a head tank from which excess flowed back, as shown in Figure 18-7. The system was in use for several years before the inevitable happened. Tank B was in use; tank A was full, and the flow from the head tank caused it to overflow.
- (c)** A funnel was installed below a sample point so that excess liquid was not wasted but returned to the process (Figure 18-8). What will happen if a sample is taken while the vessel is being drained?

FIGURE 18-6 Valve A could pass a higher rate than valve B, thus making a spillage inevitable.

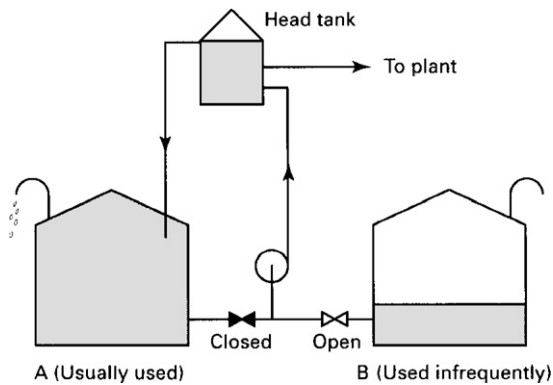
FIGURE 18-7 If A is full and suction is taken from B, A will overflow.

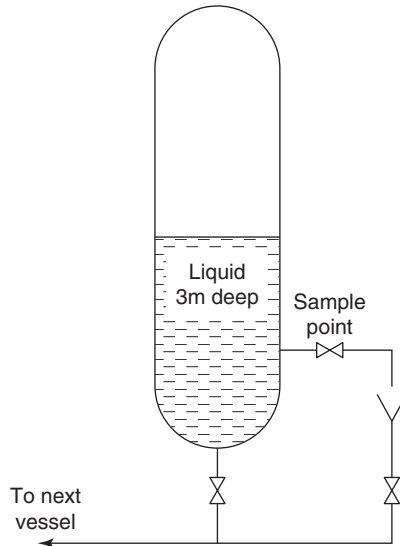
FIGURE 18-8 What will happen if the vessel is drained while a sample is being taken?

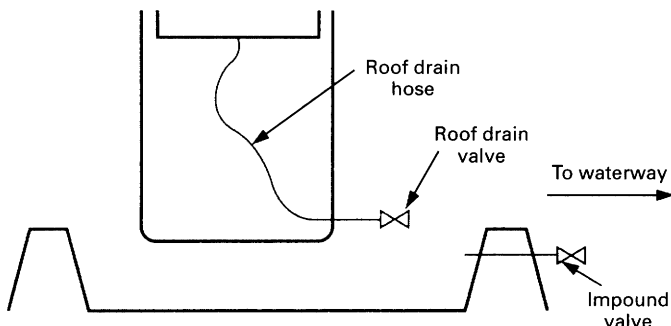
- (a) Figure 18-9 shows a floating-roof tank located in a dike. Rainwater can be drained from the roof into the dike and from the dike into a waterway. The team members are considering whether any substance other than water can get into the waterway. For this to occur, there would have to be a hole in the hose, and both valves would have to be left open. An inexperienced team may decide that a triple failure is so improbable that there is no need to consider it further.

FIGURE 18-9 Liquid other than rainwater can reach the waterway only if there is a hole in the hose and both valves are left open. This is not as unlikely as it seems at first sight. (Used with permission from *Hydrocarbon Processing*, Apr. 1992. Copyright © 1992 Gulf Publishing Co. All rights reserved.)

Someone with knowledge of the practicalities of plant operation would realize that during prolonged rain the operators may leave both drain valves open, whatever the instructions say, to avoid frequent visits to the tank. Any hole in the hose will then contaminate the waterway with oil [20].

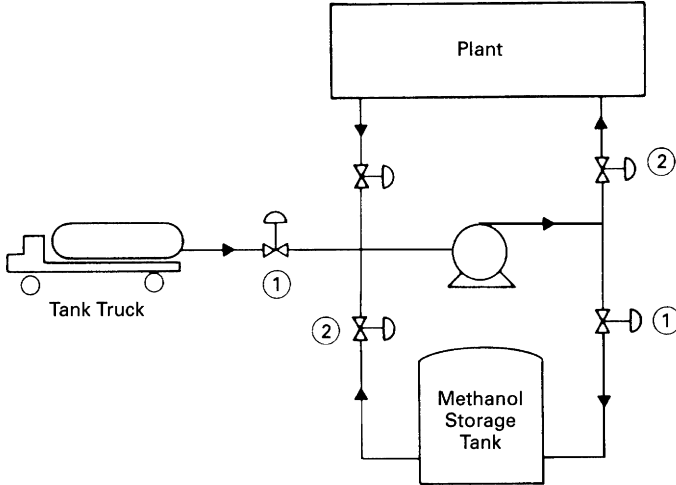
A pump and various pipelines were used for three different duties: for transferring methanol from a tank truck to storage, for charging it to the plant, and for moving recovered methanol back from the plant (Figure 20-1). A computer set the various valves and monitored their positions.

A tank truck was emptied. The pump had been started from the control room but had been stopped by means of a local button. The next job was to transfer some methanol from storage to the plant. The computer set the valves, but as the pump had been stopped manually, it had to be started manually. When the transfer was complete, the computer told the pump to stop; but as it had been started manually, it did not stop, and a spillage occurred [3].

FIGURE 20-1 A pump and lines, controlled by a computer, were used for several different jobs. The pump could also be started and stopped locally. (1) Valves open for first job; others closed. (2) Valves open for second job; others closed.

A thorough Hazop probably would have revealed that this error could have occurred. The control system could have been modified, or better still, separate lines could have been installed for the various different movements, thus greatly reducing the opportunities for error. The incident shows how easily errors in complex systems can be overlooked if the system is not thoroughly analyzed. In addition, it illustrates the paradox that we are willing to spend money on complexity but are less willing to spend it on simplicity [4]. Yet the simpler solution, independent lines (actually installed after the spillage), makes errors less likely and may not be more expensive if lifetime costs are considered. Control systems need regular testing and maintenance, which roughly doubles their lifetime

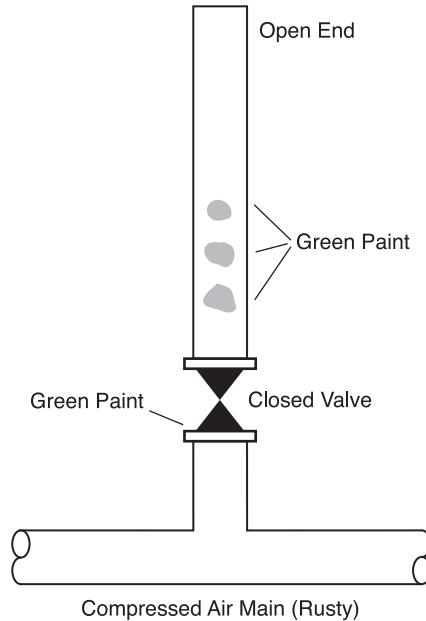
One of the sections was a short vertical length of pipe, 75 mm (3 in.) in diameter and ≈ 1.5 m (5 ft) long, sticking up above a compressed air main that was still in use (Figure 23-1). The valve between the pipe and the main was tagged to show that it was closed to protect equipment under maintenance. The short length of pipe was marked with several green patches. Unfortunately, there was also some green paint on the flange below the isolation valve. This green paint might have been the remains of an earlier job or it might have accidentally got onto the flange while the pipe above it was being sprayed. The mechanic who had been asked to remove the pipe broke this flange. There was a sudden release of compressed air at a gauge pressure of ≈ 7 bar (100 psig). Fortunately, the mechanic escaped injury.

The mechanic did not, of course, realize that the compressed air line was still in use. Like the old pipes he was removing, it was rusty and he assumed it was out of use.

FIGURE 23-1 The lower flange was unbolted in error.

which joint or joints should be broken. The report on the incident stated that in the future, maintenance workers should be shown precisely which piece of equipment is to be maintained, which joint to break, and so on. However, experience shows that this is not enough. Before starting work, the maintenance worker may go for tools or for spares and then come back and break the wrong joint or remove the wrong valve. Equipment to be worked on should be numbered or labeled and the number or name put on the permit-to-work. If there is no permanent number, a numbered tag should be tied to the flange that is to be broken, the valve that is to be changed, or the pipe that is to be cut (and at the point at which it has to be cut).

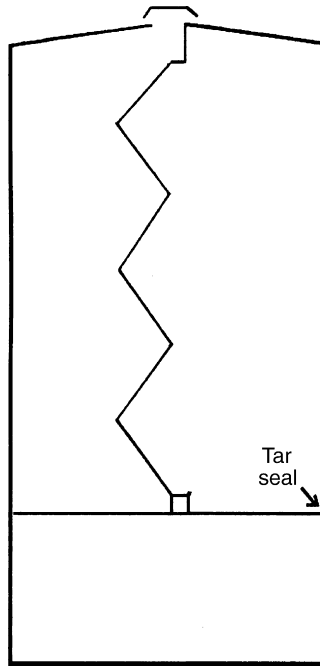
At a guess, the volume of the gasholder was several thousand m^3 and its height was $\approx 3 \times$ its diameter. To get inside it, we had to go up a staircase onto the roof, through an opening in the center, and then down a Jacob's ladder, a folding ladder, onto the disc. As Figure 24-2 shows, during half the descent we were clinging to the wrong side of the sloping ladder. Fortunately, the gasholder was nearly empty and the angle of the ladder was not too great.

FIGURE 24-2 Diagram of dry gasholder showing Jacob's ladder.

atmosphere above the disc in the gasholder was not tested before we entered and there was no entry permit and no standby man, although the foreman mentioned that strictly speaking there should have been one (this was many years ago). The whole experience was eerie, and I have never forgotten it.

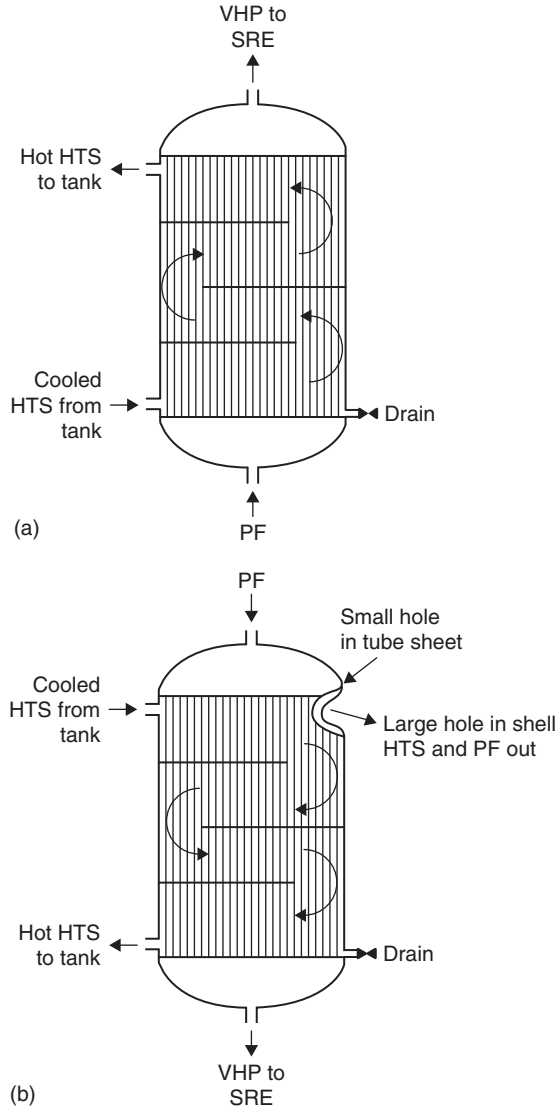
Figure 25-1a shows the original design of a reactor. Hot feed gas (PF [preheated feed]) was passed upward through catalyst tubes 3 m (10 ft) long. The heat of reaction was removed by circulating a molten salt (HTS [heat transfer salt]) through the shell. Note that the flow of this liquid was also upward.

The hot exit gases were cooled in a waste heat boiler. During a review of the model, the contractors pointed out that the boiler required an expensive structure to support it. They could avoid this cost, they said, by reversing both flows through the reactor, as shown in Figure 25-1b, and putting the boiler at ground level. This was agreed.

FIGURE 25-1 (a) Original design of reactor. (b) Reversing the flow allowed a gas bubble to be trapped below the top tubesheet and led to overheating of the tops of the tubes. PF = preheated feed; HTS = heat transfer salt; VHP = very hot product gases; and SRE = steam raising exchanger. From reference 10. (Reprinted with the permission of the Institution of Chemical Engineers.)

It might have been possible to retain the downward flow and to vent any gas bubbles back to the suction tank in the salt system. However, preventing the formation of bubbles is better than letting them form and then getting rid of them.

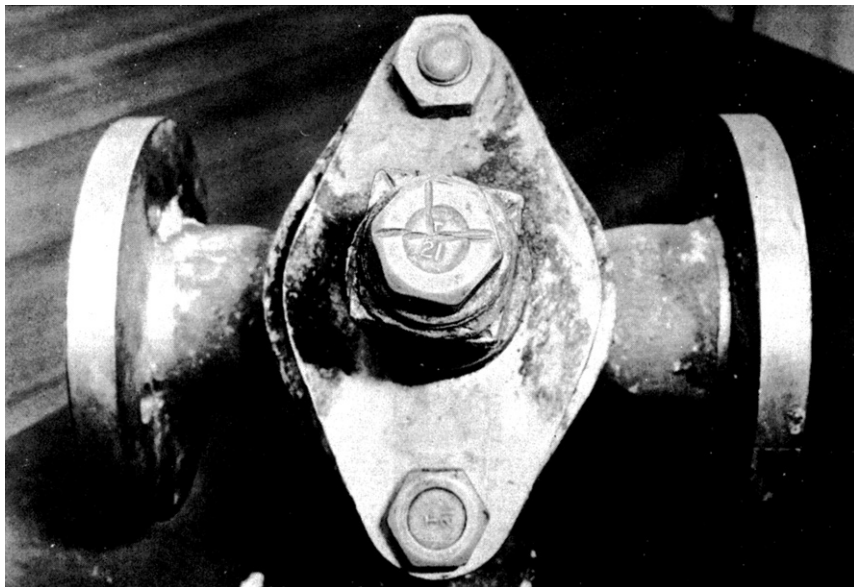
Figure 25-3 shows a three-way cock in which the top of the central bolt has been marked to show the position of the cock. This was presumably done because the marks on the plug itself are hard to see. They are just faintly visible in the photograph.

Originally the marks on the bolt corresponded to those on the plug. At some time, two washers were placed underneath the bolt. It could no longer be screwed right in and the marks no longer corresponded.

FIGURE 25-3 The central bolt was marked to show the position of the cock. When two washers were inserted under the bolt, it could not be screwed down as far as before and the marks no longer corresponded with the position of the cock.

Most of the operators on the unit set the cock according to the marks on the bolt. Ultimately, this led to misdirection of a process stream, formation of an explosive byproduct, and an explosion.

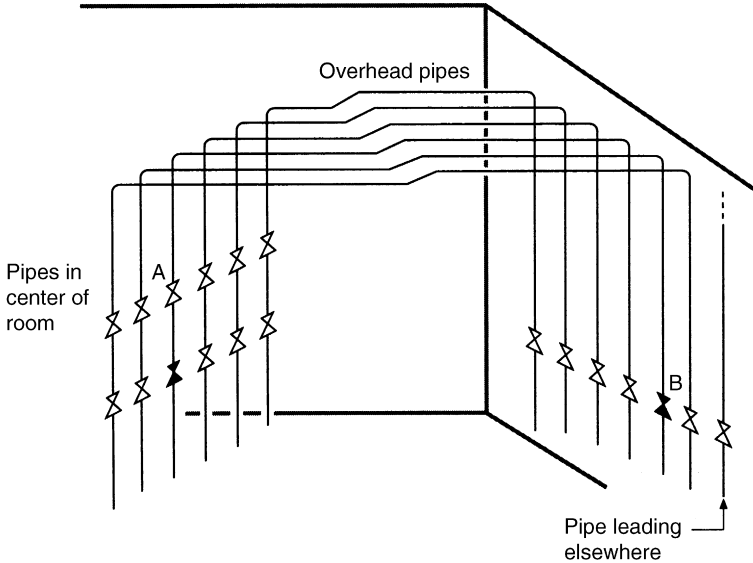
The fine adjustment valve A in Figure 27-1 had to be changed. The operator closed the valve below it. To complete the isolation, he intended to close the valve on the other side of the room in the pipe leading to valve A. He overlooked the double bends overhead and closed valve B, the one opposite valve A. Both of the valves that were closed were the third from the ends of their rows. Note that the bends in the overhead pipes are in the horizontal plane. When the topwork of valve A was unbolted, the pressure of the gas in the line caused the topwork to fly off and hit the wall, fortunately missing the mechanic who had unbolted it.

FIGURE 27-1 To change valve A, the operator closed valve B and the valve below valve A. Both closed valves are shown in black. From reference 5. (Reprinted with the permission of the Institution of Chemical Engineers.)

The report on the incident recommended various changes in the instructions to make the duties of people who prepare equipment for maintenance clearer than they were. They were told to trace lines to make sure that the correct isolations have been made.

Color coding of the pipes or valves would have been much more effective but was not considered. The default action of many of the people

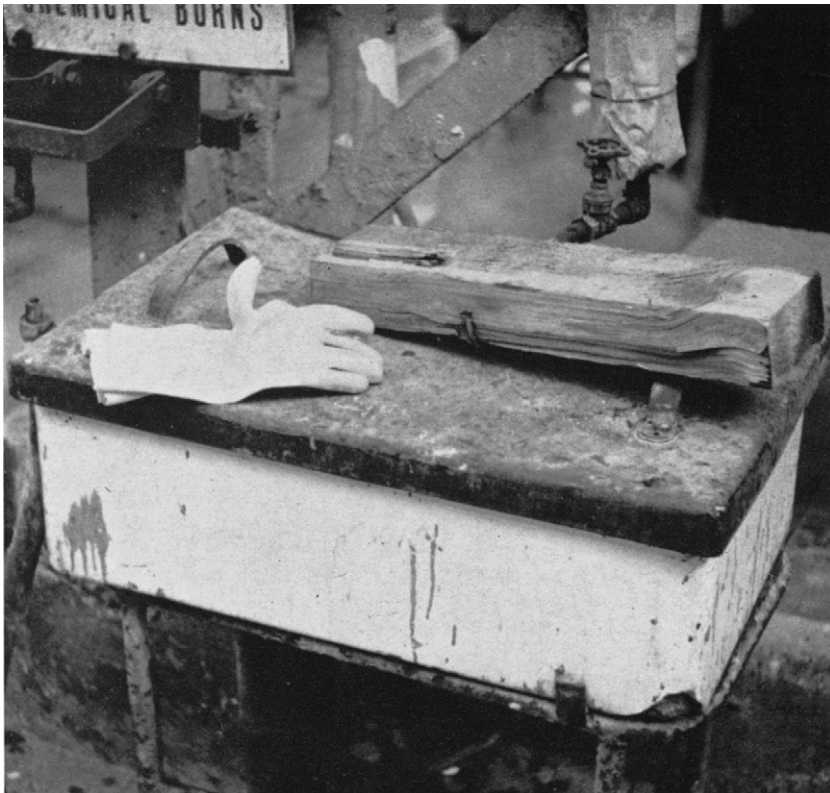
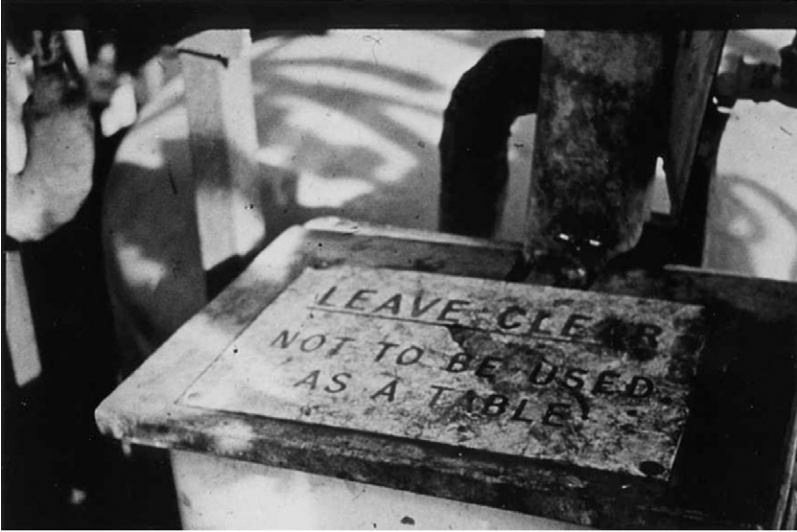
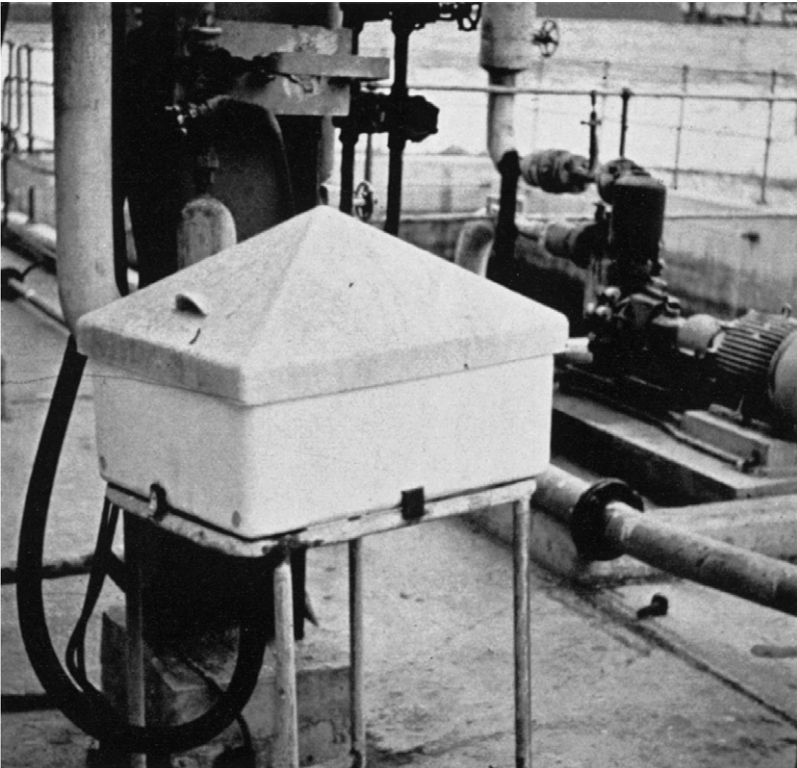
Washbasins filled with water were installed at a plant so that anyone splashed with a corrosive chemical could wash it off immediately. The basins were covered to keep the water clean, but people used the covers as tables (Figure 27-4a). Figure 27-4b shows the action taken, and Figure 27-4c shows a better solution.

Perhaps there is something wrong with our educational system or company culture when educated and professionally trained people take the action shown in Figure 27-4b.

FIGURE 27-4 (a) The cover over the washbasin was used as a table. (b) The solution. (c) A better solution.

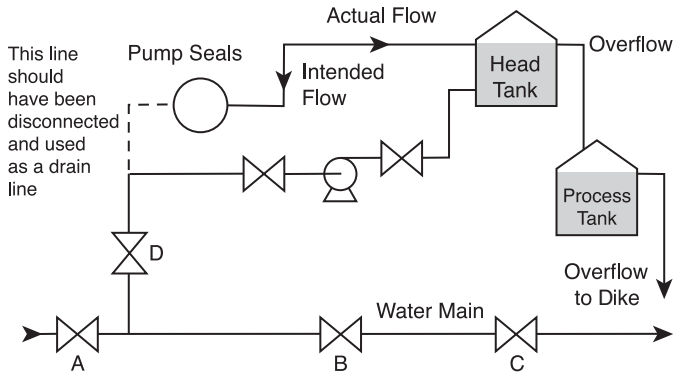
Figure 29-1 shows the layout of the relevant pipework on an experimental unit that was used intermittently. In the original design, the pump

FIGURE 29-1 When the unit was modified, the contractors forgot to disconnect the dotted pipeline. As a result, water flowed in the opposite direction to that intended and into the head tank.

seals were supplied with water via valve D. However, the pressure in the main varied and therefore, to provide a more consistent supply, a small head tank was installed and the old supply line to the pump seals was then used as the drain line. During construction, the need to disconnect it from the water main was overlooked and it remained connected. Perhaps the designers of the modification failed to tell the construction team that the line should have been disconnected, or perhaps they were told but failed to do so. Either way, nobody checked the job thoroughly (if at all) after completion and the company's procedure for the control of modifications was ignored, as the plant was only an experimental one.

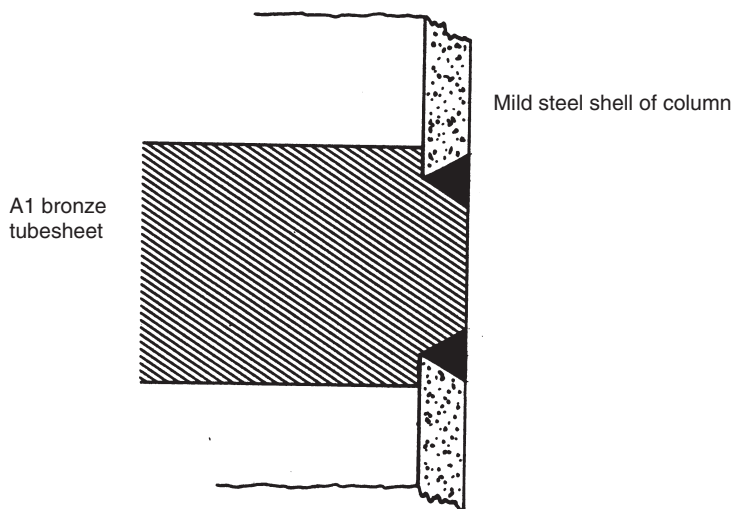
FIGURE 32-2 No one at the plant was aware of this unusual method of construction.

An unusual method of construction produced another hidden hazard. A steel fractionation column was fitted with an internal condenser that had an aluminum-bronze tubesheet. It had the same diameter as the vessel but was welded to it in an unusual way, as shown in Figure 32-2. One of the welds cracked in service, and flammable vapor escaped. Fortunately, it did not ignite.

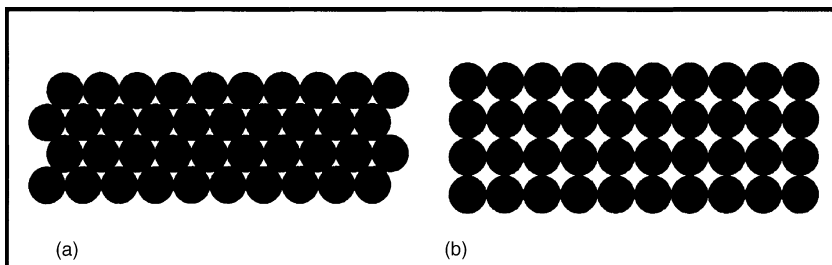
FIGURE 32-3 (a) Close packing of uncharged spheres. (b) Open packing of charged spheres.

showed that this amount of powder would fit into the bags, nevertheless it backed up into the machine and caused it to stall. It had to be stripped down and cleaned before packing could continue.

Experiments showed that rapid filling of the powder lowered the bulk density by 10% as charges of static electricity on the particles pushed them farther apart. Instead of being closely packed as in Figure 32-3a, they were more openly packed as shown in Figure 32-3b. As the output of the plant was large, a machine for eliminating the static charge was designed and installed [13].

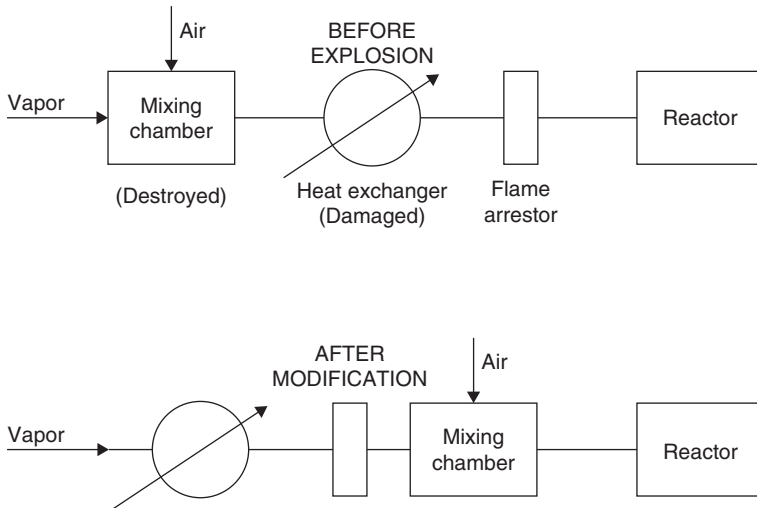
After a two-year operation, an explosion demolished the mixer and damaged the heat exchanger. The probable source of ignition was an

FIGURE 32-4 Layout of equipment in vapor phase oxidation unit before and after explosion in reactor.

unlikely one. The vaporizer had to be cleaned from time to time. Various agents had been used including acids, which had attacked the vaporizer and deposited a mixture of metal and organic residues in the mixer. These oxidized and became hot enough to ignite the flammable mixture of reactant vapor and air in the mixer.

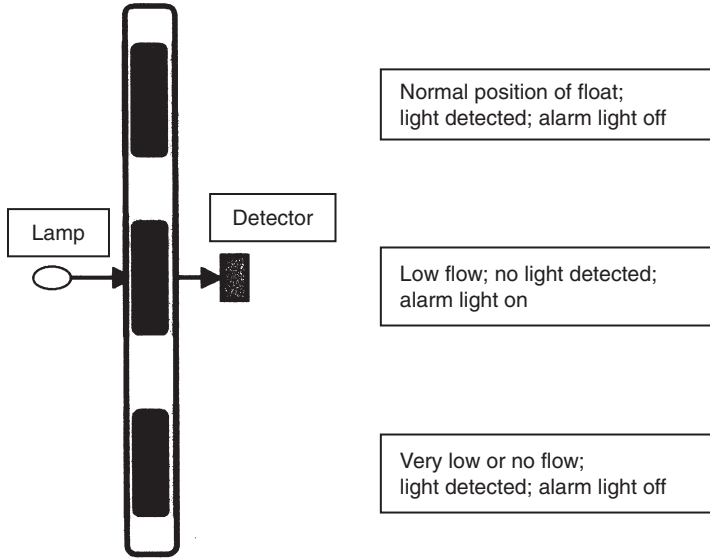
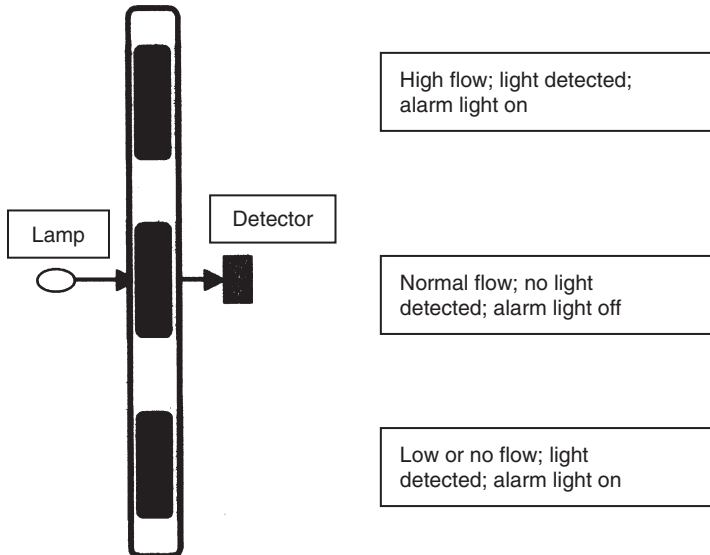
The design had limitations. If the flow diminished only slightly, the light beam remained broken and the alarm light stayed on after the alarm bell was silenced. However, if the flow fell substantially or stopped completely, the float dropped farther, the light beam was no longer broken, and the alarm light went out (Figure 33-2a). One day when the flow actually failed, the operator canceled the alarm, but with no light to remind him he was distracted by other problems and forgot that the gas flow had stopped. Several hours passed before this was discovered.

FIGURE 33-2 (a) Original design of rotameter low-flow alarm. (b) Revised design of rotameter low-flow alarm.

Afterward, the design was changed so that the light beam was broken when the flow was normal but fell on the light sensor if the flow changed (see Figure 33-2b). The alarm light then remained lit as long as the low flow continued. As a bonus, it was also activated by a high flow.

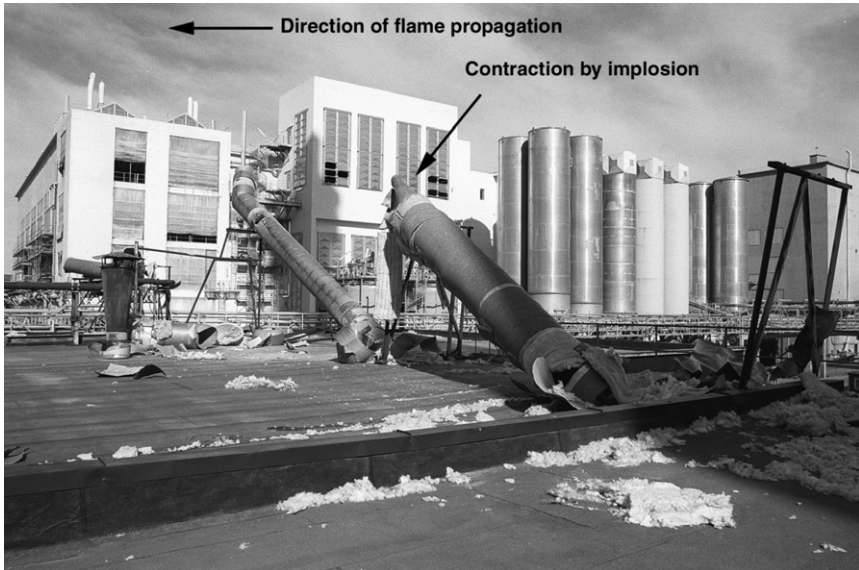
During shutdowns, the ammonia plant was swept out with nitrogen, which contaminated the carbon dioxide. Nitrogen has twice the thermal conductivity of hydrogen, so the hydrogen measurements were ignored until the nitrogen had been swept out of the pipeline. You have already guessed what happened: air got into the transfer line during this period and an explosion occurred; 850 m (2,800 ft) of the pipeline was destroyed (Figure 33-3).

FIGURE 33-3 The result of hydrogen and air entering a pipeline. From reference 1. (Reprinted with the permission of the American Institute of Chemical Engineers.)

instead of nitrogen for sweeping out the ammonia plant. The source of ignition may have been heat from cutting a bolt.

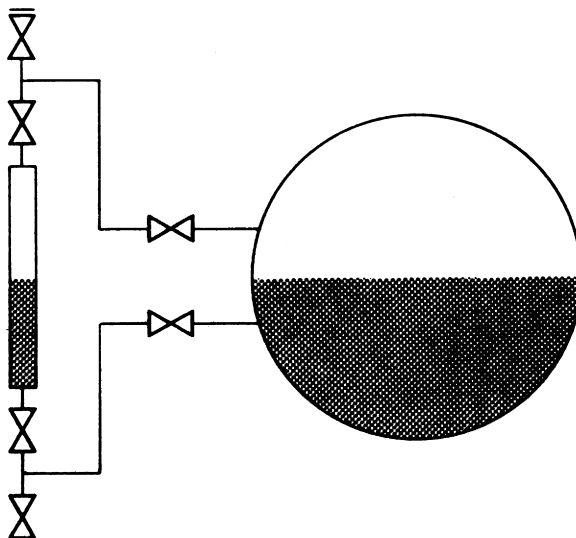
A sight-glass 1.2 m (4 ft) long was connected to vessel branches 0.6 m (2 ft) apart as shown in Figure 33-4. It will indicate the correct level only when the liquid in the vessel is between the two branches. If the liquid level is below the lower branch, the liquid in the sight-glass is isolated and its level cannot fall. If the liquid level is above the upper branch, vapor will be trapped in the upper part of the sight-glass. As the level rises, this vapor will be compressed. If any noncondensable gas is present, the

FIGURE 33-4 A level glass with a limited range. From *Chemical Engineering Progress*, July 1980. (Reprinted with the permission of the American Institute of Chemical Engineers.)

pressure in the sight-glass will rise and the level in the sight-glass will be depressed below the level in the vessel.

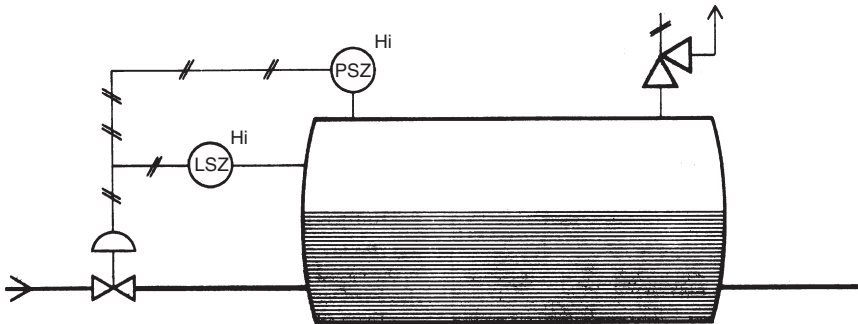
FIGURE 33-6 The designer of this system seemed unaware of the difference between vapors and noncondensable gases. From *Chemical Engineering Progress*, July 1980. (Reprinted with the permission of the Institution of Chemical Engineers.)

petroleum gas (LPG) is fitted with a level controller (not shown) and, in addition, a high-level trip to isolate the inlet line if the level gets too high (Figure 33-6). The high-level trip might fail; the relief valve will then lift and discharge liquid to the atmosphere so a high-pressure trip is installed as well.

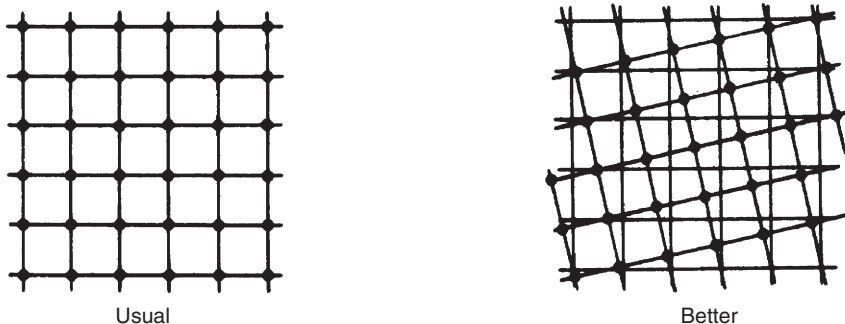
If tests are being carried out on a vessel, they are often made on the points of a grid. Lines of weakness (such as welds) may then be missed.

FIGURE 33-8 If test points are on a grid, it should be tilted so that no lines of weakness are missed.

The grid should be tilted so that the test points are not all above or below each other (Figure 33-8).

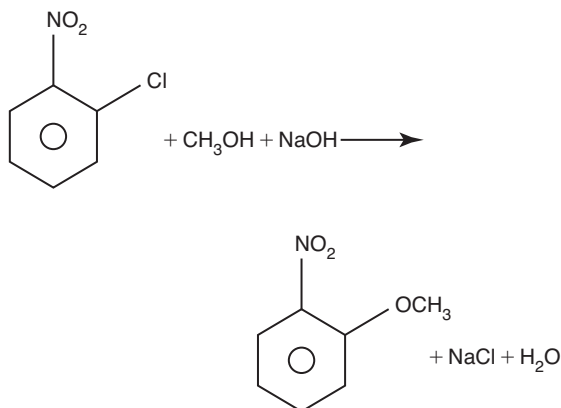
One day, after replacing the manway cover (step 3), the operator forgot to switch the stirrer back on. There was no mixing, and the caustic soda plus methanol (added in step 5) formed a separate layer. No reaction occurred,

FIGURE 35-1 Late mixing of this reaction led to a leak that covered 75 acres.

and the operator had to apply heat instead of cooling to the jacket to maintain the temperature at 80°C (175°F). When the operator realized that the stirrer was not running, he switched it on. A very rapid reaction occurred, the temperature rose to at least 160°C (320°F), and the pressure rose to 16 bar gauge (230 psig). Most of the contents of the reactor, 10 tons of liquid, were discharged through the relief valve and a yellow deposit was distributed over 300,000 m² (75 acres) of a builtup area, a suburb of Frankfurt, Germany.

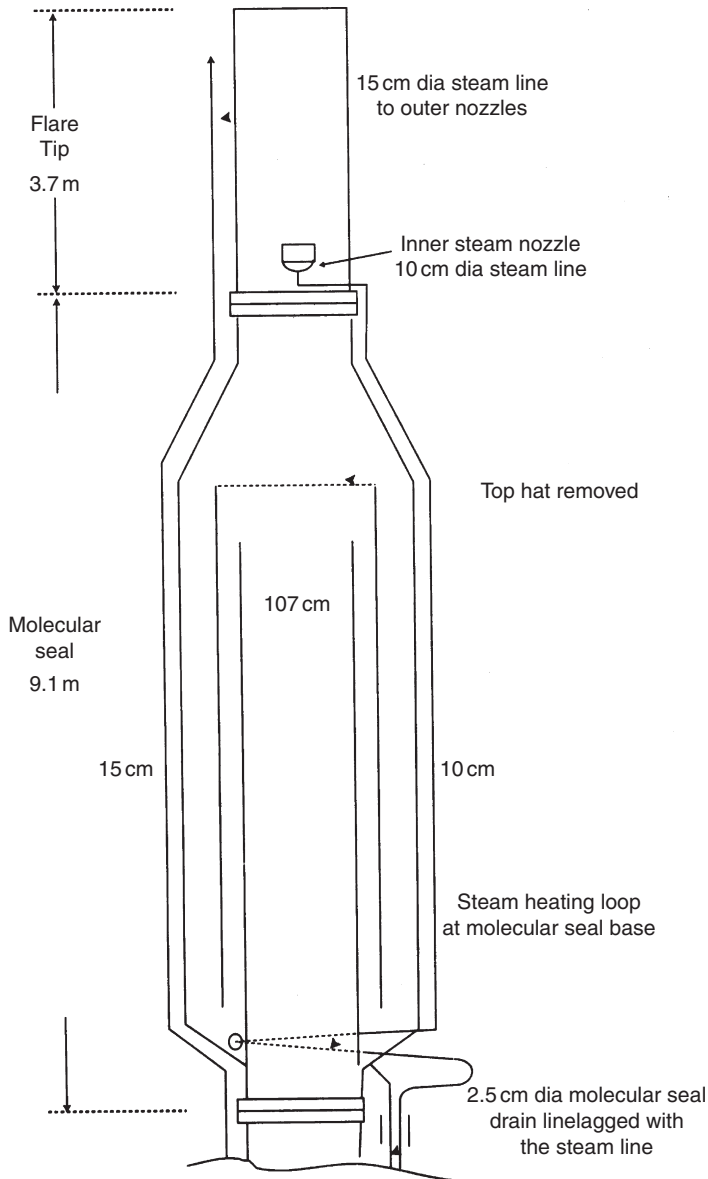
Many explosions have occurred in flarestacks because a normally continuous flow of gas failed or fell to a very low level and air diffused down the stack, forming an explosive mixture (see Chapter 6). To reduce such diffusion, many companies have installed molecular seals: the gas leaving the stack and any air diffusing down follow a labyrinthine path, as shown in Figure 36-2. However, these seals have disadvantages. Carbon from incompletely burned gas can fall into the bottom of the seal and block the flow. Ideally, material discharged from a relief valve should follow a simple and straightforward path without any equipment that might obstruct the flow. For this reason, some companies have had second thoughts and removed the top of the molecular seal, called the “top hat,” as shown by the dotted line in Figure 36-2. This effectively neutralizes the seal but leaves the rest of it in position. On one plant, a steam nozzle was added inside the stack to cool the tip and to reduce smoke formation. Some of the steam condensed and flowed down the drain line into the knock-out drum. In the stack shown in Figure 36-2, the drain line was insulated with the steam line to prevent freezing.

Unfortunately, the drain line had only a 1-in. diameter. It became partially blocked with carbon and a pool of water formed in the bottom of the molecular seal. It filled the outer rings of the seal and overflowed into the inner pipe. Some of it froze when unusually large quantities of cold gas had to be flared during cold weather, partially choking the inner pipe. Finally, there was a rumbling noise and bits of ice and a stream of water were blown out of the stack. The flame was extinguished. Similar

FIGURE 36-2 The top of a flarestack fitted with a "top hat." From reference 6. (Reprinted with the permission of the Institution of Chemical Engineers.)
